April 2022

Dealer Service Instructions for:

Customer Satisfaction Notification Y97 Hub Bolts

2020 - 2021 (RU) Chrysler Pacifica/Voyager (AWD)

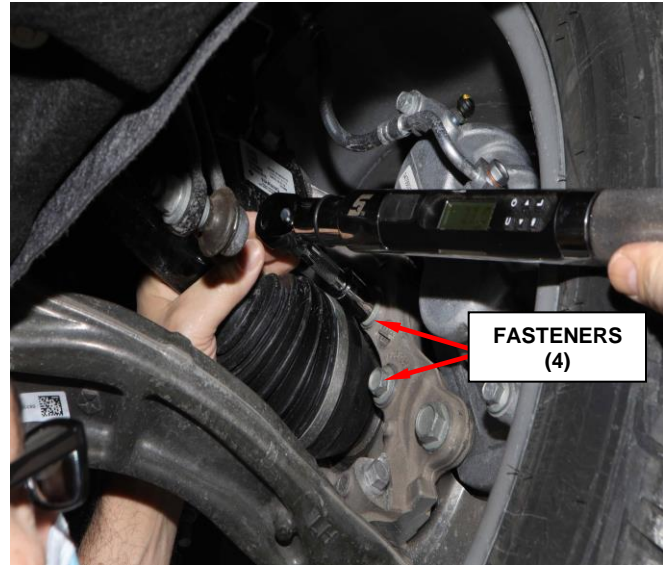
Figure 1 – Hub-to-Knuckle Fasteners

The front suspension bearing-to-hub bolts on about 11,060 of the above vehicles may have not been properly torqued. This can result in noise coming from the front suspension which may sound like a “Clunk or Clank” while driving.

1. Raise vehicle on a hoist.
2. Using a torque wrench check all of the front hub-to-knuckle mounting fasteners if they are torqued to 125 N·m (92ft. lbs.) Figure 1.
 - **If all** of the Hub-to Knuckle fasteners are torqued to specification, no further service is required, proceed to step 3.
 - **If one or more** Hub-to-Knuckle faster is found loose, replace the fastener(s) proceed to section **B. Hub-to-Knuckle fasteners replacement procedure.**
