Windshield Replacement

This bulletin involves replacing the windshield if it has distortion.

2022 (WS) Grand Wagoneer/Wagoneer

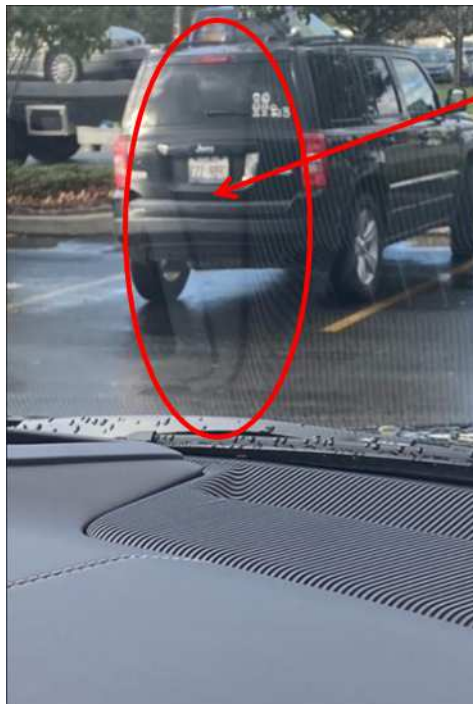
- Windshield vertical distortion in the center area of the windshield surface. (Fig. 1)

Fig. 1
Windshield distortion

1. Replace the windshield. Refer to the detailed service procedures available in DealerCONNECT> Service Library under: Service Info>23 - Body / Stationary Glass / Windshield / Removal and Installation.
2. Replace the Humidity Rain Light Sensor (HRLS) mounted on the windshield behind the Interior Mirror with the Solar Tint (HRLS). Refer to the detailed service procedures available in DealerCONNECT> Service Library under: Service Info>08 - Electrical / 8R - Wipers/Washers / MODULE, Humidity Rain Light Sensor / Removal and Installation
