NUMBER: 23-010-22 REV. A

Rear Windshield Wash Low Fluid Output / Inoperable

2022 (WS) Grand Wagoneer/Wagoneer

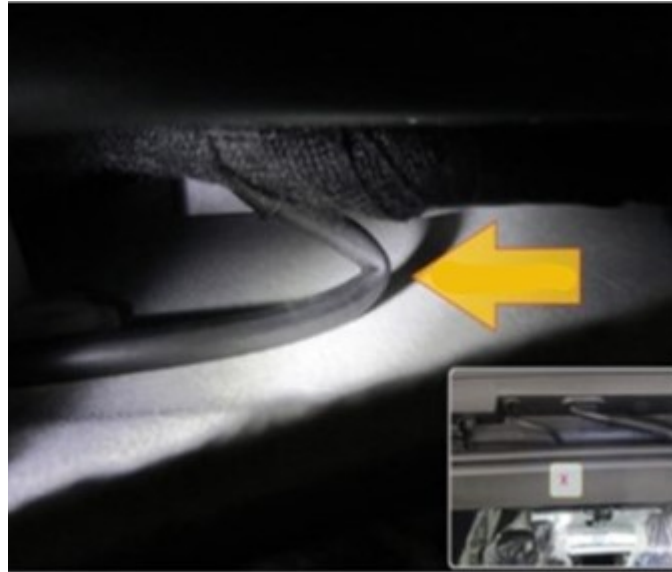
Fig. 1

- The rear wiper wash is inoperative, or low fluid output.

Rear Washer Hose Kink

1. Cycle the rear washer spray. Does it have weak fluid output?
 - YES>>> Proceed to [Step 1](#).
 - NO>>> This bulletin has been completed, use inspect LOP (23-43-10-96) to close the active RSU.
1. Remove the D-Pillars. Refer to the detailed procedures available in DealerCONNECT > Service Library> under: 23 - Panel, D-Pillar Trim Removal and Installation.
2. Lower the headliner at the rear.
3. Adjust the washer hose to remove any kinks ([Fig. 1](#)).

4. Reposition the headliner at the rear.
5. Install the D-Pillars. Refer to the detailed procedures available in DealerCONNECT > Service Library> under: 23 - Panel, D-Pillar Trim Removal and Installation.
