**NUMBER:** 07-001-22 REV. B

**GROUP:** 07 - Cooling

Water Pump Inlet Tube Fastener Torque

2018 - **\*\*2022\*\*** (JL) Jeep Wrangler

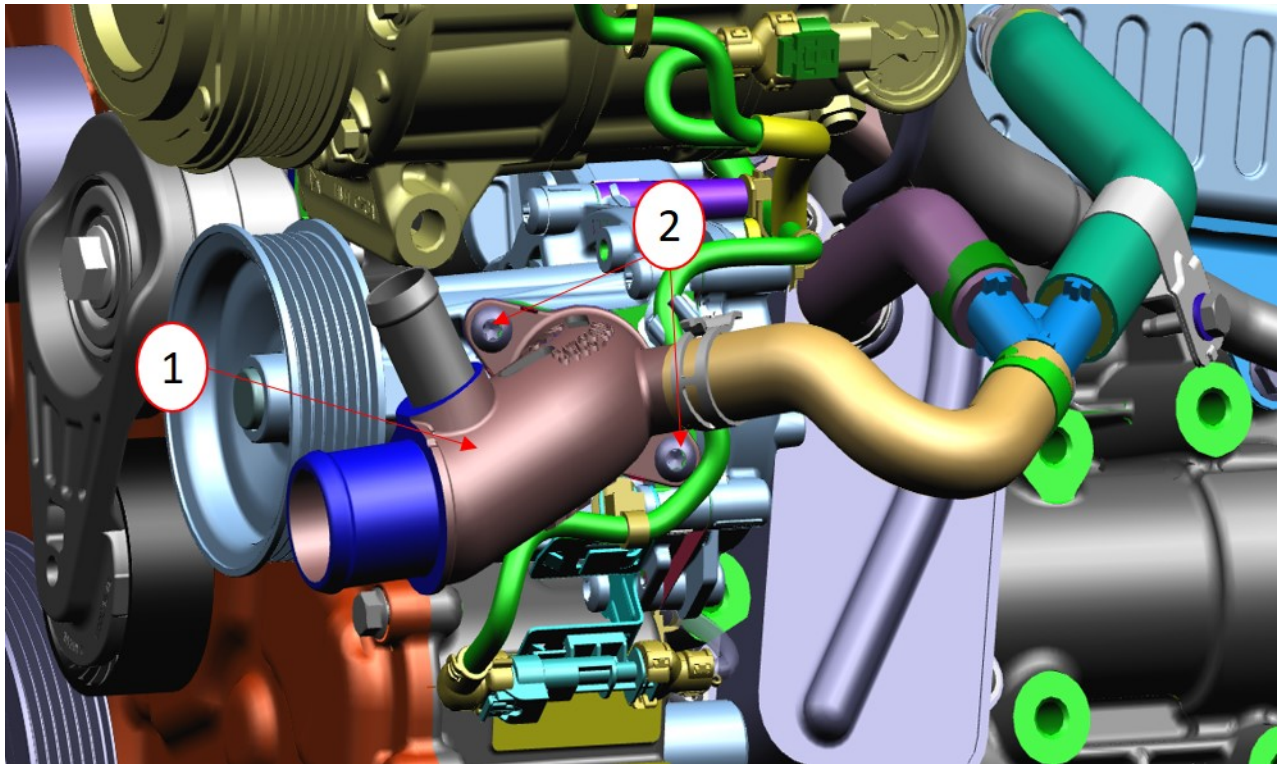
**Fig. 1**  
**Water Pump Inlet Tube Fasteners**

This bulletin involves checking the torque on the water pump inlet tube fasteners to possibly eliminate coolant leak at this location.

3. Was coolant found to be leaking from the water pump inlet tube at the engine (Fig. 1) ?
- YES>>> Proceed to [Step 1](#) of the Repair Procedure.
  - NO>>> Coolant was not leaking from this area. This bulletin does not apply. Normal diagnosis should be performed.

1. Remove one inlet tube fastener (Fig. 1) .

2. Apply Mopar 04318031AC (or equivalent) to fastener thread.
3. Install the water pump inlet tube fastener and tighten to 11 N·m (97 in. lbs).
4. Remove the other water pump inlet tube fastener.
5. Apply Mopar 04318031AC (or equivalent) to fastener thread.
6. Install the water pump inlet tube fastener and tighten to 11 N·m (97 in. lbs).
7. Wait 10 minutes after last fastener is installed prior to pressure testing the coolant system or running the engine to allow for prescribed blue thread locking adhesive cure time.

8. Pressure check the coolant system. Refer to the detailed service procedures available in DealerCONNECT>Service Library under: Service Info>07 - Cooling / Diagnosis and Testing >Leak Testing>Pressure Tester Method.
9. Is coolant still leaking from the water pump inlet tube at the engine (Fig. 1) ?
  - YES>>> Further diagnosis should be performed.
  - NO>>> This bulletin has been completed.
