# TECHNICAL SERVICE BULLETIN

Technical Service Bulletin: 51-1576

Forest River is alerting you to an issue involving certain 2022-2023 Georgetown, FR3, Coachmen Encore, Mirada, pursuit and Coachmen Class A Motorhome recreational vehicles. Please see the information below which describes the issue and provides you with details on the steps you should take to have your vehicle repaired.

# JACK INSPECTION, REMOVAL AND REPLACEMENT (IF NEEDED) FOR 8K JACKS ON MOTORIZED UNITS

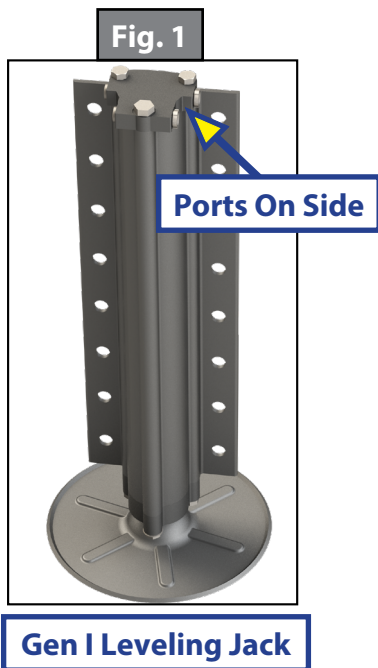
1. Inspect the unit's 8K jacks to determine if they are Gen I or Gen II jacks. Gen I jacks have ports on the side (Fig. 1) and Gen II jacks have ports on the top (Fig. 2).

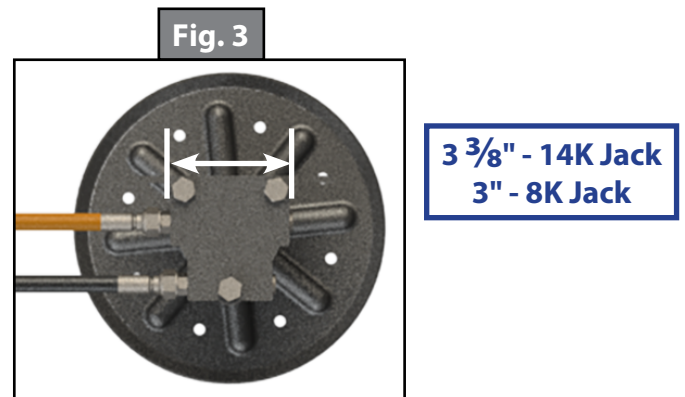
2. If the unit has 14K jacks, they do not need to be inspected or replaced. The 14K jacks, which are typically located in the rear of the unit, can be identified in two ways:
  - A. By measuring across the top cap of the jack from side to side. A 14K jack should measure 3 3/8" while an 8K measures 3" (Fig. 3).
  - B. By measuring the diameter of the rod that the footpad is attached to. A 14K jack should measure 1 7/8" while an 8K measures 1 1/2" (Fig. 4).

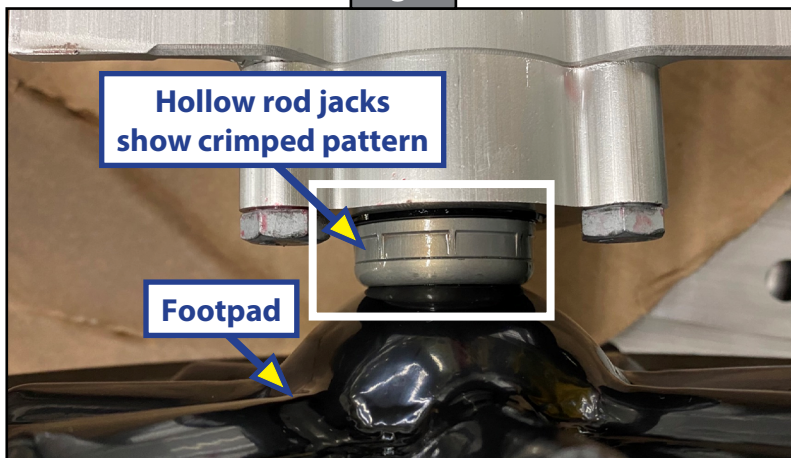
Fig. 5

3. If the unit has 8K Gen I jacks, the ONLY Gen I jacks involved in this TSB document have a crimped pattern which indicates a hollow rod (Fig. 5), visible even when the jack is retracted. Solid rod jacks do not have the crimped pattern (Fig. 6), showing a solid smooth edge around the machined end.

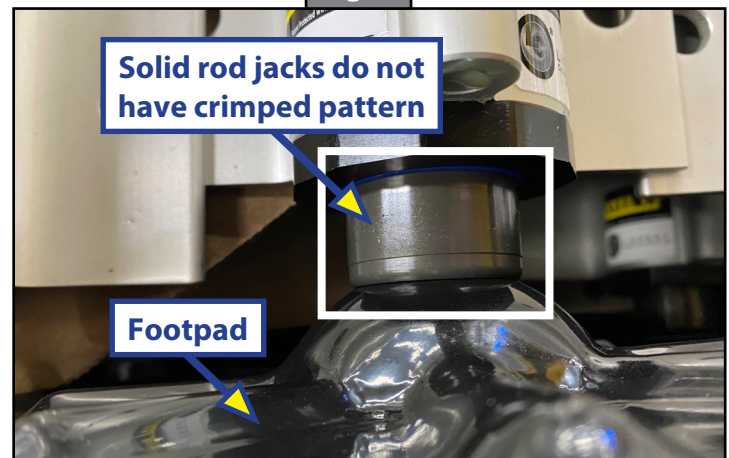
Fig. 6

**NOTE:** If it is determined that the unit has Gen I jacks with a solid rod, then no replacement per this TSB is required.
