Subject: REVISION: N212350630-02 - Service Update
Overhead Console Sets DTC Incorrectly
Revised Parts Table

Models: 2022 Buick Envision

N212350630 Overhead Console Sets DTC Incorrectly

Revision: 02

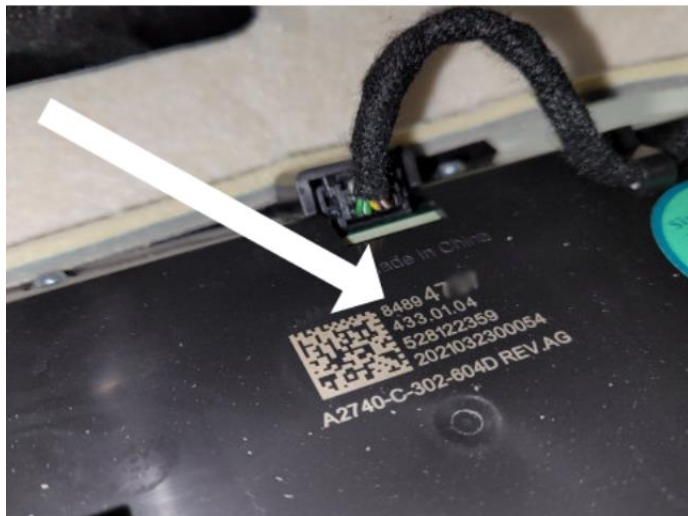
6028952

2. Locate the part number on the roof console. Compare the part number with the table below.

1. Remove the roof console. Refer to *Roof Console Replacement* in SI. Do not disconnect the electrical connector at this time.
