GLOBAL SAFETY FIELD INVESTIGATIONS
DCS6381
URGENT - DISTRIBUTE IMMEDIATELY

Subject: REVISION: N212354520-04 - Customer Satisfaction Program
Heated Vented Seats Retrofit
Front Seat Heater Vent Module and Programming
Revised Correction, Parts, Warranty and Service Procedure

N212354520 Heated Vented Seats Retrofit - Front Seats Only

Revision: 04

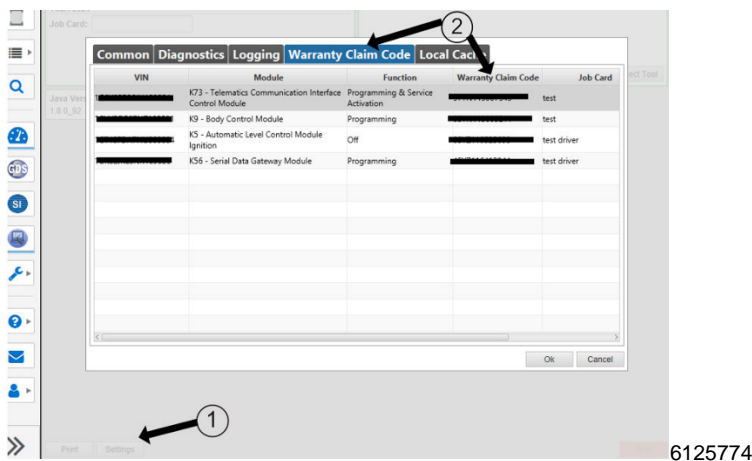
If the Warranty Claim Code was not recorded on the Job Card, the code can be retrieved in the SPS2 system as follows:

1. Open TLC on the computer used to program the vehicle.
2. Select and start SPS2.
3. Select Settings (1).
4. Select the Warranty Claim Code tab (2).

The VIN, Warranty Claim Code and Date/Time will be listed on a roster of recent programming events. If the code is retrievable, dealers should resubmit the transaction making sure to include the code in the SPS Warranty Claim Code field.

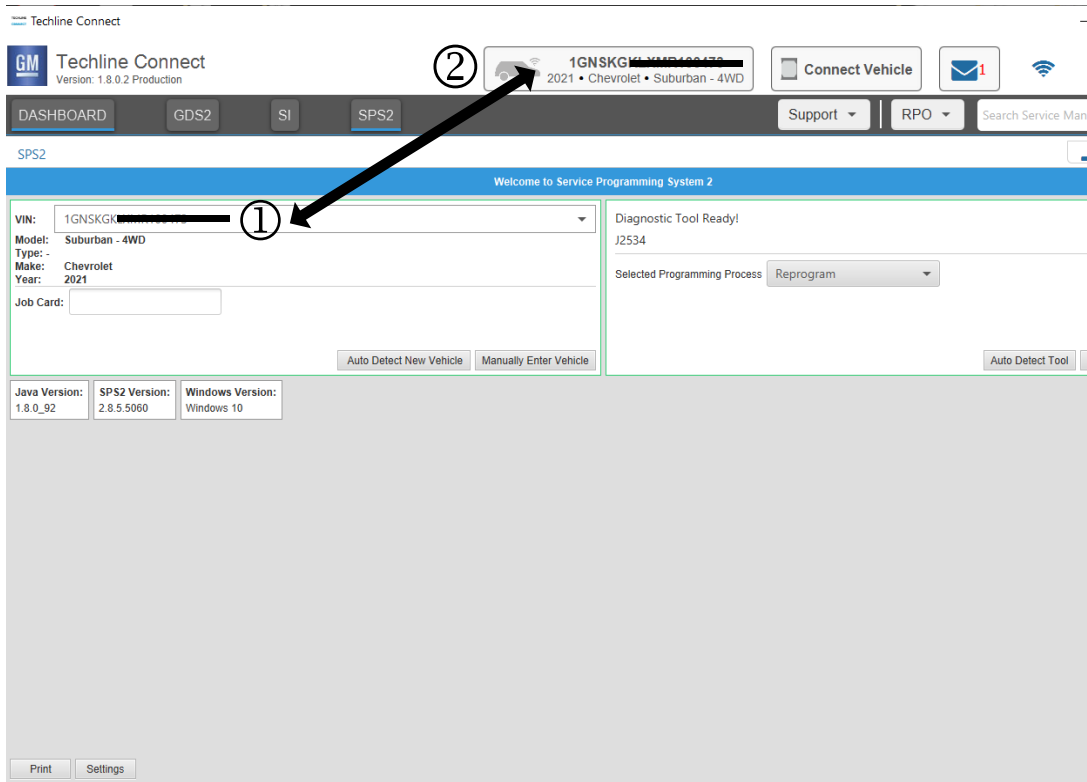
5743643

Caution: Be sure the VIN selected in the drop-down menu (1) is the same as the vehicle connected (2) before beginning programming.

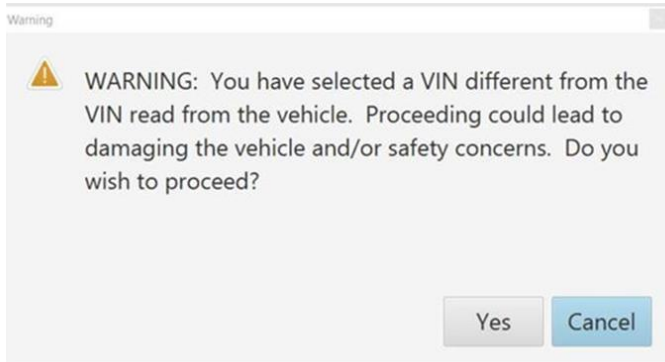
5877000

Important: If the vehicle VIN DOES NOT match, the message below will be shown.
