34-22-01 - Gearbox Resonance

Release date: 12/05/2022

Gearbox may produce a resonance at 450 Hz, also described as a transmission rattling noise.

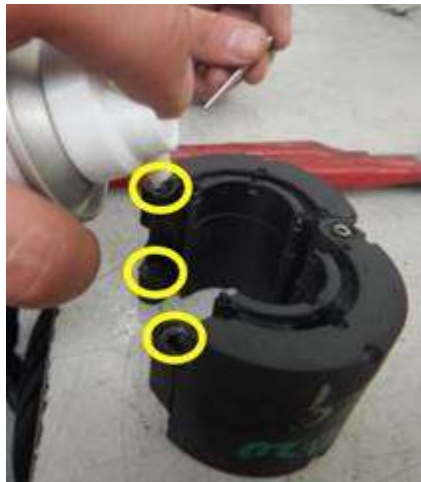
Figure 1. Lubricate pin holes of the damper weight in marked locations.

1. Lift the vehicle and turn the wheels fully to the right to have free access to the left drive shaft.
2. Lubricate pin holes of the damper weight (part number 5WA407267) with silicone spray (part number D 007000A2). see Figure 1.

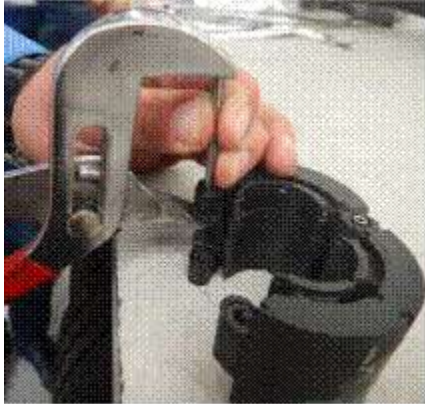
Figure 2. Hold-down pin insertion.

3. Insert the hold-down pin (part number N 10877901) with suitable pliers, see Figure 2.

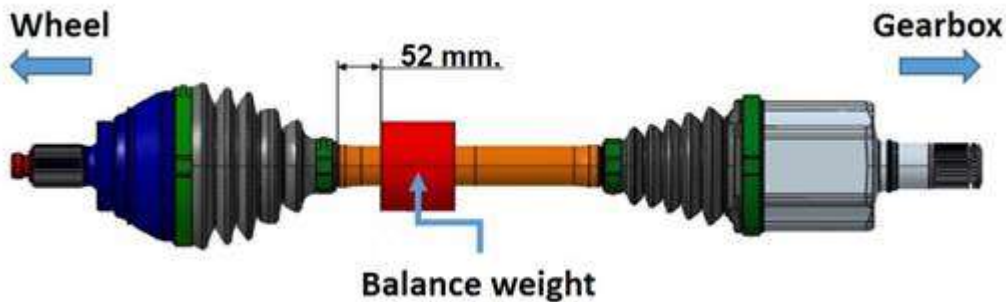
Figure 3. Damper weight positioning.

4. Place damper weight (part number 5WA 407 267) on the left drive shaft and mark the installation position with a suitable pen (see Figure 3, measurement = 52 +/- 1 mm).

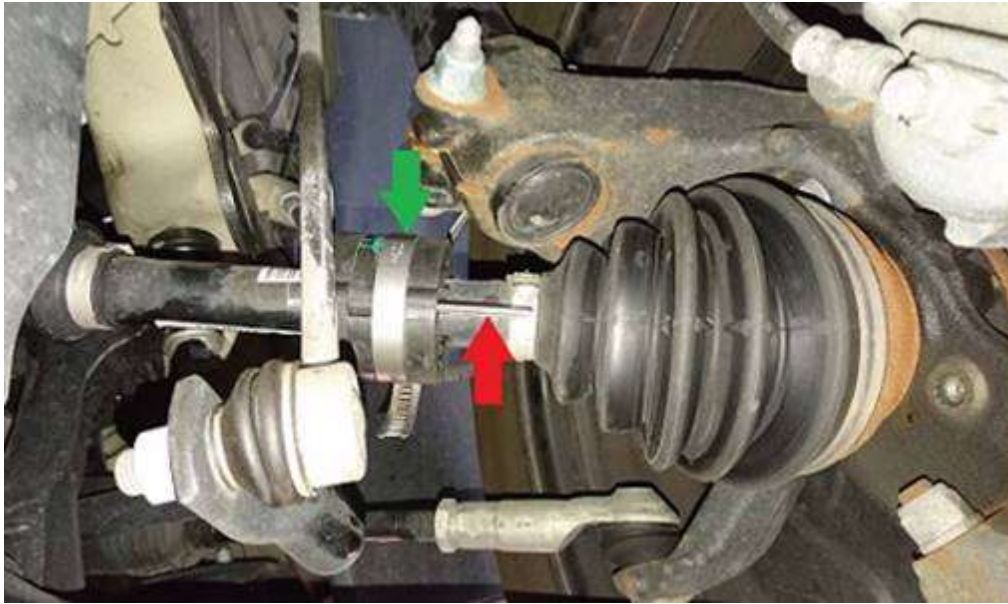
Figure 4. Damper weight fixed in position using a screw-type clamp.

5. Fix the damper weight in position with a screw-type clamp (part number N 10518801), see Image 4, green arrow. Hold-down pin install position from step #3, see Figure 4, red arrow.

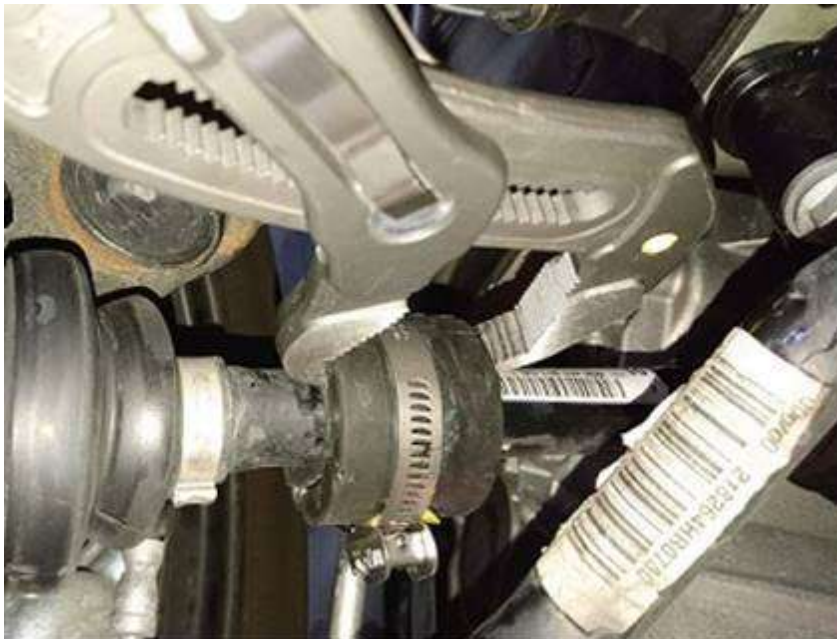
Figure 5. Pressing of the hold-down pin into the damper weight.

6. Carefully press in the hold-down pin into the damper weight with suitable pliers (see Figure 5).

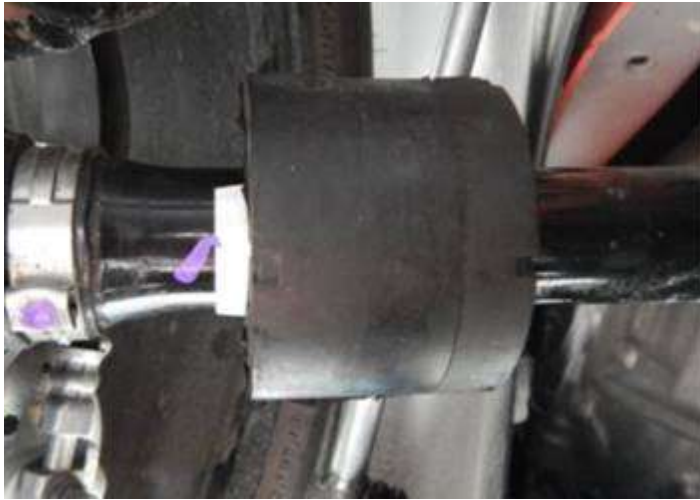
Figure 6. Final positioning of damper weight without screw clamp.

7. Remove the screw-type clamp from the damper weight.
