94-22-01 - Taillight Cluster Condensation

Release date: 12/12/2022

Condition

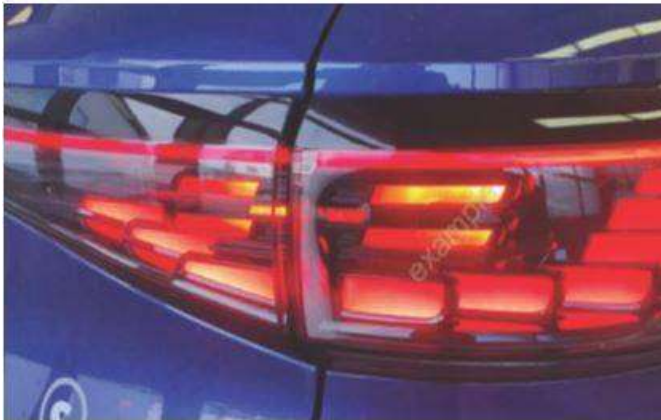
Figure 1:

1. Example of tail light with slight condensation, no drips or water droplets.

1. Taillights: the condensation should systematically dry out after a change of the climate conditions.

**This condition is normal, no replacement necessary.**

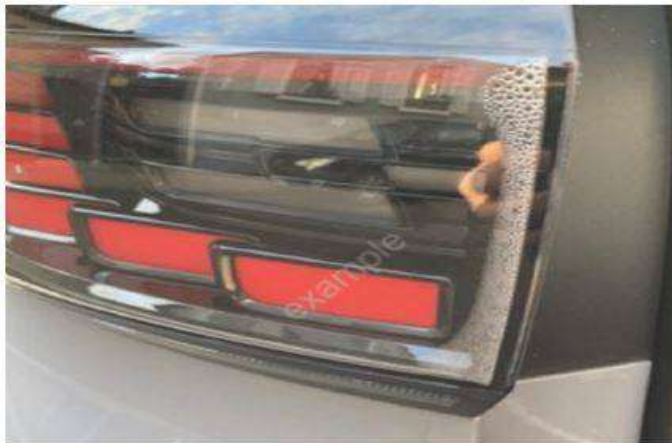
Figure 3:

2. Examples of tail light condensation, with droplets or water dripping.

2. In case of an obvious water ingress check the tail light cluster for optical faults (seal fit, taillight housing cracks).
