94-19-01 - Exterior Lights, Moisture Accumulation

Release date: 12/12/2022

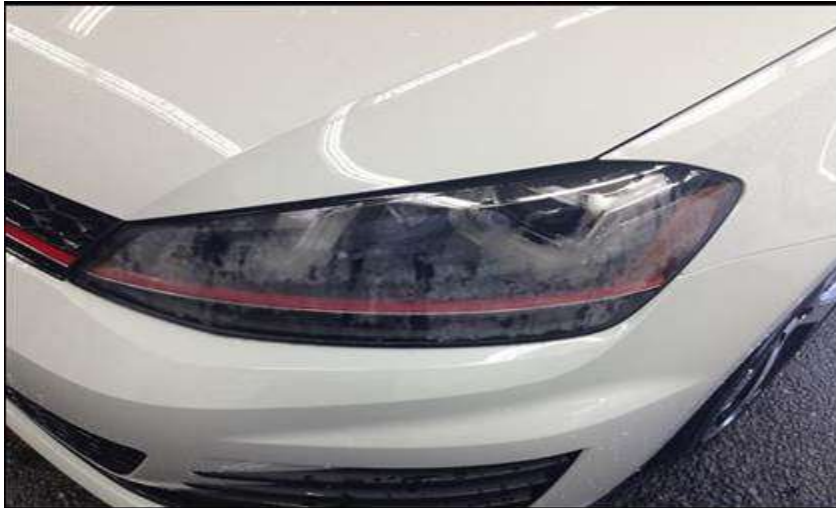
Figure 1

Exterior light assemblies (headlights, taillights with incandescent bulbs, fog lights, turn signals) are vented and may collect moisture on their inner surfaces, depending on humidity and climatic conditions. The unfavorable condensation built up (Figure 1) visible to the customer is more common with modern exterior lights because of clear glass optics, however this condition will not have an impact on the functionality or durability of the component.

For headlight condensation that is due to environmental conditions, the affected lens surface should be cleared after approx. 30 minutes of light operation.

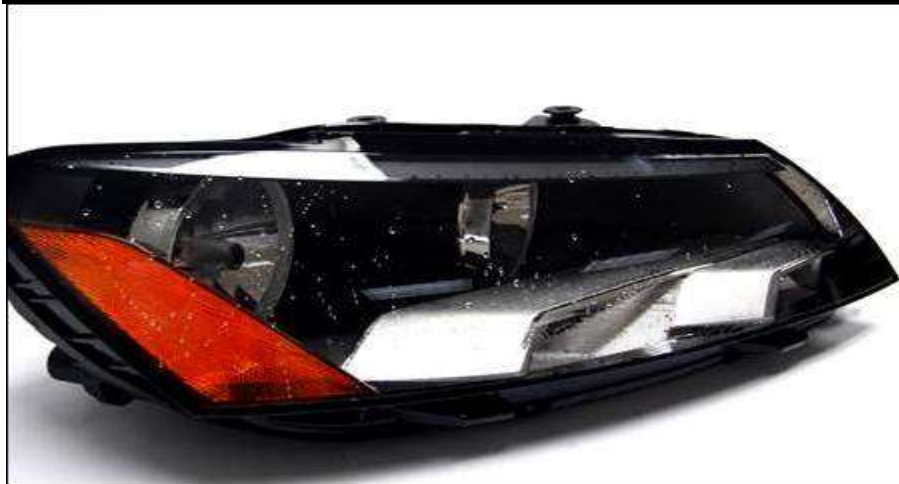
Figure 2

In cases where larger water droplets have formed on the inside of the lens or significant amount of water has collected at the bottom of a light assembly, Figure 2:

DO NOT replace light or lens assemblies unless damage is found.

If damage to seals or cracks to lenses or assemblies are found:

- Follow normal repair procedures for this type of failure (provide photograph(s) with repair documentation for verification).
