# Service Bulletin

Bulletin No.: 22-NA-142

**Subject: Radio Software Version W164 – Multiple Updates**

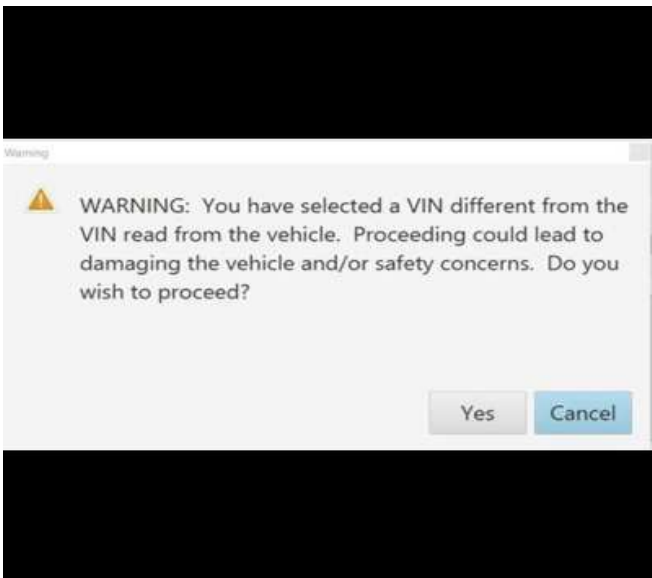
5877000

**Important:** If the vehicle VIN DOES NOT match, the message below will be shown

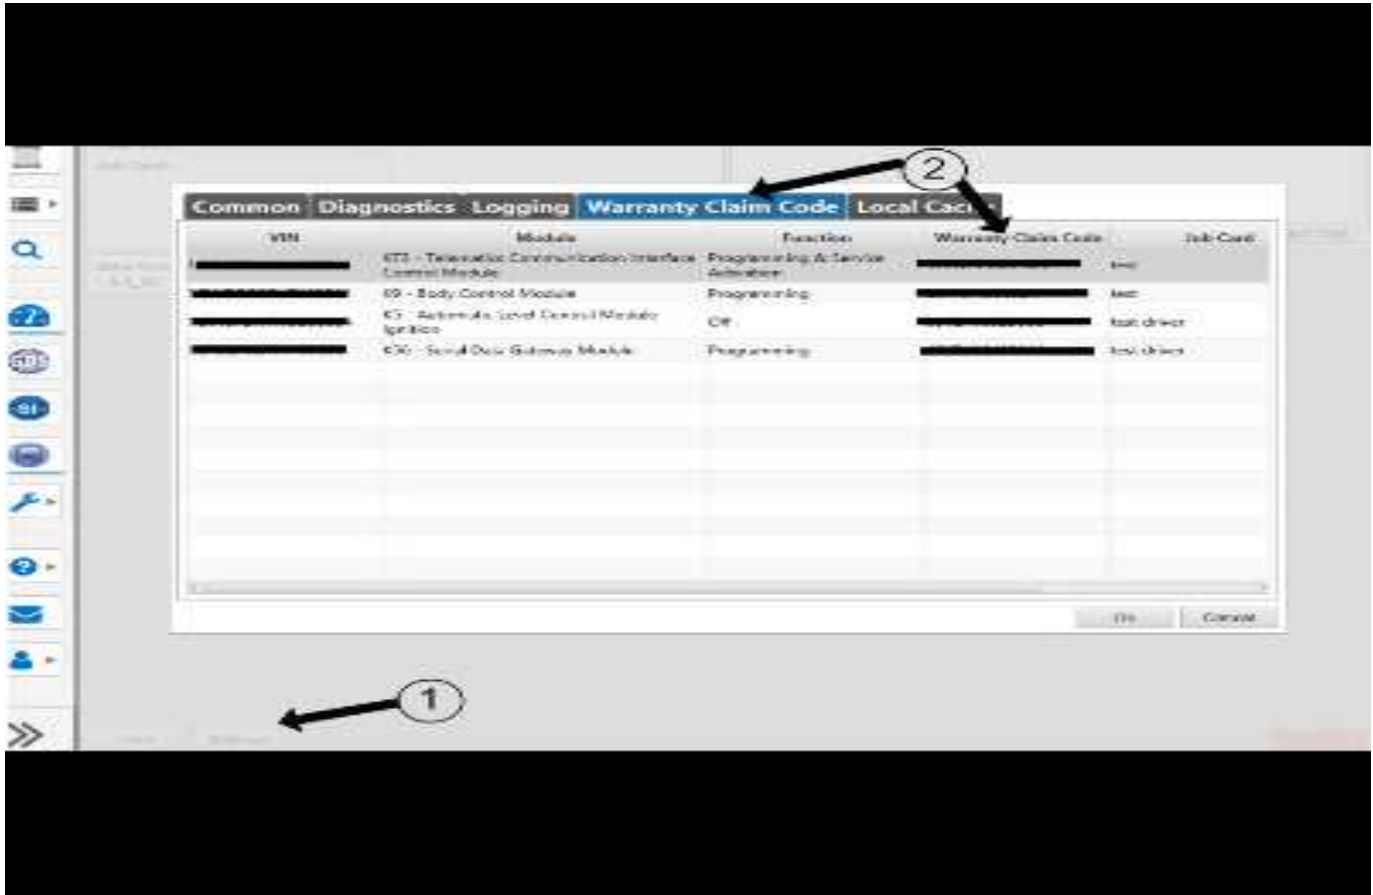
6125774

If the Warranty Claim Code was not recorded on the Job Card, the code can be retrieved in the SPS2 system as follows:

1. Open TLC on the computer used to program the vehicle.
2. Select and start SPS2.
3. Select Settings (1).
4. Select the Warranty Claim Code tab (2).
