Service Bulletin

Bulletin No.: 22-NA-246

Subject: Information on Unnecessary Replacement of Extension Housing and 1-2-3-4-5-REV Clutch Piston Assembly for 8L45, 8L90 Automatic Transmissions

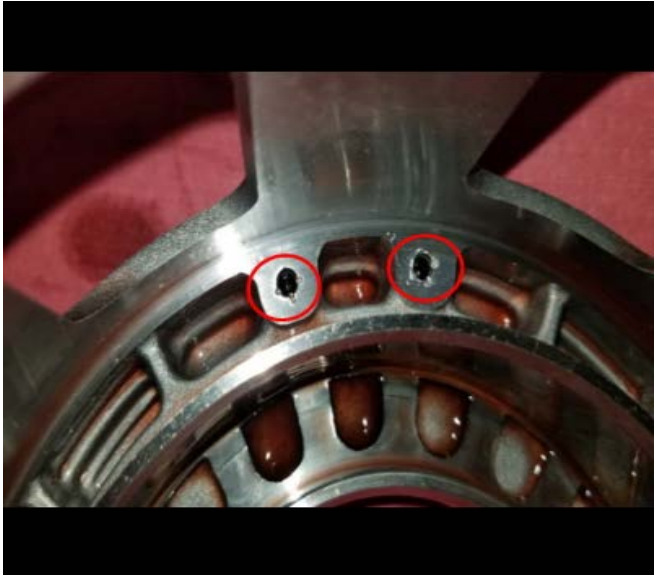
6201397

<p>The orifices are normally staked into the two passages and may become dislodged during time.</p>
