SIB 22 02 22

DIAGNOSING THE ENGINE STABILIZER LINK

F39 (X2 Sports Activity Coupe)	F44 (2 Series Gran Coupe)	F48 (X1 Sports Activity Vehicle)
--------------------------------	---------------------------	----------------------------------

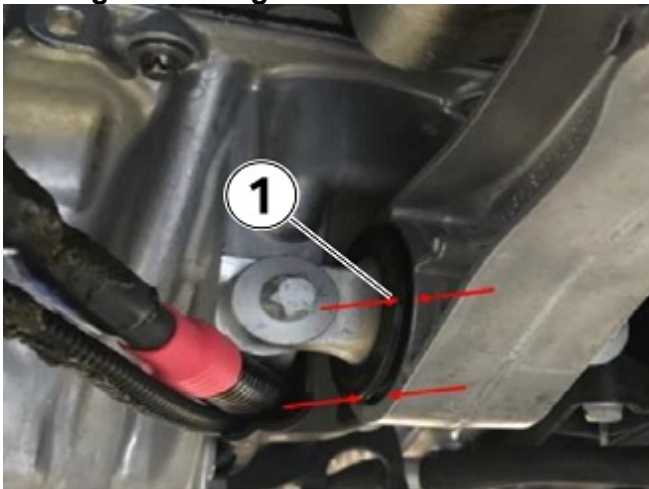
Bushing on the engine side:

There can be up to a 2 mm gap in the bushing and the stabilizer link (1). Only replace the link if it is in actual contact with the oil pan. Reference [SIB 22 03 22](#) for replacement of the stabilizer link.

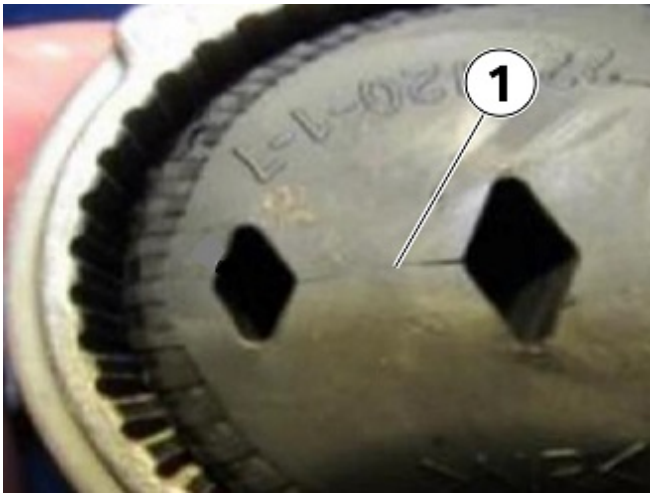
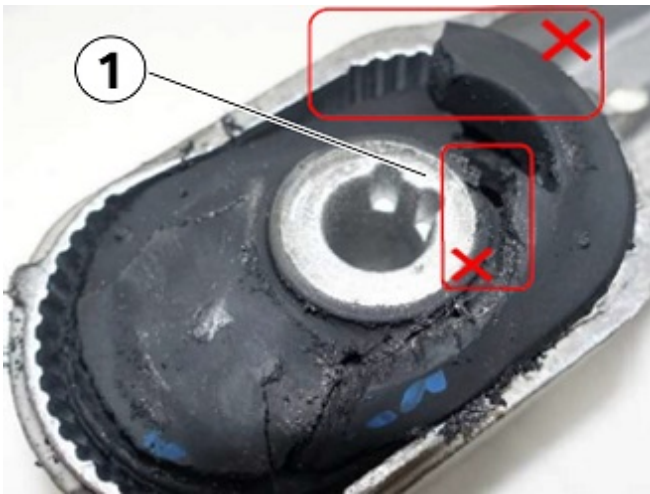
Bushing on Subframe side:

Do not replace the link if cracks measuring 10 mm or less are permissible (1).

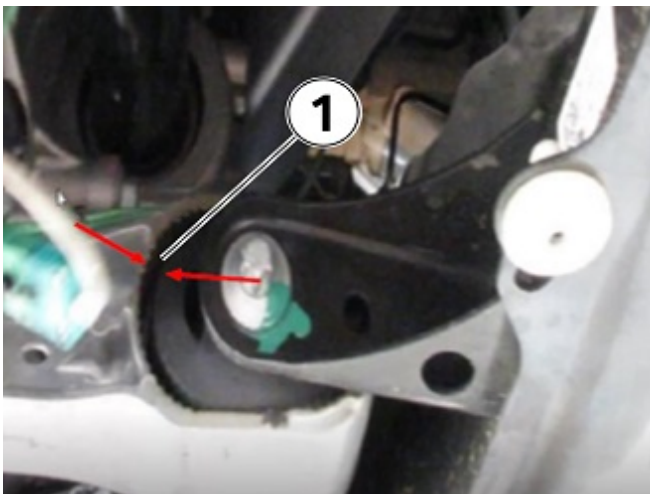
Cracks over 10 mm or where the bushing separates should be replaced (replace link).

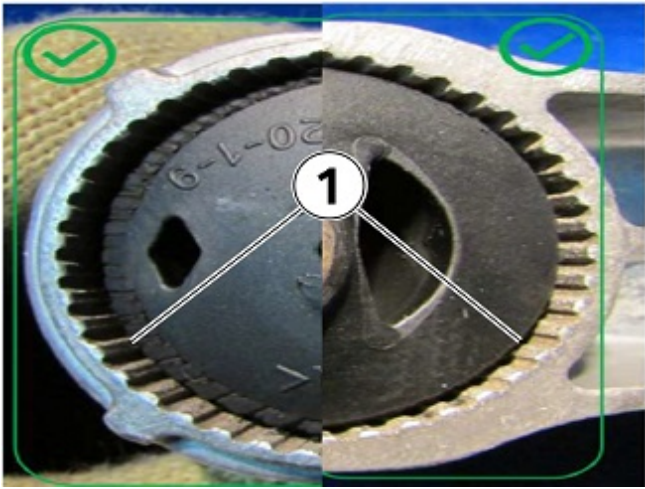
There can also be a lateral gap in the bushing and the link at the ridges in the aluminum (1). Do not replace the link.
