SIB 22 03 22

CREAKING NOISE FROM THE LOWER ENGINE AREA

F39 (X2 Sports Activity Coupe)	F44 (2 Series Gran Coupe)	F48 (X1 Sports Activity Vehicle)
--------------------------------	---------------------------	----------------------------------

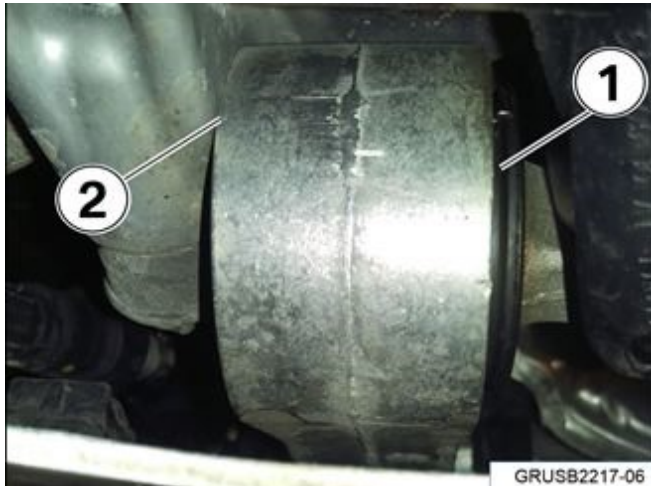
During load reversal or taking off from a stop, there is a creaking or droning noise heard from the lower engine area.

The bushing in the lower engine stabilizer link (1) is working its way out of its aluminum housing.

The aluminum housing starts to rub against the engine oil pan (2).

Confirm the noise is coming from the lower engine stabilizer link and replace the link.

Refer to Repair Instruction 22 11 095 “Removing and installing/replacing holder with rubber mount”.
