SIB 41 07 22

## CRACKING SOUND FROM THE TOP OF B-PILLAR

**MODEL**

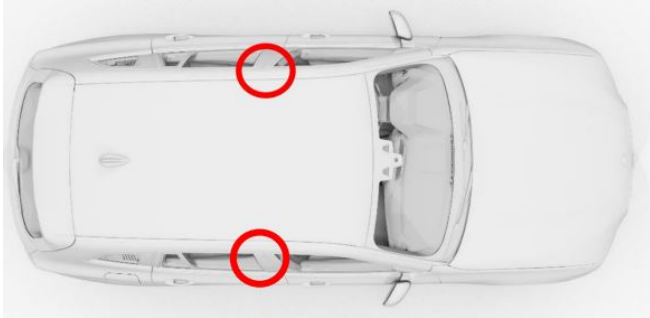
While driving the vehicle on normal roads at 10mph and above, a cracking sound from the top of the B-pillar(s) is heard.

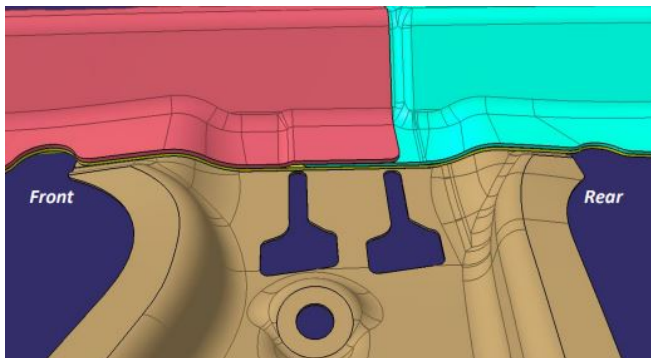
Movement of the sheet metal layers at the B-pillar(s).

Slightly bend the sheet metal layer at the top of the B-pillar.

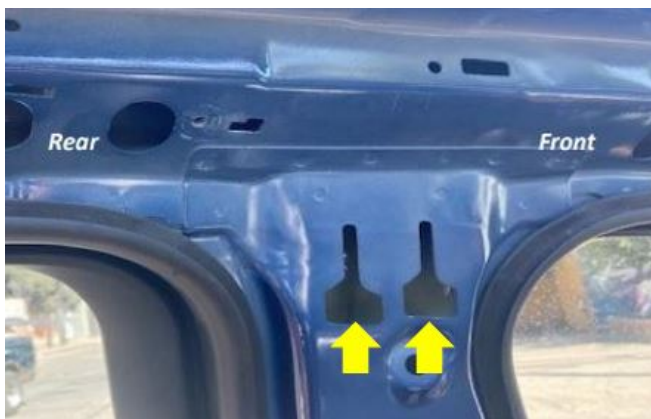
2. Using a borescope, check whether the sheet metals are making contact.
