## SIB 51 20 22 CRACKING SOUND IN THE HEADLINER AREA

2022-11-04

E-Series	Model Description	Production Date	Affected Option Code
F44	2 Series Gran Coupe	SOP (start of production) – December 22, 2022	402 Panoramic Moonroof

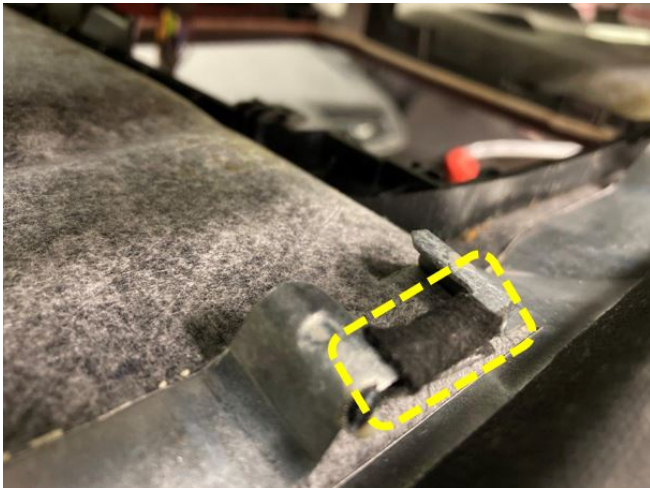
While driving on rough roads, a cracking sound is heard coming from the headliner area.

Movement of the headliner holding clips.

3. Cut felt strips to 20 mm x 10 mm dimensions and apply it to all the brackets on the headliner (shown).
