SIB 61 16 22

2022-11-17

## DELIVERY STOP: HIGH-VOLTAGE BATTERY

E-Series	Model Description	Production Date
I20	iX Sports Activity Vehicle (SAV)	April 29, 2022 – September 22, 2022

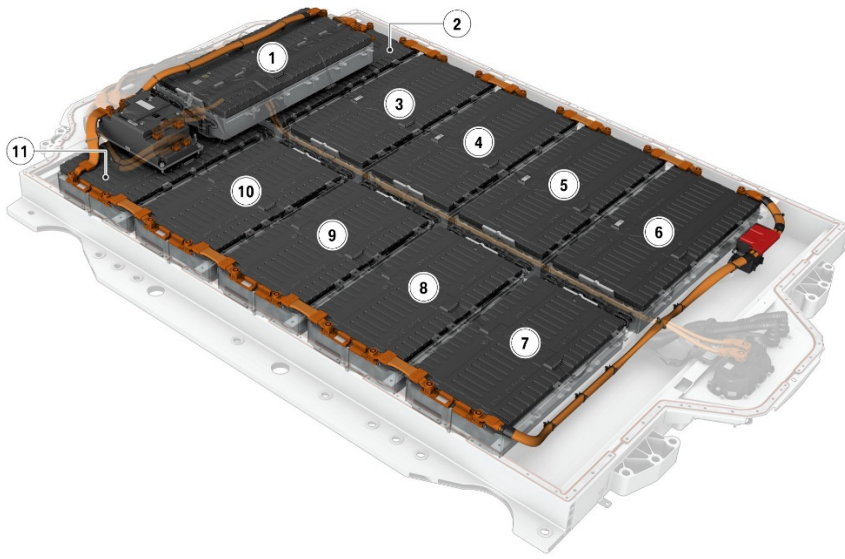
i20 xDrive50/xDrive60 - SE10 HV Battery module locations shown below-

The low voltage wiring harness plug connected to cell module to was manufactured without its insulation compound. This insulation layer is designed to protect the contact from environmental influences such as moisture or dirt contamination.

A short circuit may form between the individual electrical contacts of the low voltage connector due to the presence of moisture or dirt contamination.

2. Replace the defective high-voltage cell modules using repair instructions **61 27 703** to **61 27 723** depending on the affected cell module location.
