SIB 64 07 22

2022-11-14

AIR WHISTLE NOISE FROM B PILLAR VENT(S)

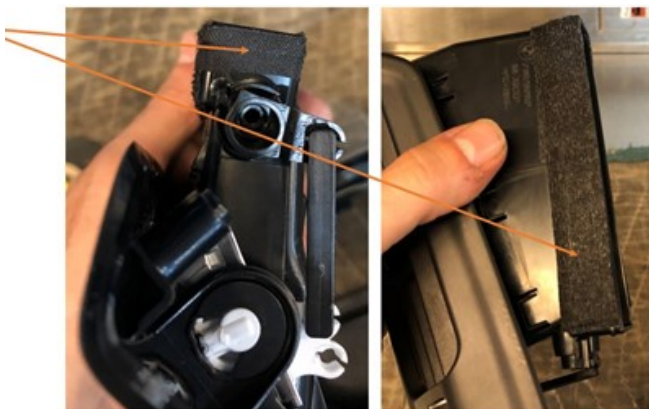
Air leaks from the junction between the B pillar duct and the B pillar vent. This air leak can be heard if the vent slats are closed.

Separate the vent assembly from the ductwork.

**NOTE:** The vent is referred to as *Grille* in the repair instructions
