SIB 64 08 22

INOPERATIVE OR IRREGULAR A/C COOLING POWER

E-Series	Model Description	Production Date
I20	iX Sports Activity Vehicle	From start of production to December 6, 2022
G26	4 Series Gran Coupe BEV

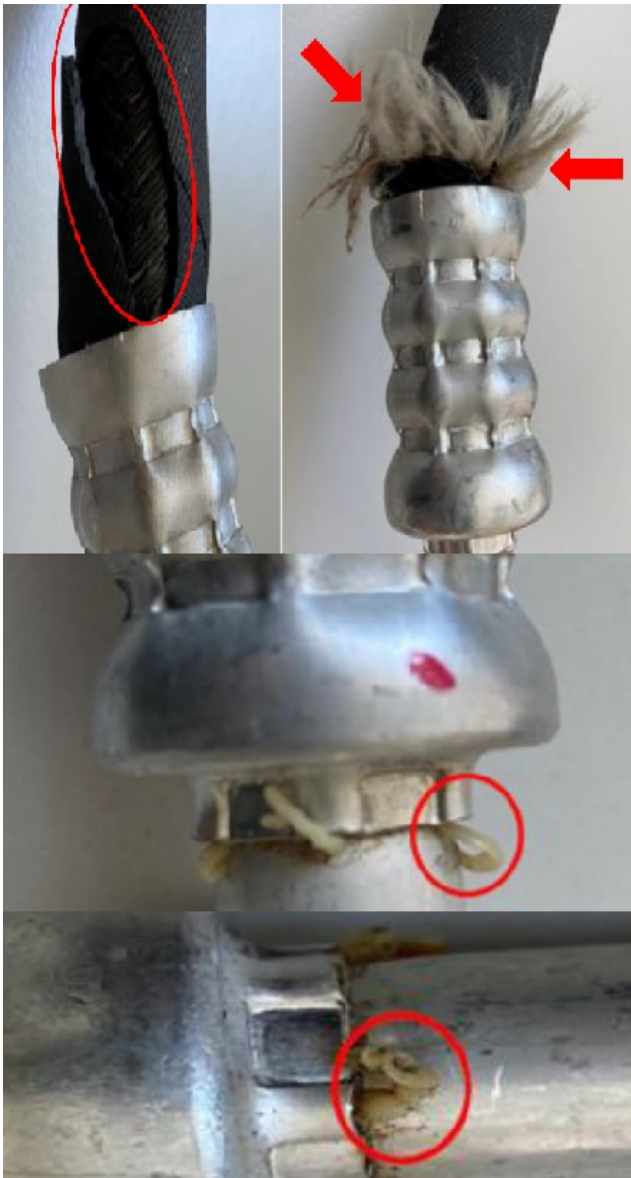
Check the compressor-capacitor pressure line for damage.

**Important:** If the leaking components include the electric A/C compressor (EKK) and/or the compressor-capacitor pressure line, the following components must be replaced in combination:

- Compressor-condenser pressure line
- Electric A/C compressor EKK
- Air conditioning condenser
- Non-return valve (in intake pipe)
- Electrical expansion valve (at the evaporator)
- Cooling unit (referred to as a chiller in the EPC)

Then refill the system and check again for leaks.
