SIB 65 01 22

2022-11-30

## KNEE AIR BAG CHECK CONTROL MESSAGE G01 VARIANTS

This Service Information Bulletin (Revision 4) replaces SI B65 01 22 **dated June 2022**.

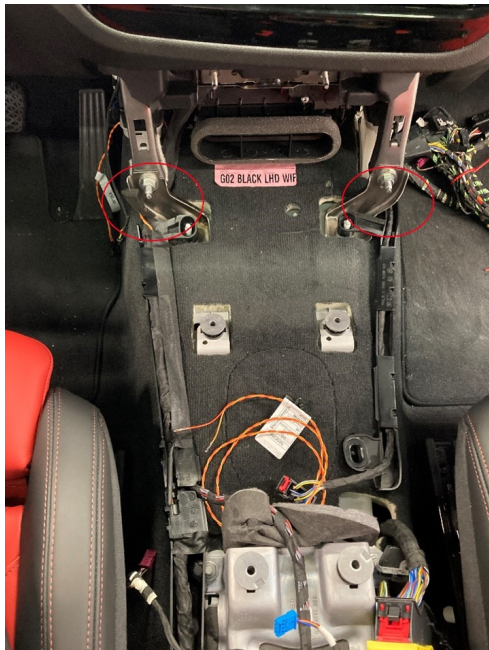
The wiring harness going to the knee air bag(s) may be rubbing against the support tube of the instrument panel.

5- Apply felt tape to the locations pictured.

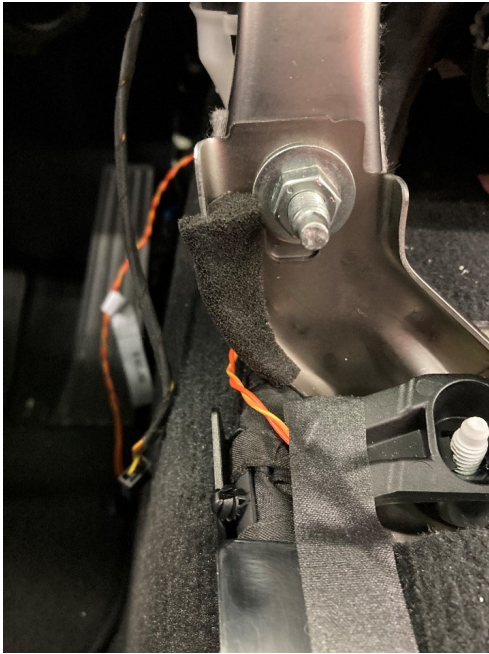
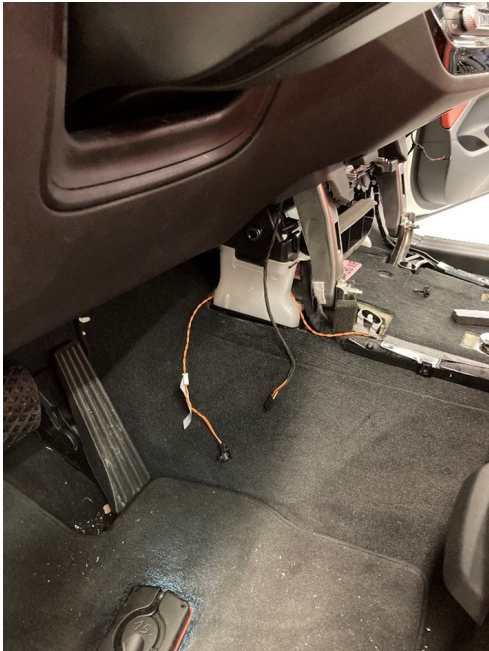
6- The knee air bag wiring should be

protected from chafing at the dash support bracket.  
 Glue the felt generously onto the support tube or to the corresponding edge.  
 (Felt tape part number **54 34 7 248 700**).  
 Important: The felt must be glued around the edge!

Install felt tape in any other potential chafe location.

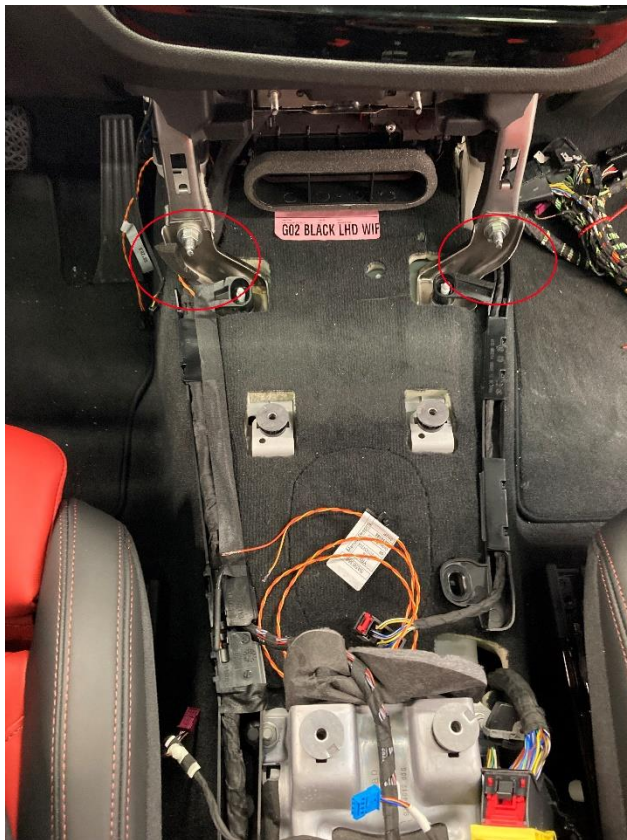
The wiring harness going to the knee air bag(s) may be rubbing against the support tube of the instrument panel.

5- Apply felt tape to the locations pictured.
