SIM 22 01 22

DIAGNOSING THE ENGINE STABILIZER LINK

F54 (MINI Clubman)	F55 (MINI Hardtop 4 Door)	F56 (MINI Hardtop 2 Door)	F57 (MINI Convertible)
F60 (MINI Countryman)

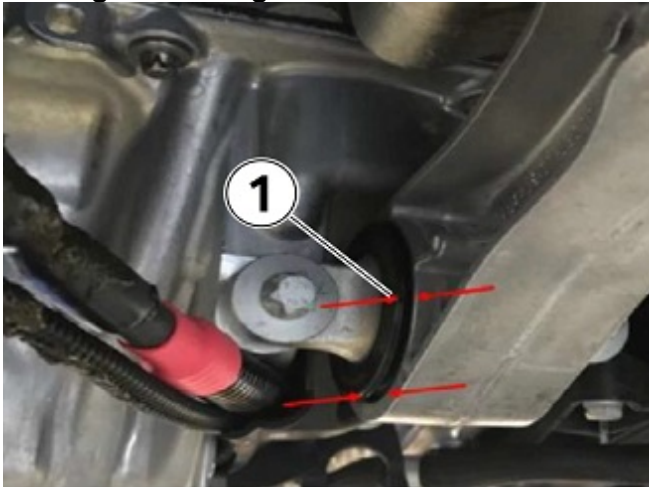
PROCEDURE**Bushing on the engine side:**

There can be up to a 2 mm gap in the bushing and the stabilizer link (1). Only replace the link if it is in actual contact with the oil pan.

Reference [SIM 22 03 17](#) for replacement of the stabilizer link.

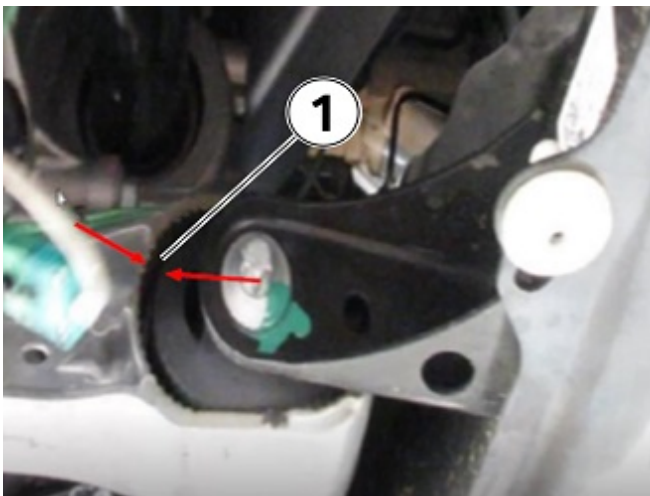
Depending on engine load, a gap may form between the bushing and the link. This is a normal characteristic of the bushing. Do not replace the stabilizer link.

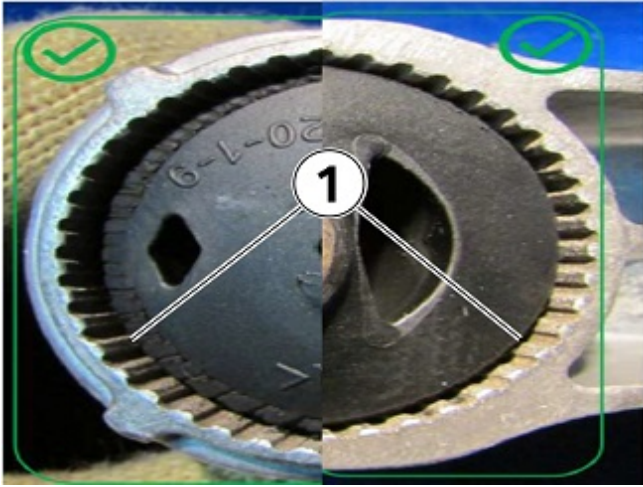
There can also be a lateral gap in the bushing and the link at the ridges in the aluminum (1). Do not replace the link.
