Technical Journal

No Remote key function

REF NO: TJ 35954.4.0	ISSUING DEPARTMENT: Technical Service	CAR MARKET: United States and Canada	
PARTNER: 3 US 7515		ISSUE DATE: 2022-06-16	STATUS DATE: 2022-07-28
FUNC GROUP: 3666	FUNC DESC: Access (central looking & remote)	Page 1 of 5

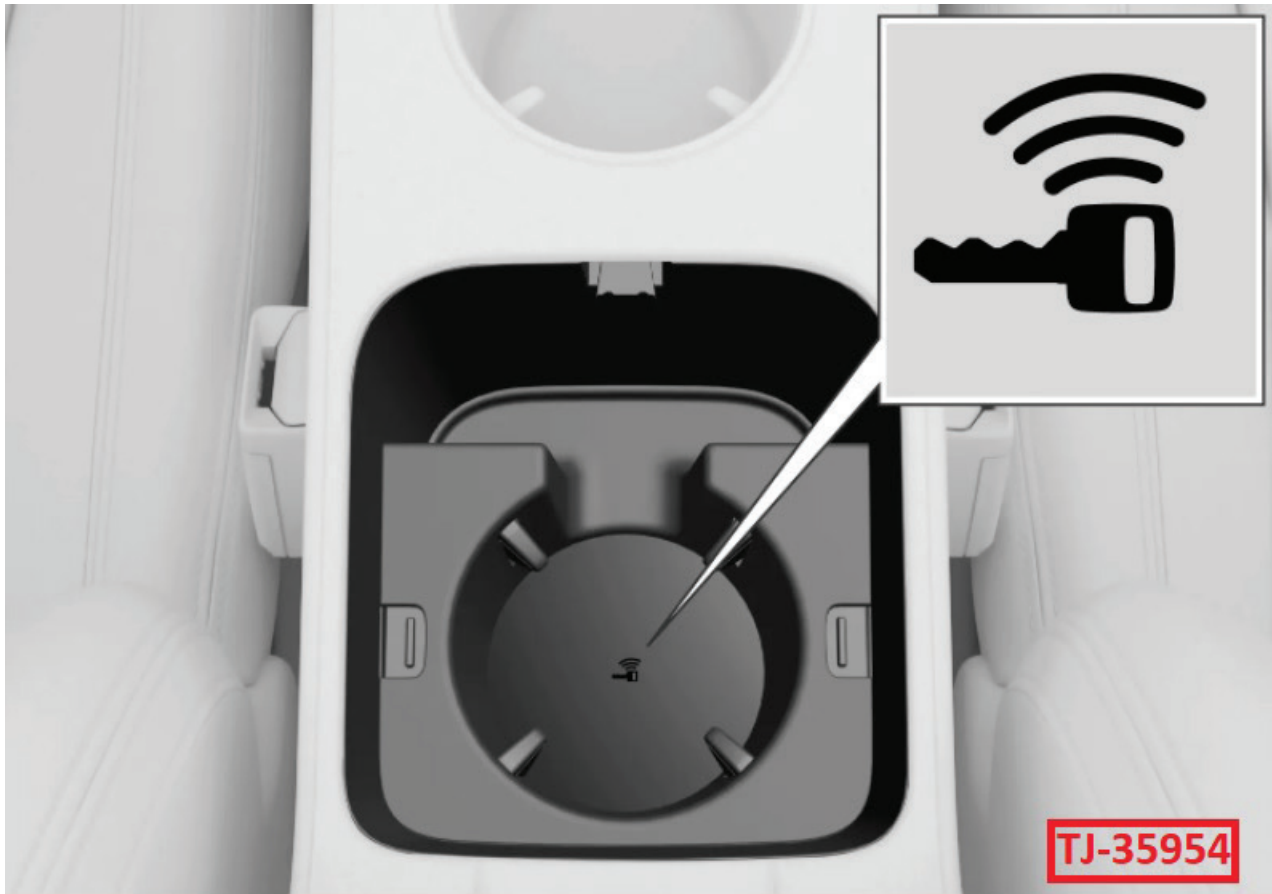
1. Cannot Lock/unlock vehicle with the “RCK”, but vehicle can be unlocked with the mechanical key blade located inside the “RCK” (see attachment “**Mechanical Location**”).
2. Attempting to start the vehicle through keyless function, results in DIM message stating “Key not found”
3. The vehicle can only be started with the “RCK” in the backup position located in the tunnel console (See attachment “**Backup Position**” for backup location)
4. No communication when attempting to connect/readout vehicle with VIDA.
5. If Symptom #1 has been confirmed and the vehicle cannot be started with the “RCK” in the backup position due to not being able to disconnect the charging cable.
