## MMD Fan Hub Bolt Torque

**Section** Function Group 263

### Applicability

| Model Years | Models |
|---|---|
| 2023 | MD6, MD7 |

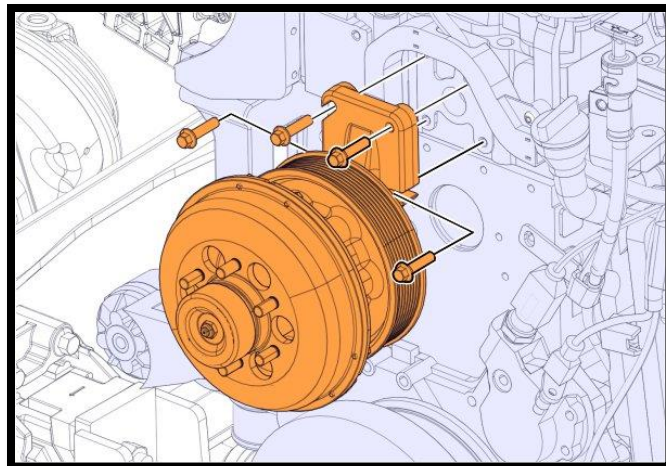
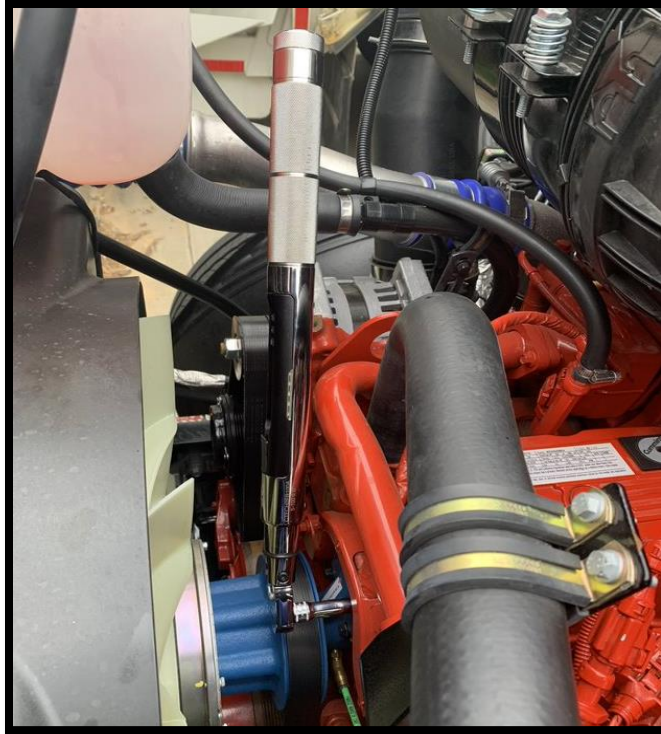
Mack trucks has determined that certain model year 2023 Mack Medium Duty (“MMD”) vehicles, may have been assembled with an under torqued condition on the fan hub retaining hardware. To correct this issue and uphold Mack’s stringent quality standards, a retorque of the hardware is required.

7. Using a torque wrench, retorque the 4 fan hub mounting bolts to  **$24\pm4\text{Nm}$  ( $10\pm3\text{lbf}\cdot\text{ft}$ )**

| Tightening torque | |
|---|---|
| Fan hub mounting hardware | 24±4Nm (10±3lbf·ft) |
