**HYUNDAI**
Technical Service Bulletin

GROUP BODY	NUMBER 22-BD-010H
DATE DECEMBER 2022	MODEL(S) ELANTRA (ADa), SONATA (LFa), SANTA FE SPORT (AN)

SUBJECT: WHITE PAINT WARRANTY EXTENSION (TXXW)

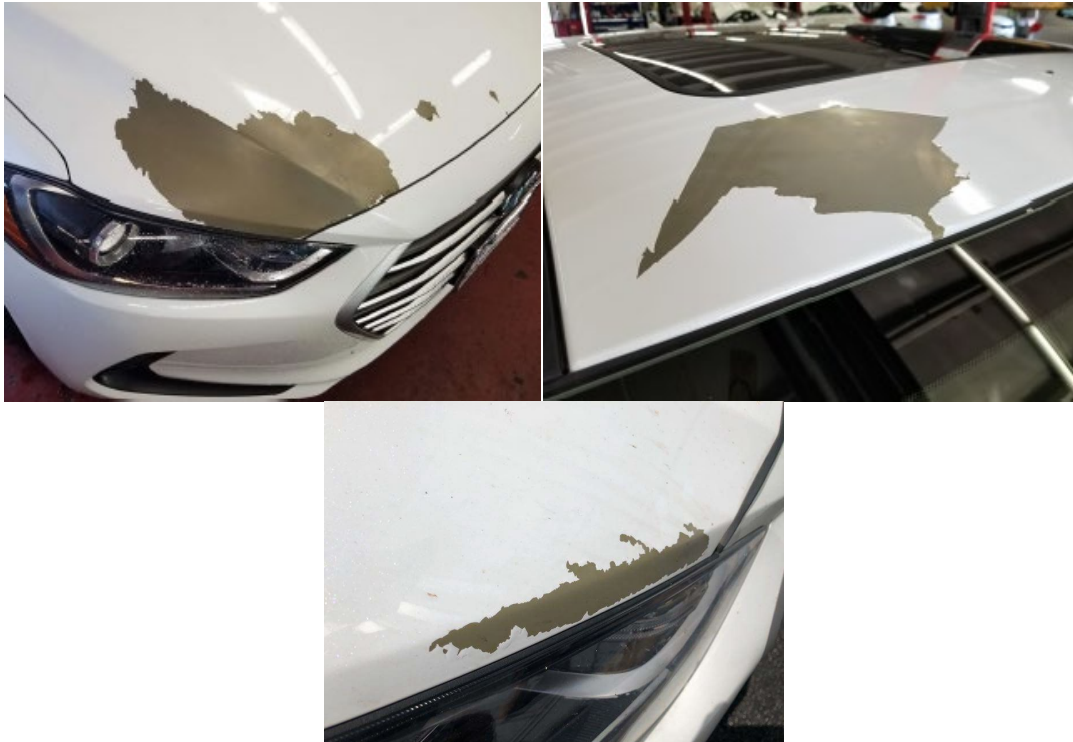
Description: Certain 2017-2018MY Elantra (ADa), Sonata (LFa), and Santa Fe Sport (AN) vehicles manufactured by Hyundai Motor Manufacturing Alabama (“HMMA”) may exhibit peeling or bubbling of the white paint in various areas of the vehicle, most commonly on or around the hood, fender, and roof. The paint warranty coverage for these vehicles with white exterior paint has been extended to the following:

1. Determine which panel(s)/area(s) that may be affected by this white paint condition.
2. Take a STUI picture(s) of the the affected panel(s)/area(s) illustrating the peeling and/or bubbling paint.
3. Repair and refinish the parts of the affected panel(s)/area(s) according to the established procedures in the Shop Manual for the vehicle and standard body shop repair practices (paint matching and blending).
