<b>HYUNDAI</b> <b>Technical Service Bulletin</b>	GROUP <b>CAMPAIGN</b>	NUMBER <b>22-01-094H</b>
	DATE <b>DECEMBER 2022</b>	MODEL(S) <b>Ioniq 5 Electric (NE1)</b>

**SUBJECT:** IONIQ 5 EV BATTERY CONDITIONING TO OPTIMIZE COLD DC CHARGING (SERVICE CAMPAIGN T9Q)

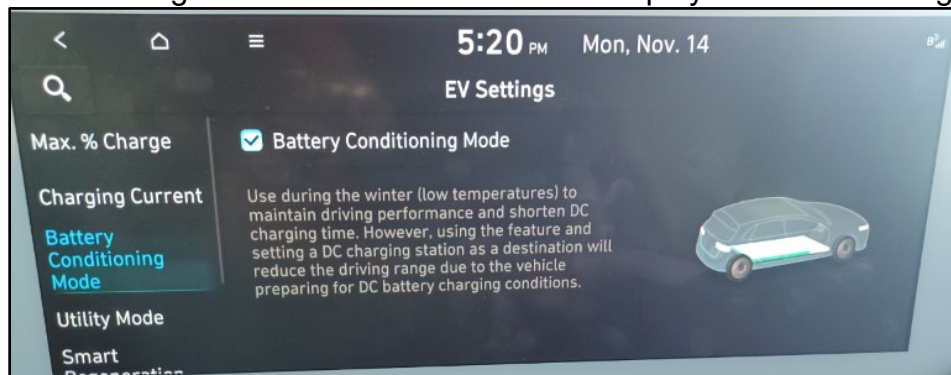
1. The Battery Conditioning must be enabled in the AVN display at the EV Settings Screen:

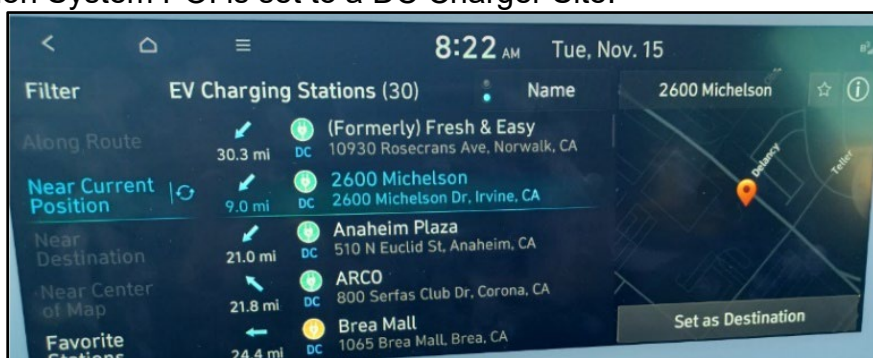
2. The Navigation System POI is set to a DC Charger Site.

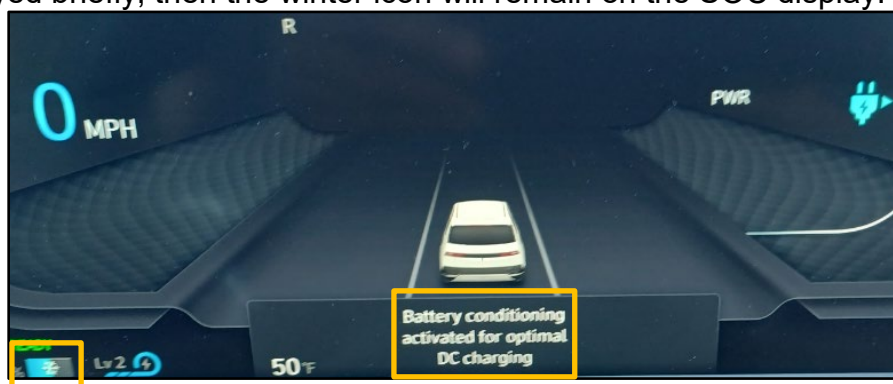
3. When the Battery Module Temperature is below 68°F (20°C), then the Battery Conditioning will activate after 1 - 2 min of heating system checks and preparation. The following splash screen will be displayed briefly, then the winter icon will remain on the SOC display.

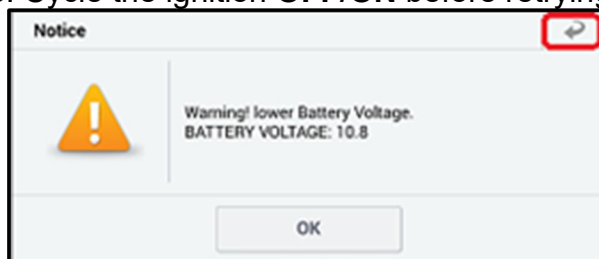
- If the voltage is below 12 volts as per the GDS warning, then select **Back** and run the vehicle at least 15 minutes to reach an adequate battery state of charge to prevent an ECU Update failure. Cycle the ignition **OFF/ON** before retrying ECU update again.

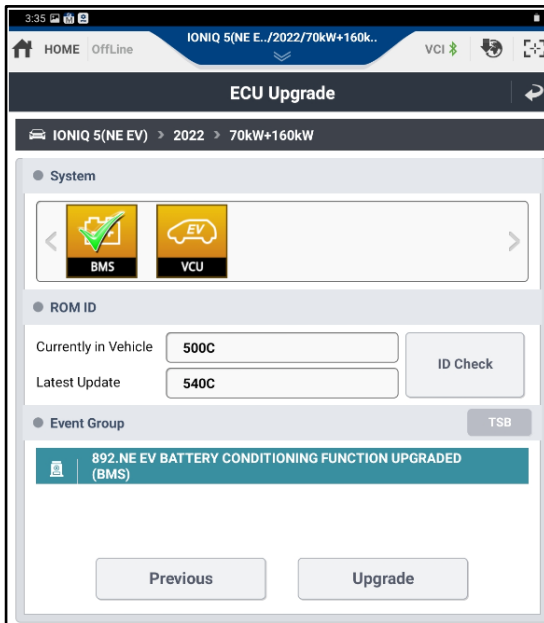
1. Perform the BMS Update in Auto Mode.
  - a. Use the Auto Mode ID Check to verify the BMS ROM ID before updating the software.

- b. After the ECU Upgrade process shows 100% complete, cycle the ignition key to **OFF** for at least 10 seconds to reset the control unit. This step is important for establishing normal communication and to prevent system errors.

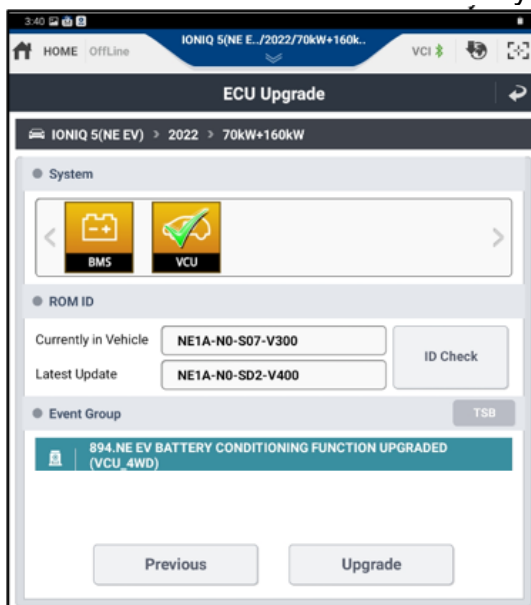
- a. Use the Auto Mode ID Check to verify the VCU ROM ID before updating the software.

- b. After the ECU Upgrade process shows 100% complete, cycle the ignition key to **OFF** for at least 10 seconds to reset the control unit.
3. Perform an All Systems Fault Code search and erase the history of the DTC that had incidentally occurred from the ECU update.
4. Start the vehicle in **Ready** mode to confirm a proper operation of the vehicle.
5. Check and perform the AVN Map Update if required. Insert STUI photo if required. If not required, then skip to step 6.

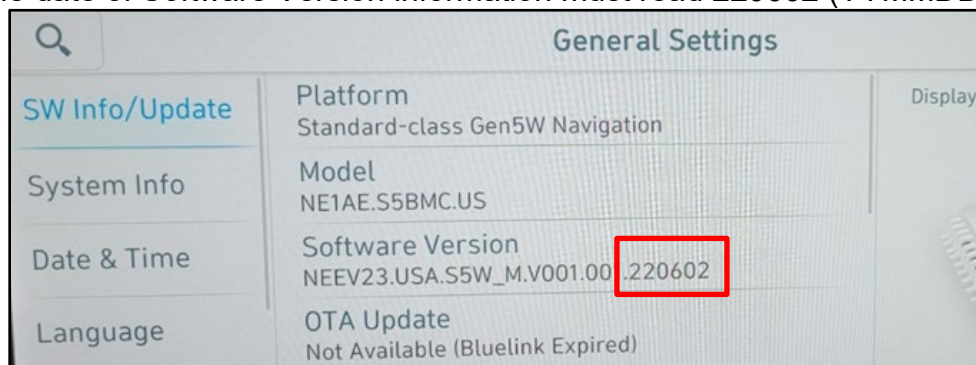
- Press the SETUP button on the trim below the display screen.
- Press General Settings in the menu displayed on the screen (if not displayed you may need to scroll down)
  - a. The date of Software Version information must read 220602 (YYMMDD)
