Service Alert

MAZDA CONNECT SYMPTOM TROUBLESHOOTING (7TH
GENERATION VEHICLES)

Last Issued: 12/14/2022

2019-2023 Mazda3 2020-2023 CX-30 2021-2023 CX-5 2021-2023 CX-9 2022-2023 MX-30 2023 CX-50

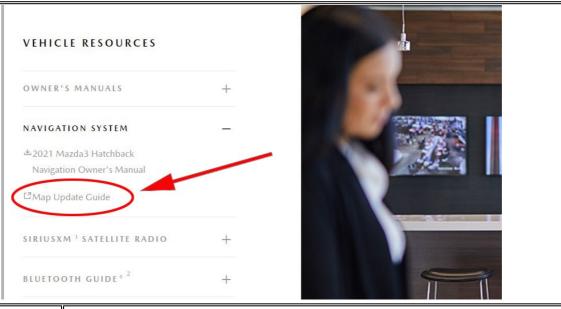
License Error message in Mazda Toolbox

Customer is locked out of map update on Mazda Toolbox due to unauthorized or counterfeit navigation SD card.

How to unlock the customer account in Mazda Toolbox

- 1. Purchase a Genuine Mazda Navigation SD card.
- Customer or dealer must contact NNG helpdesk by email at piracy@nng.com and request customer account unlock.
