# Service Alert

<b>Subject:</b>  CONNECTED VEHICLE SYMPTOM TROUBLESHOOTING	<b>Service Alert No.:</b> SA-017/22
	<b>Last Issued :</b> 12/13/2022

2019-2023 Mazda3  
2020-2023 CX-30  
2021-2023 CX-5  
2021-2023 CX-9  
2022-2023 MX-30  
2023 CX-50

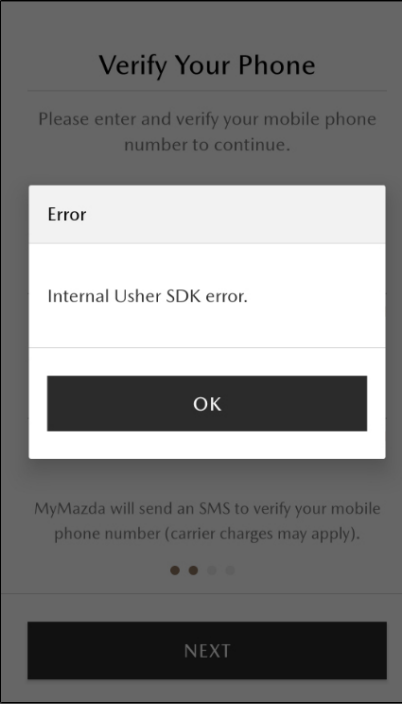
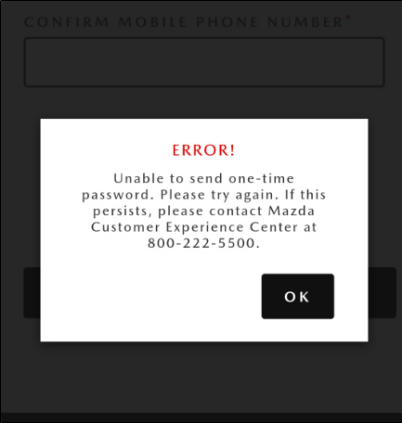
Connected Vehicle Troubleshooting		
Symptom	Cause	Action
<p>The customer is not able to create a MyMazda account. The customer receives the following error:</p> <p><b>MyMazda App - Internal Usher SDK error.</b></p>

<p>1</p> <p><b>MyMazda Website - ERROR! Unable to send one-time password.</b></p>

<p>Customer inadvertently texted <b>“Stop”</b> to 1-949 518-0058 (Twilio SMS for Mazda)</p>

<ol style="list-style-type: none"> <li>Text <b>“Start”</b> to 1-949 518-0058 (Twilio SMS for Mazda)</li> <li>Retry to create a MyMazda account.</li> </ol> <p><b>NOTE: USA and Canada only</b></p>

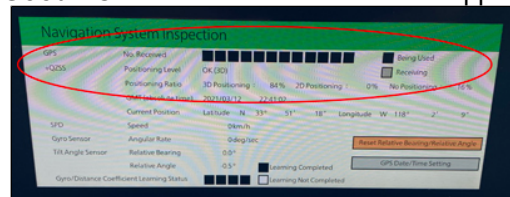
**Good** - Contact Hotline for technical support

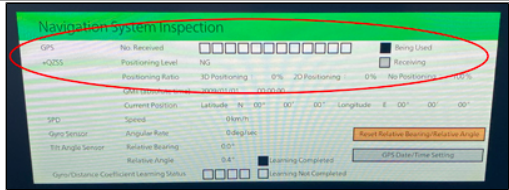
**No Good** - Swap Tel antenna No. 1 with known good vehicle
