Subject: RATTLE FROM SUNROOF AREA	Service Alert No.: SA-032/22
	Last Issued : 12/22/2022

2023 CX-50

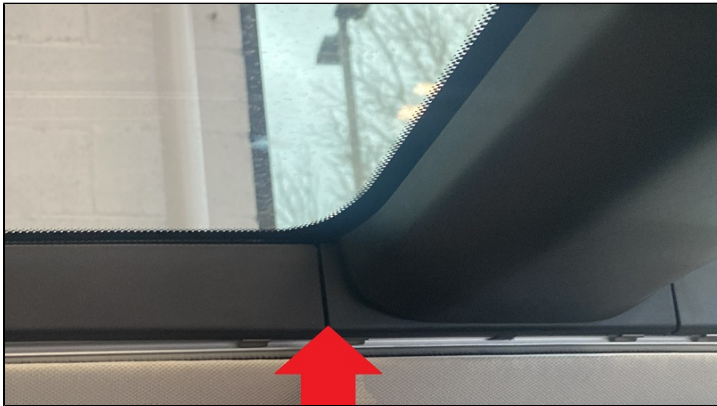
The noise comes from the side cover vibrating against the assembly at the location marked by the arrow due to poor retention of the cover clips.

1. Test drive the vehicle and if you hear the noise, press the area at the red arrow on both sides of the vehicle.

2. Remove the side covers from the sides of the sunroof assembly.
3. Bend the mount clips as shown below. If needed, remove them from the covers.

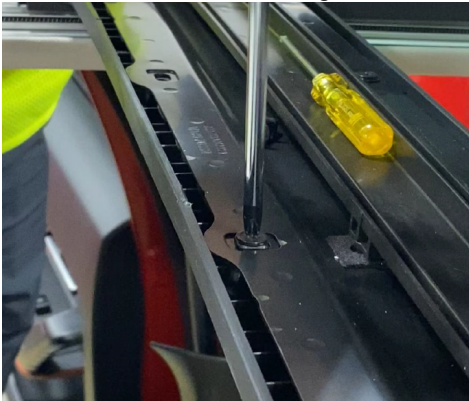
The noise comes from the cross brace cover after the vehicle has been driven and the clips loosen. Follow the instructions below to eliminate the noise.

2. Remove the rear glass panel using the SUNROOF REAR GLASS PANEL REMOVAL procedure.
3. Remove the pushpins and then remove the trim.

CAUTION: DO NOT damage the trim as it is only available with the sunroof assembly.

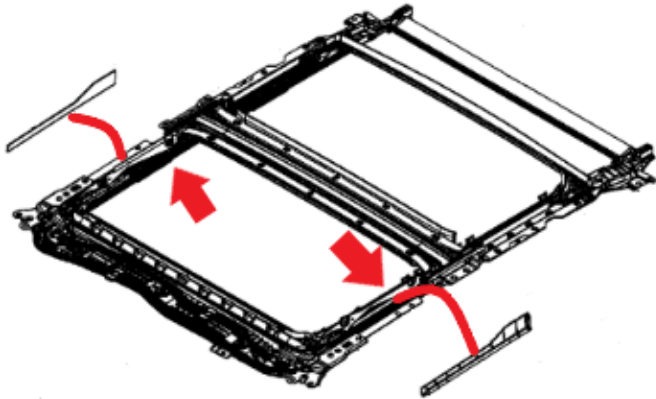
1. Remove the side cover at the front of the assembly to eliminate it as a possible noise source and for better access to the sunroof linkage.
2. Drive the vehicle with the sunroof open and confirm if there is a rattle coming from the linkage in the general areas the red arrows point to.
NOTE: If you can reach the links that are rattling, you can hold them to confirm if the noise is eliminated.

3. If there a noise from the linkage in this area?
YES: Replace the sunroof unit.
NO: Create a video of the concern and then contact the Mazda Technical Assistance Hotline.
