# Technical product information

<b>Topic</b>	DTC B17B801 and/or B17B804 - evident within address 0019 and/or DTC U112300 evident in 00A5
<b>Market area</b>	Russische Föderation (5RU),Australia E04 Bentley rest Asia and Australia (6E04),China 796 VW Import Comp. Ltd (Vico), Beijing (6796),Germany E02 Bentley rest Europe (6E02),Japan E03 Bentley Japan (6E03),Korea, (South) E08 Bentley South Korea (6E08),United Arab Emirates E06 Bentley Middle East and Africa (6E06),United Kingdom E01 Bentley UK (6E01),United States E05 Bentley USA and rest America (6E05)
<b>Brand</b>	Bentley
<b>Transaction No.</b>	2063855/5
<b>Level</b>	EH
<b>Status</b>	Approval
<b>Release date</b>

DTCB17B801 and/or B17B804 - evident within address 0019 and/or DTC U112300 evident in 00A5

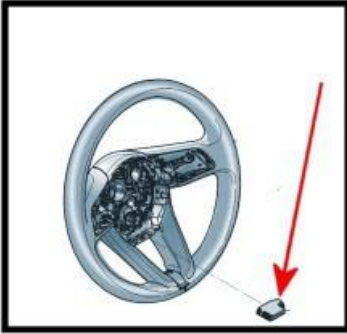
DTC - B17B801 - Steering Wheel Touch Recognition Control Module evident within address 0019

DTC B17B804 - Steering Wheel Touch Recognition Control Module electrical error - evident within address 0019

DTC U112300 with symptom Code 1123220 within address 00A5

2) Referring to Figure 1 - Fit a new Control Unit for Steering Wheel Contact Detection (J1158) to the new steering wheel
