Technical product information

Topic	Engine overheating - Warning on the DIP - V8 Kovomo
Market area	Bentley: worldwide (2WBE)
Brand	Bentley
Transaction No.	2061369/4
Level	EH
Status	Approval
Release date

Bentayga-New Continental GT/C-New Flying Spur (V8 Kovomo)

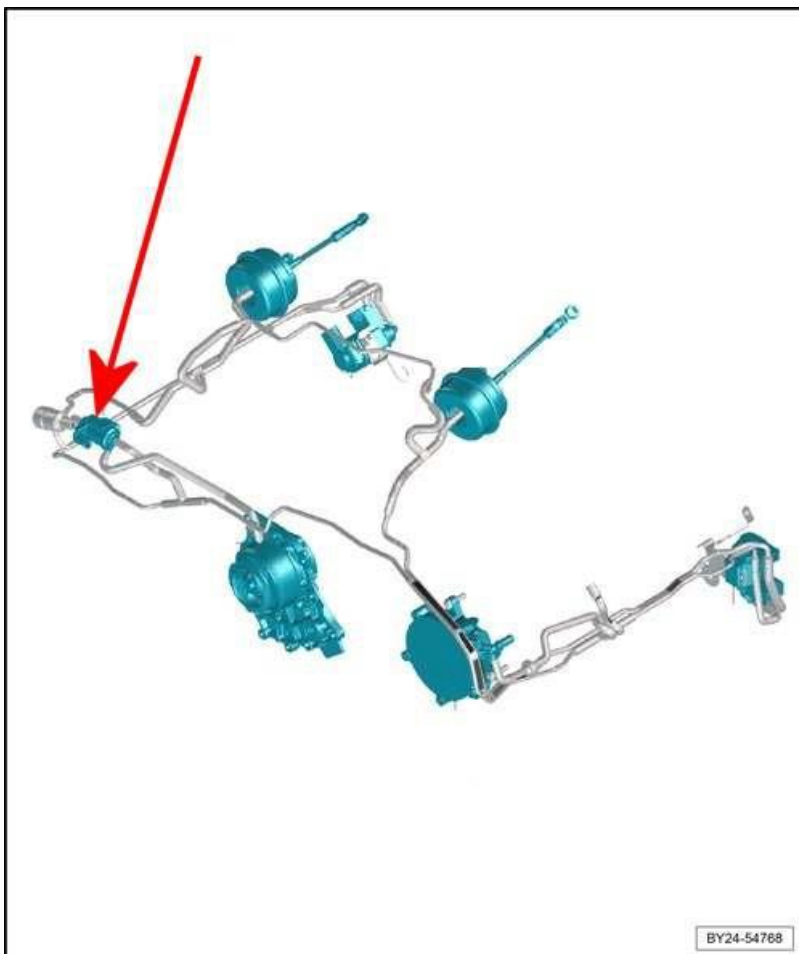
Figure 1 Shows Bentleyaga (Arrow)

TIP: When the switch valve for mechanical coolant pump N649 is at fault (sticking open) the vacuum supply is constant, this allows the sleeve to stay in position around the impeller which leads to the symptoms described within the Customer statement/Workshop findings section of this TPI

IMPORTANT: The switch valve for mechanical coolant pump N649 fails due to an internal leak from coolant pump causing corrosion within the unit from coolant migration

1) Referring to Figures 1,2 and 3 - With care (visually monitor for any traces of coolant) disconnect each vacuum hose from the switch valve for mechanical coolant pump N649

2) Referring to Rep.Gr 19 - Replace all of the following parts

- Coolant pump
- Coolant regulator (Thermostat)
- Switch valve for mechanical coolant pump N649

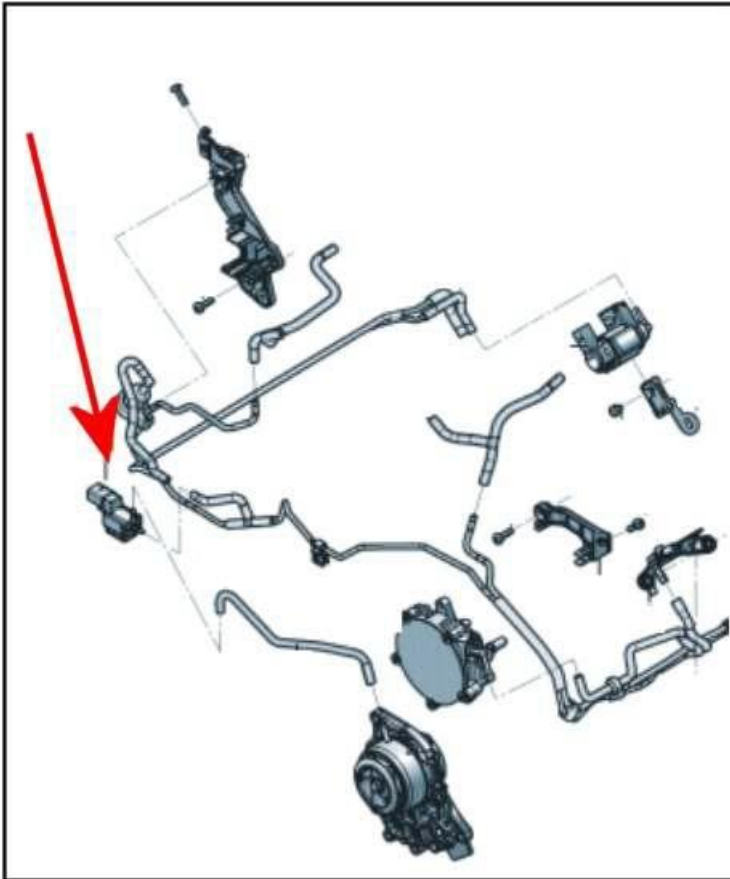
Figure 2 Shows New Continental GT/ GTC and Flying Spur (Arrow)

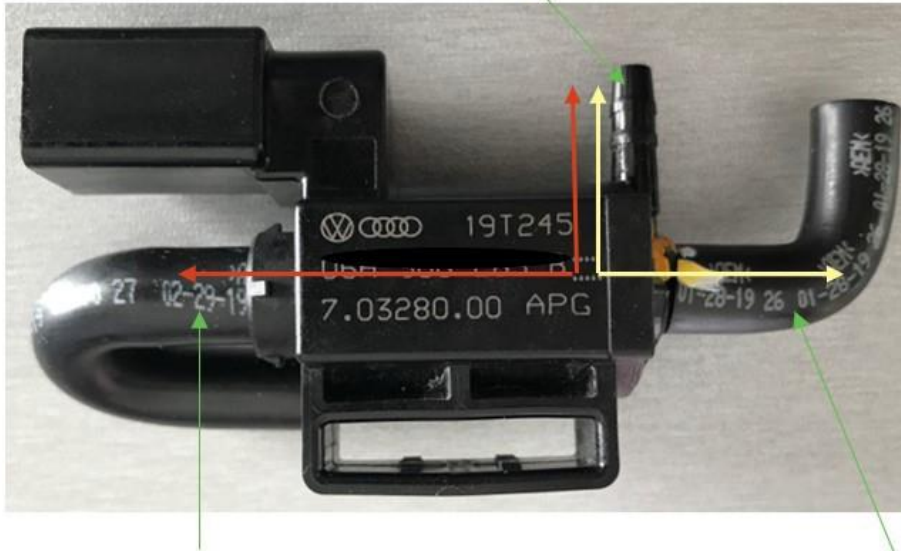
- Referring to Figure 3 the standard operation of N649 (with no operational issues) is as follows:
- Un-energised state (Ignition off) = coolant pump connected to vent connection (red arrows)
- Energised state (Ignition on) = engine vacuum connection to coolant pump (yellow arrows)

HINT: Figure 3 shows an example of N649 for photographic and reference purposes only

- Refer to the video on the Bentley Hub referencing TPI2061369/- to check for any signs of coolant within the vacuum hoses
- Where possible check and confirm N649 is sticking open and supplying a constant vacuum
