# Technical Service Bulletin

## 53 Creaking or knocking noises from rear of vehicle

53 22 06 2068978/1 December 21, 2022.

| Model(s) | Year | VIN Range | Vehicle-Specific Equipment |
|---|---|---|---|
| Q4 Sportback e-tron | 2022 – 2023 | All | Not Applicable |

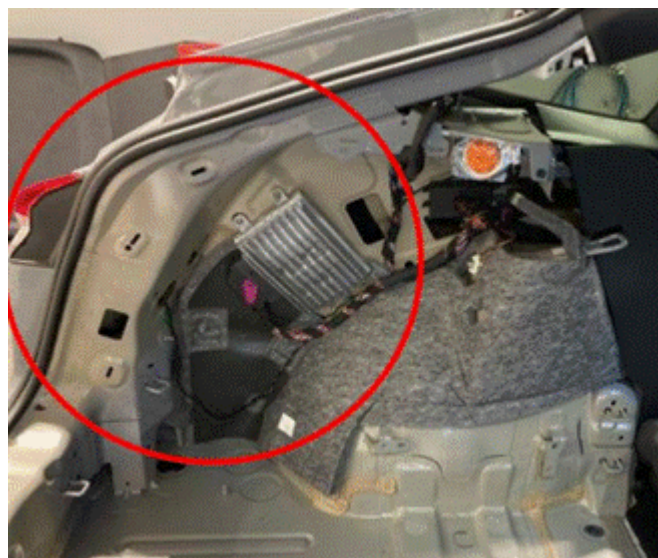
**Workshop findings:** The noises can be replicated in these driving conditions. The noises are diagnosed as originating specifically in the rear cargo area from the sheet metal overlap of the left rear side panel and the left rear cross panel.

**Figure 1.** Area of cargo area where noises are generated.

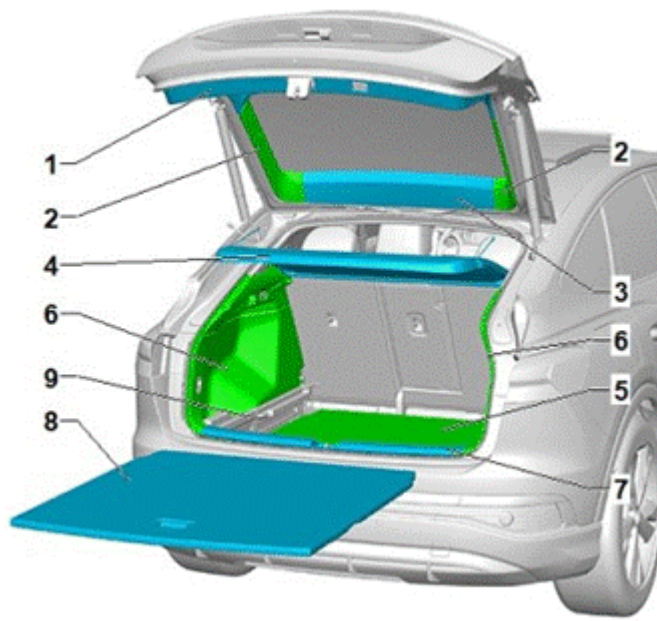
**Figure 2.** Luggage compartment trim.

1. Detach the left rear luggage compartment side trim panel according to the work procedure in Elsa: *Repair manual>>Body>>Body Interior>>70 Interior Trim>>Luggage Compartment Trim Panels>>Luggage Compartment Side Trim Panel, Removing and Installing.*

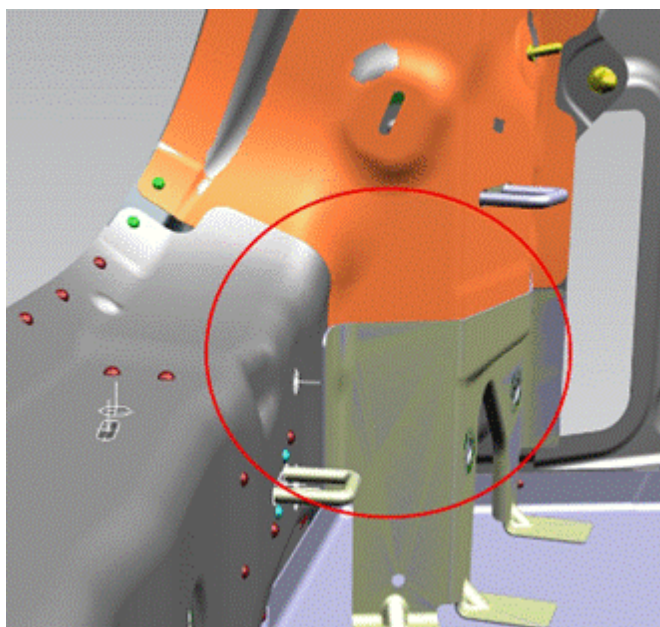
**Figure 3.** Area of left rear panel overlap to be repaired.

2. Figure 3 shows the exposed area where the work is to be performed.

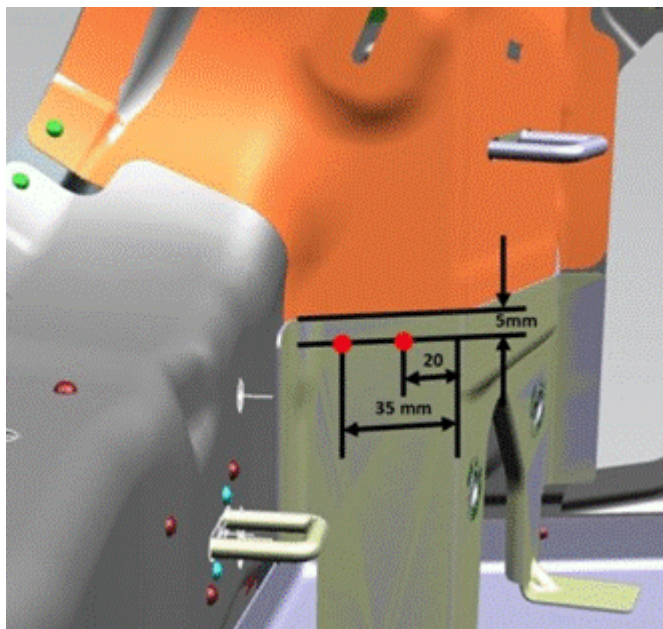
**Figure 4.** Location of 6.5mm holes to be drilled.

- Using the forward fold and the upper edge of the lower support bracket as a guide measure and mark 20mm and 35mm rearward from the fold and 5mm from the upper edge of the lower support bracket on the left corner. In these two spots shown in the measuring schematic in Figure 4 drill two 6.5mm holes through both panels as located by the red dots. Make sure to completely de-burr these drill holes.

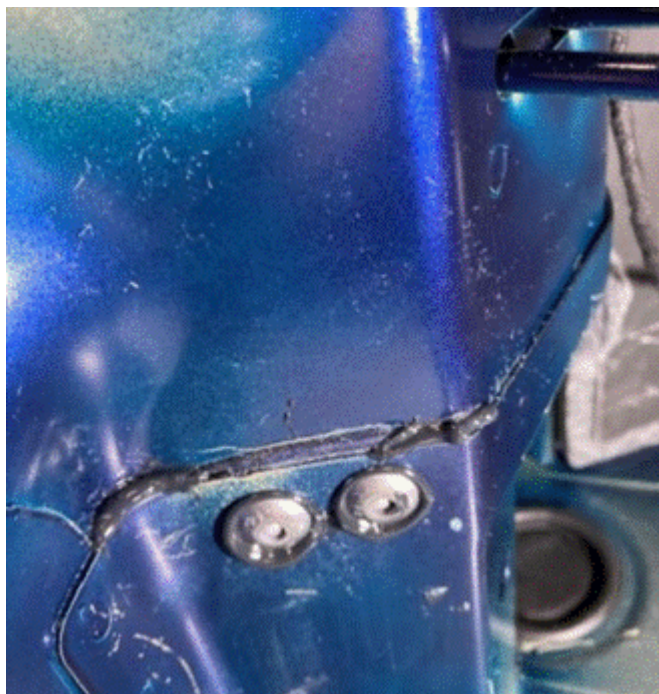
**Figure 5.** Panels with two-part body adhesive and rivets installed.

- Using a plastic wedge separate the two panels slightly and inject D 180004M2 two-part body adhesive between the mating panels and around the drilled openings. Insert and install two WHT005413A pop rivets into the drilled holes. Observe the appropriate curing time for the adhesive.

- After the curing time is complete, seal the entire work area with cavity wax (D 308SP5M1 or equivalent e.g. 3M™ 08852). Test drive the vehicle to confirm resolution of the noises. Reinstall the luggage compartment trim.
