Technical product information

Topic	Oil leaking from tell tale hole - CDA actuator fixings or Fuel rail fixings or Vacuum assembly fixings - V8 Kovomo
Market area	Russische Föderation (5RU),Australia E04 Bentley rest Asia and Australia (6E04),China 796 VW Import Comp. Ltd (Vico), Beijing (6796),Germany E02 Bentley rest Europe (6E02),Japan E03 Bentley Japan (6E03),Korea, (South) E08 Bentley South Korea (6E08),United Arab Emirates E06 Bentley Middle East and Africa (6E06),United Kingdom E01 Bentley UK (6E01),United States E05 Bentley USA and rest America (6E05)
Brand	Bentley
Transaction No.	2064679/4
Level	EH
Status	Approval
Release date

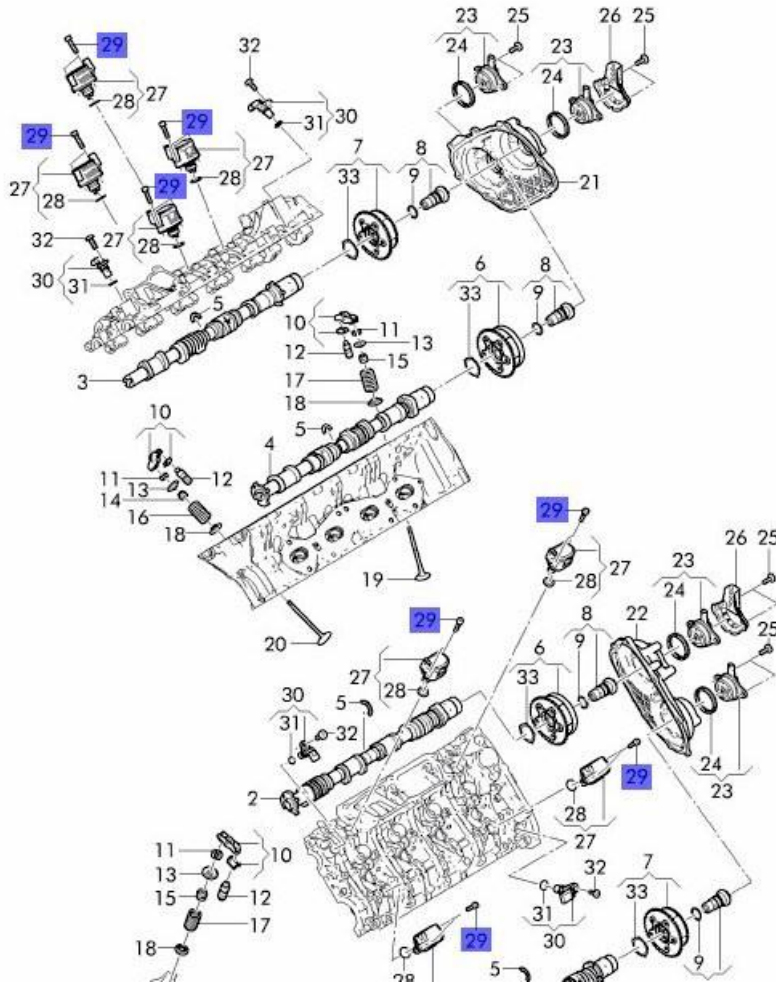
- CDA activation/ deactivation solenoid fixings - Figure 1 (Item 29 - Quantity of 16 in total)

Scenario 1 - CDA solenoid fixings

- In the event that x1 (or more) of the CDA solenoid fixing/s are leaking – All 16 CDA solenoid fixings MUST BE REPLACED as a complete set - Refer to Rep. Gr 15 - Ensuring the procedure is followed to enable access to all CDA solenoid fixings

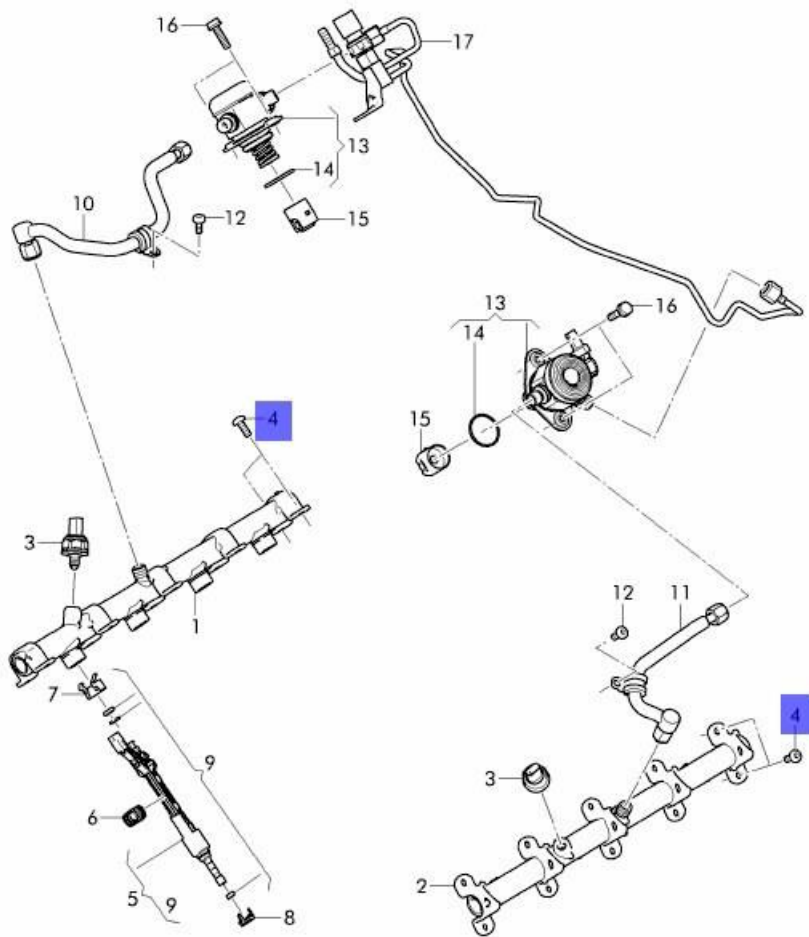
- Fuel rail fixings - Figure 2 (Item 4 - Quantity of 20 in total)

Scenario 2 - Fuel rail fixings

- Refer to Rep. Gr 24 - Fuel rail store remove and refit - Ensure the procedure is followed to enable access to the fuel rail fixings on both Banks 1 and 2 - Replace all 20 fixings

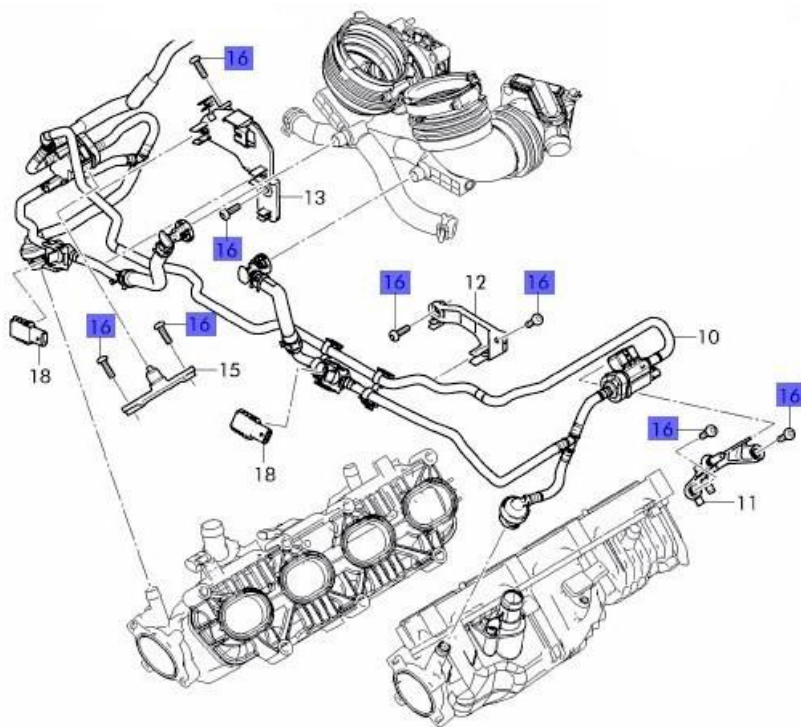
- Fixings for the vacuum system assembly - Figure 3 (Item 16 – Quantity of 8 in total)

Scenario 3 - Vacuum assembly fixings

- Remove the front end module - Refer to "Front end module - to remove and fit"
- All models continued
- Rep.Gr 20 - Evaporative Emission Purge Valve and Rep.Gr 28 - Ignition coil replacement to gain access to the fixings
- Replace all Vacuum assembly fixings
- Refit all previously removed parts

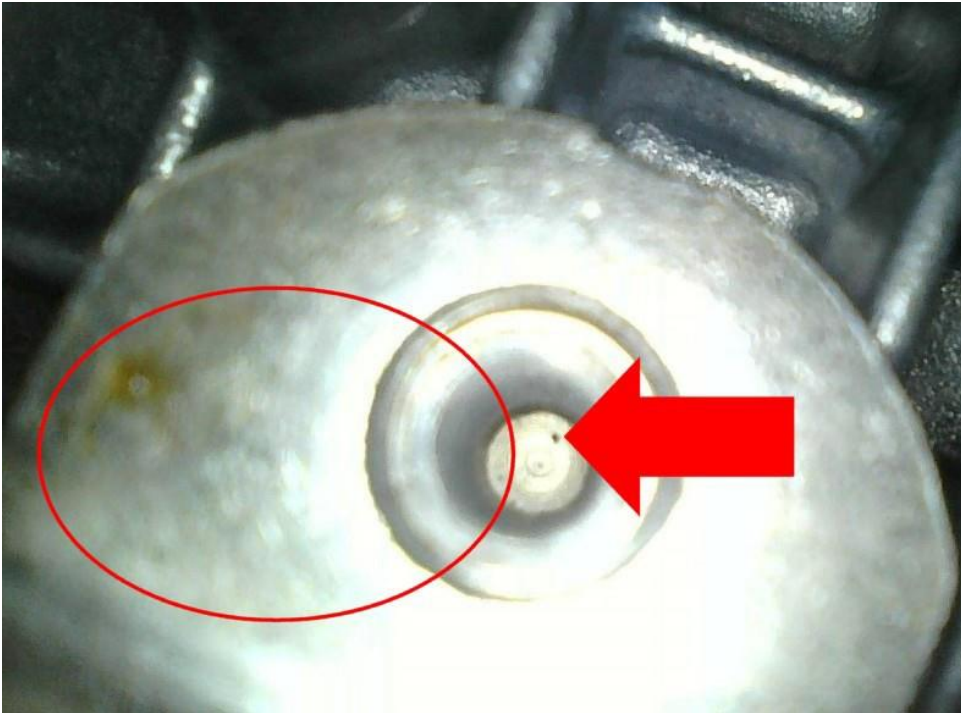
Figure 4 shows oil leaked which had leaked from the tell tale hole at the top of the fixing (Arrow)

Upgraded fixings prevent oil leaks from the tell hole
