RSB-60-22-001-1: Temporarily Disable Powered Tonneau Cover

Rivian is initiating a technical service bulletin for some R1T vehicles that may have a tonneau cover that does not properly open or close. If necessary, Rivian will open the tonneau cover and temporarily disable it so that it remains in a fully-open position.

Document Type	Technical Service Bulletin
Date	December 2, 2022
Affected Region(s)	USA
Affected Model(s)	R1T
Model Year(s)	2022
Approximate Build Dates	August 2021 - November 2022

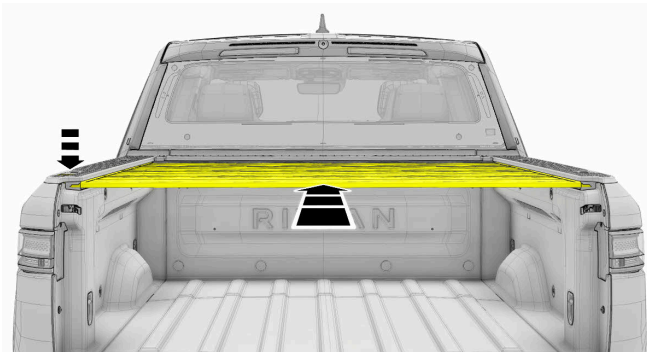
Note: The visible panel should protrude 25-50 mm (1-2 inches) from the housing.

3. Press and hold the tonneau cover button while pushing the panels into the tonneau cover housing. Check and adjust fit and/or flushness.
