Technical Service Bulletin

90 Instrument cluster: the Audi virtual cockpit displays a colorful line (pixel error)

90 22 84 2064983/5 December 1, 2022. Supersedes Technical Service Bulletin Group 90 number 22-78 dated August 9, 2022, for reasons listed below.

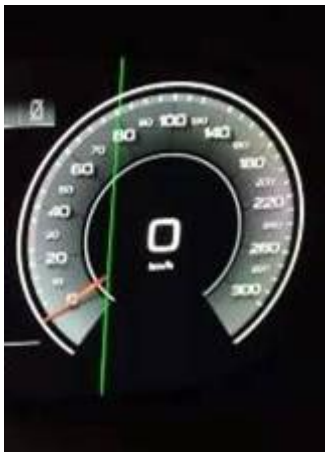
- A red, green, or blue continuous vertical line is displayed on the instrument cluster (pixel fault) (Figures 1-2).
- The line may be vertical or horizontal.

Figure 1. The vertical line through the instrument cluster display.

There is a hardware issue in Audi virtual cockpit.

1. Please take photos of the area of concern and upload them into DOC-IT with the repair order. Photos should:
 - a. Have a date stamp and VIN reference.
 - b. Be taken in focus and with sufficient light.
2. Please replace the instrument cluster, J285 (address word 0017) according to the Elsa Repair Manual.

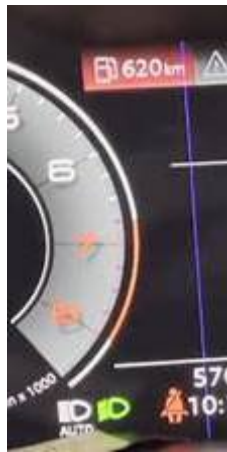
Figure 2. The vertical line through the instrument cluster display.
