Technical product information

Topic	Noises from Panoramic sun roof
Market area	Bentley; worldwide (2WBE)
Brand	Bentley
Transaction No.	2054210/4
Level	EH
Status	Approval
Release date

Bentayga series

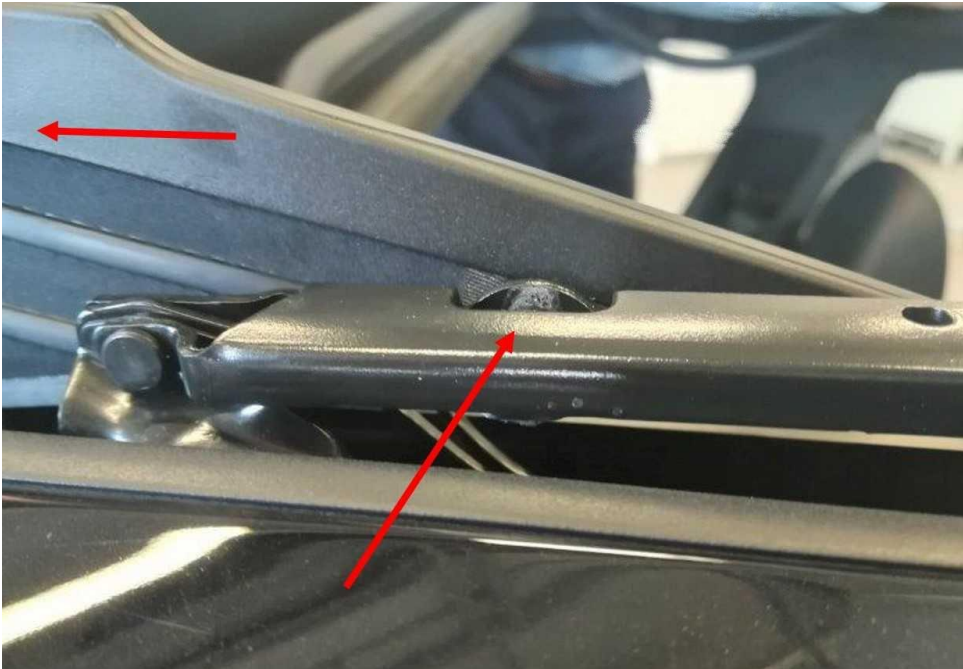
2) The above illustration shows the left mechanical system. The upper left arrow points to the driving direction. The lower arrow points to the first mounting point of the glass panel.

- For a better access to the points to be greased move the mechanical system (slightly) rearwards
- Apply grease spray G 060 567 A2 to the points shown within the onward instructions

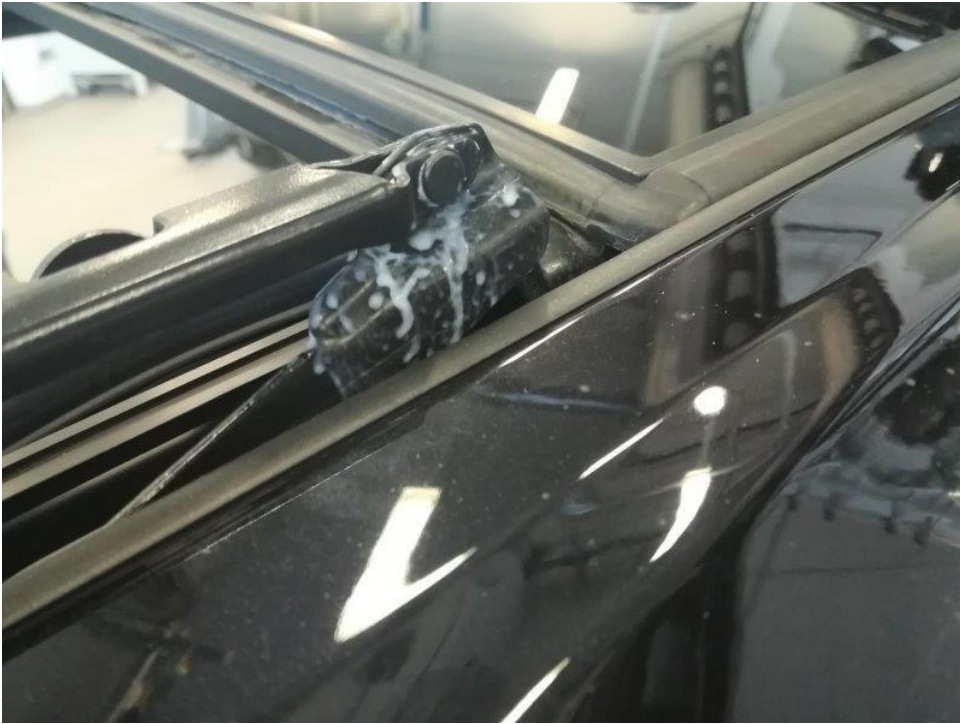
- The above illustration shows the point after the lubrication.
