91 Audi connect does not function after 91DZ campaign (MY22 e-tron GT)

91 22 56 2068824/1 December 8, 2022.

Model(s)	Year	VIN Range	Vehicle-Specific Equipment
e-tron GT, and RS e-tron GT	2022	000001 – 002700	Audi connect

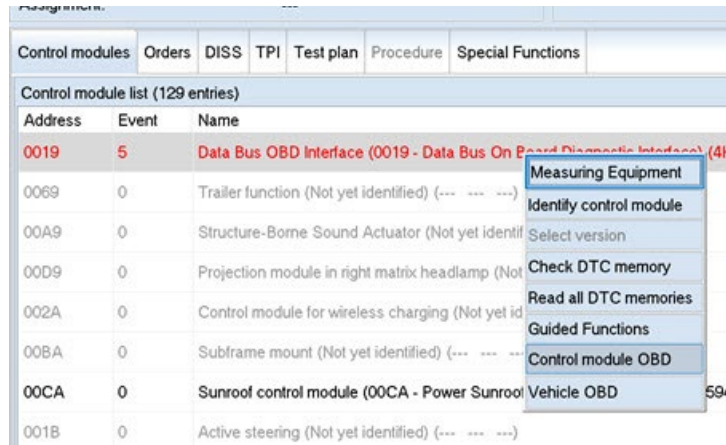
Figure 1. Control Module OBD.

1. Start ODIS, use Diagnosis (GFF), enter Control Module OBD, and query the Diagnostic Address 0019 – Data Bus On-Board Diagnostic Interface (J533). These steps can also be achieved using Self-Diagnosis, but one must use this process for warranty reporting and reimbursement. If one uses the Self-Diagnosis directly from the start of ODIS, no GFF log will be uploaded to reflect the work being performed (Figure 1).

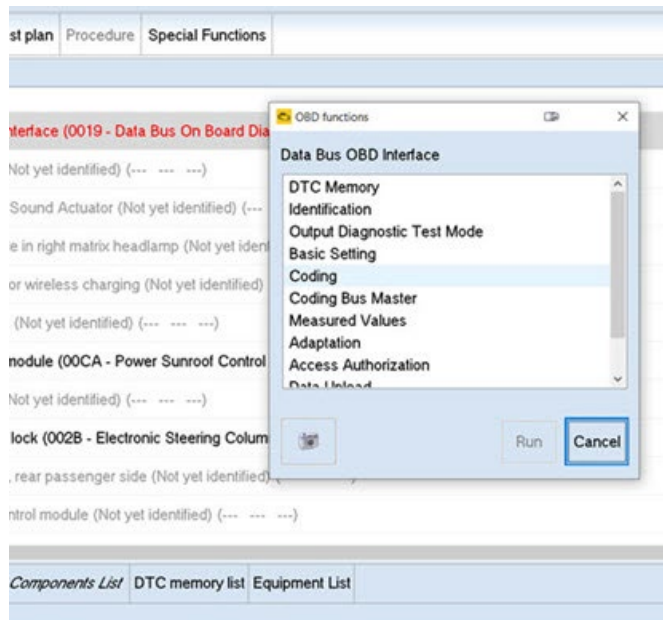
Figure 2: Coding from Self-Diagnosis.

2. Right-click on the diagnostic address 0019, On-board diagnostic interface control module (J533).
3. Select “Coding” (not the installation coding) and view the coding for Byte 28 (Figure 2).
