## SERVICE BULLETIN

**APPLICABILITY:** 2022MY Forester with Gen 2 Telematics  
 2022MY WRX with Gen 2 Telematics  
 2022-**23**MY BRZ with Gen 2 Telematics

**NUMBER:** 15-306-22R

**SUBJECT:** Intermittent Request Failure of Remote STARLINK® Services

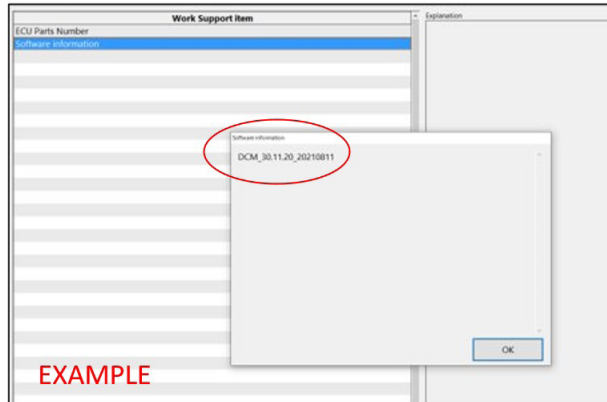
**STEP 1:** Connect the applicable Subaru Select Monitor (SSM) to the vehicle. Read the Subscription and Software Information of the DCM. Record this information for confirmation after reprogramming is performed.

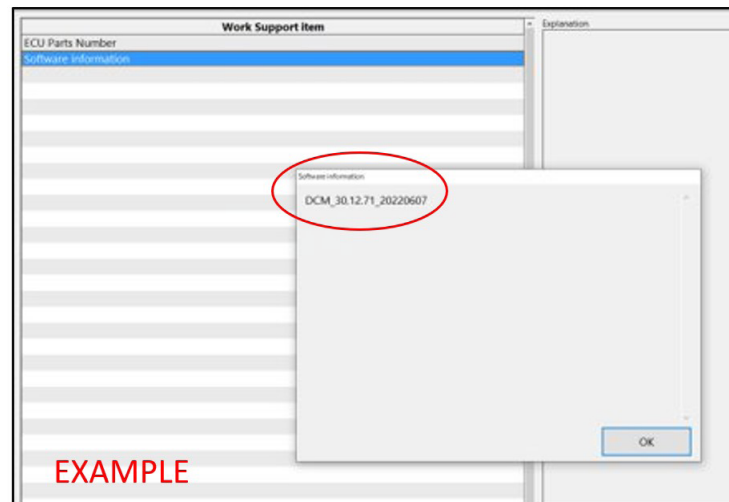
**STEP 9:** Using the applicable SSM, read the Software Information of the DCM.
