## Technical product information

<b>Topic</b>	Seat belt presenter – Intermittent operation
<b>Market area</b>	Russische Föderation (5RU),Australia E04 Bentley rest Asia and Australia (6E04),China 796 VW Import Comp. Ltd (Vico), Beijing (6796),Germany E02 Bentley rest Europe (6E02),Japan E03 Bentley Japan (6E03),Korea, (South) E08 Bentley South Korea (6E08),United Arab Emirates E06 Bentley Middle East and Africa (6E06),United Kingdom E01 Bentley UK (6E01),United States E05 Bentley USA and rest America (6E05)
<b>Brand</b>	Bentley
<b>Transaction No.</b>	2068643/1
<b>Level</b>	EH
<b>Status</b>	Released for publishing
<b>Release date</b>	18-Nov-2022

### Continental GT and GTC

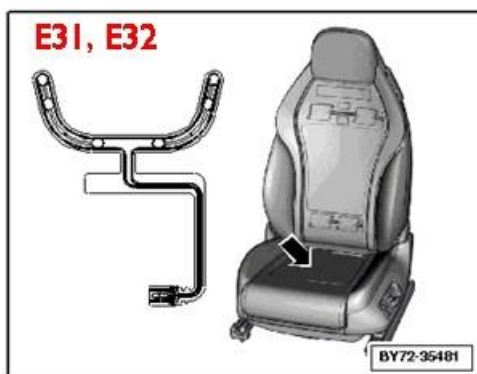
Figure 1

3. First check the occupancy sensor, E31, is function correctly (see Figure 1)

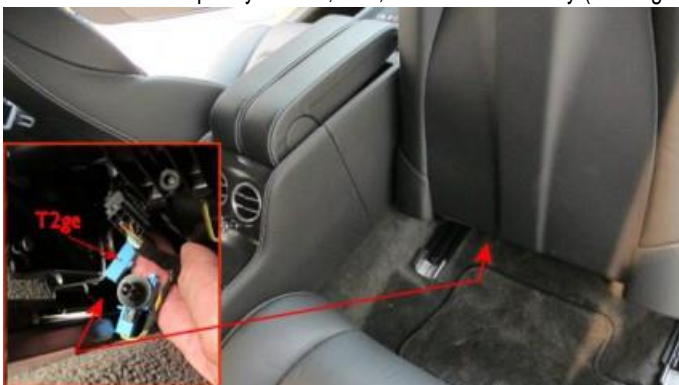
Figure 2

- Disconnect connector T2ge at the occupancy sensor (E31 Drivers, E32 Passengers). The 2 way connection can be identified by its blue connector housing located under the seat frame adjacent to the inboard seat runner (see Figure 2)

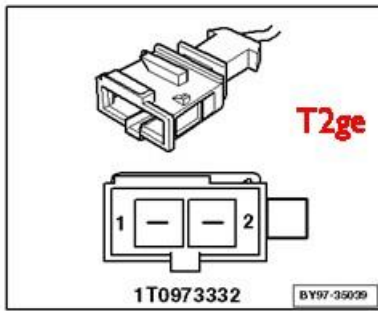
Figure 3

- With T2ge connector disconnected and an occupant sat in a natural position on the seat, with their back against the backrest, measure the resistance through the occupancy sensor (see Figure 3)
