## Climate control system improper operation with fault codes B10A207, B105C07, B109F07 and/or B113600 in ACC control unit

Topic number	LI83.10-N-071291
Version	5
Function group	83.10 - Ventilation
Date	12/11/22
Validity	Model 907
Reason for change	Change to order of remedy and title

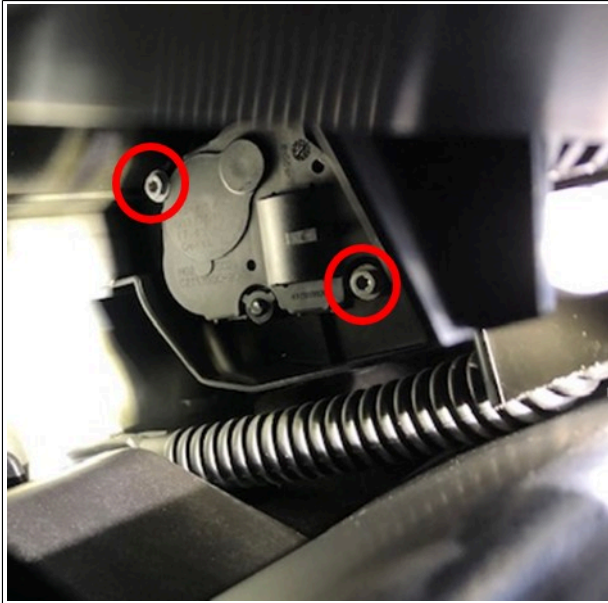
remedy 2 linkage orientation.jpg

Linkage orientation

3.Remove all three front ac stepper motors. While removed, check linkage manually for proper movement (if concern is related to temperature, please make sure temperature is achievable by manually moving the blend linkage)

4.Reinstall stepper motors (torque stepper motors to case at 1.8Nm)

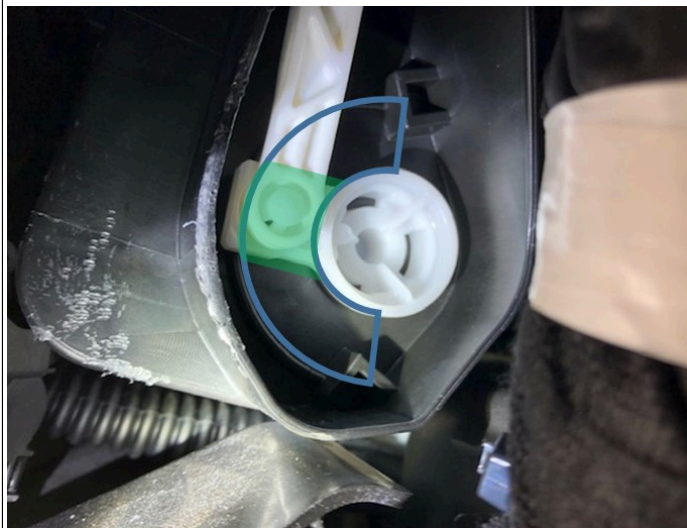
Rear additional heat exchanger.PNG

NOTE: If the vehicle is equipped with H13 (rear additional heat exchanger), There is an additional stepper motor in the rear heater case under the vehicle. This stepper motor can influence the normalization process.

N29/12

•If all three front ac actuators are functioning, please check stepper motor in N29/12 (WIS doc. - Left water valve (AR83.60-D-0003TSR))

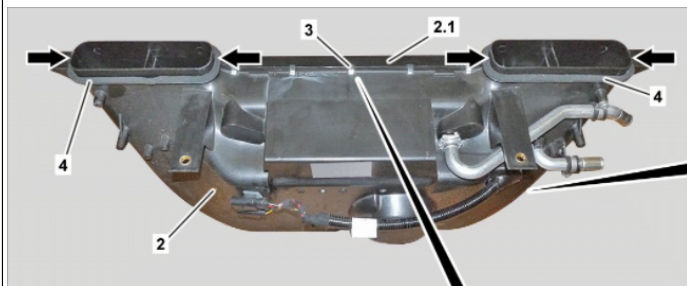
H13 stepper motor1.PNG

May include fault code: B1A9C07 the output for control valve "Left water valve" has a malfunction. There is a mechanical fault.

Stepper motor in N29/12

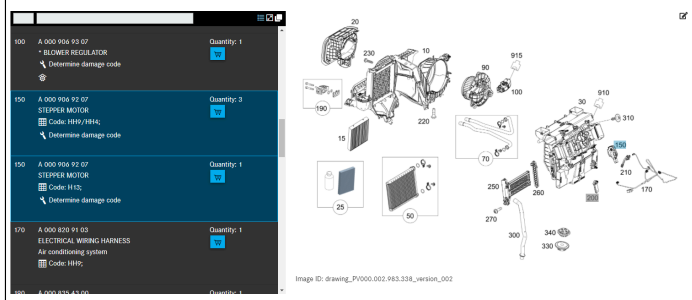
XPPI- Stepper motor for N29/12 located with the other
