Technical product information

New Continental GT/C and New Flying Spur

Grease evident at the front lower ball joint bellows

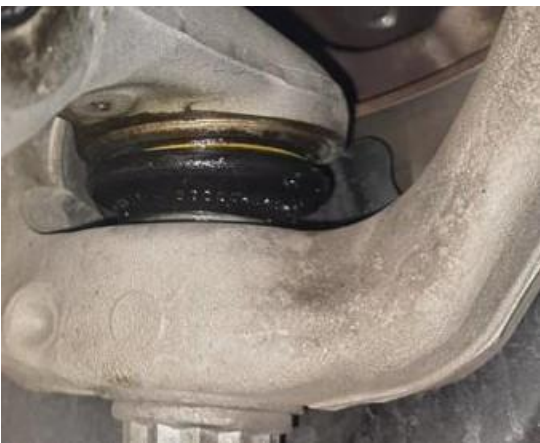
Figure 1

Grease may leak during the initial assembly of the front lower levers. This due to a maximum deflection of the conical spigot before the lower lever is assembled into the wheel carrier. Over the service life, additional foreign bodies can collect in the corresponding area and stick to the excess grease, which can then be distributed over a larger area

The level of grease on or around the lower ball joint boot/wheel bearing housing (Figures 1,2 and 3) is deemed as a normal characteristic

"Normal" Characteristic:

If there is no customer complaint about noises (rattling, pinching, creaking) from the area of the front axle and the lower levers have clearance, the operative must remove any excess grease and check the ball joint and bellows for damage

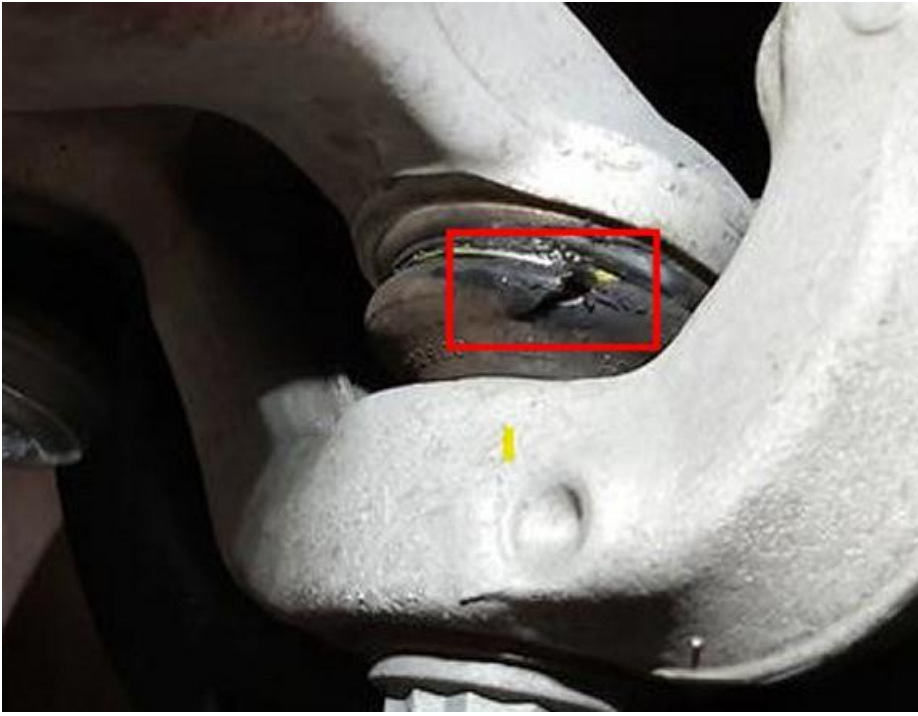
Figure 4

["Torn/split bellows" - Replacement necessary](#)

▪
If the ball joint is worn/damaged or the ball joint bellows is split/damaged (as shown in Figures 4 and 5) the lower front lever must be replaced – Refer to Rep.Gr 40

IMPORTANT: Prior to replacing the lower lever the operative MUST raise a Technical DISS query requesting permission to replace the front lower lever
