Technical Service Bulletin

Topic	W12 Engine management light on - Turbocharger speed sensor DTC's stored
Market area	Bentley: worldwide (2WBE)
Brand	Bentley
Transaction No.	2053348/10
Level	EH
Status	Released for publishing
Release date	Dec 1, 2022

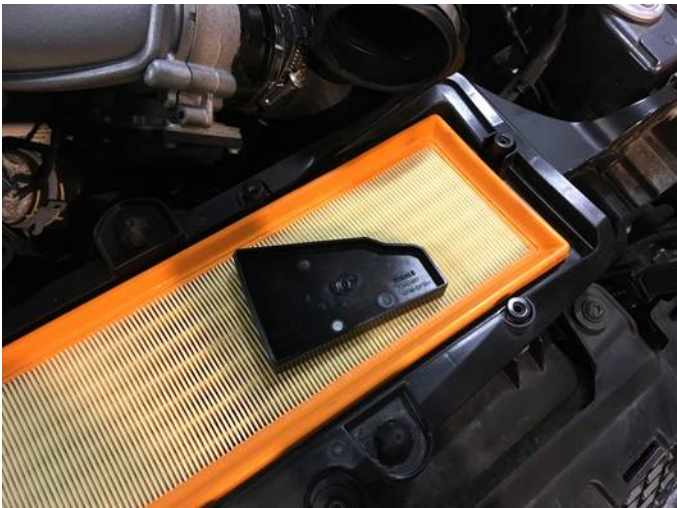
- Inspect for damage or missing components NOTE: The example in Figure 1 shows an air filter box divider that has become detached, causing DTC - P259400: Turbocharger Speed Sensor "B" - Circuit Range/Performance
- Reattach the divider and retest the vehicle if this particular fault is found
