Service Bulletin

Bulletin No.: 18-NA-073

Subject: Repair Guidelines for Engine Component Wear

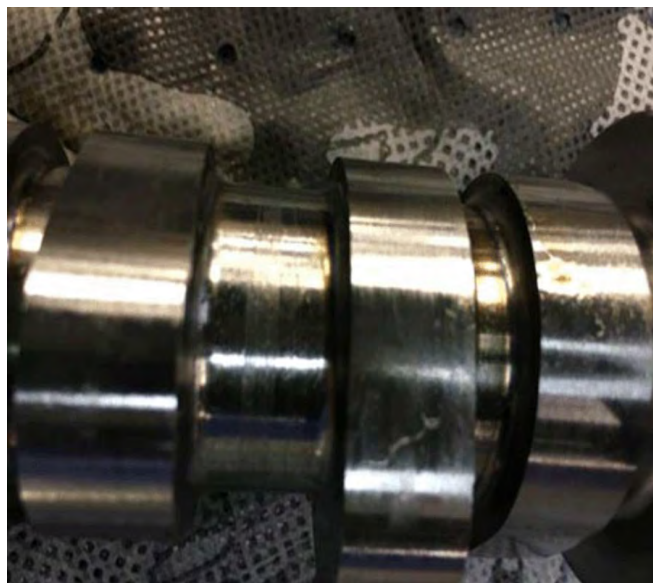
4994025

Example of minor scratching/scoring visible on camshaft lobes and/or camshaft bearing journals. In this example, the scored components can be replaced without need for engine assembly replacement.

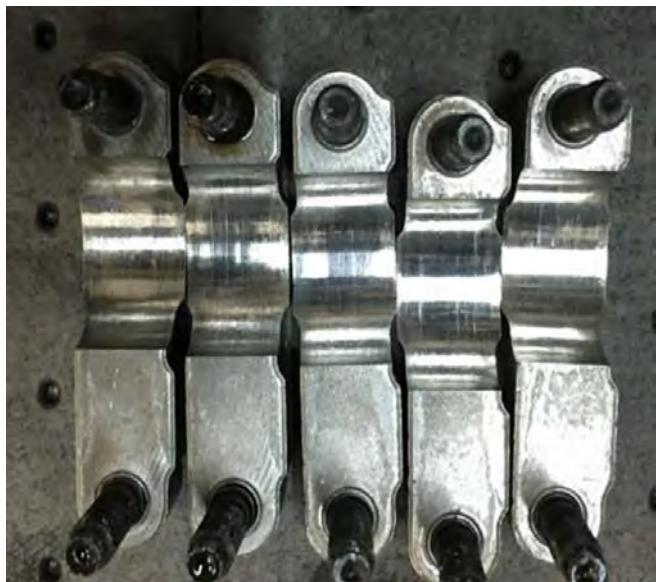
4991477

Example of minor scratching/scoring visible on camshaft bearing caps. In this example, the scored components can be replaced without need for engine assembly replacement.

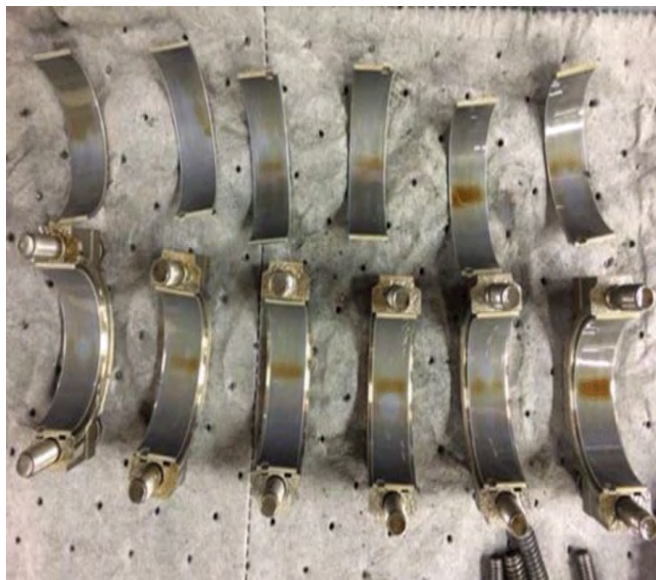
4992132

Example of minor scratching/scoring visible on connecting rod bearings. In this example, the scored components can be replaced without need for engine assembly replacement.

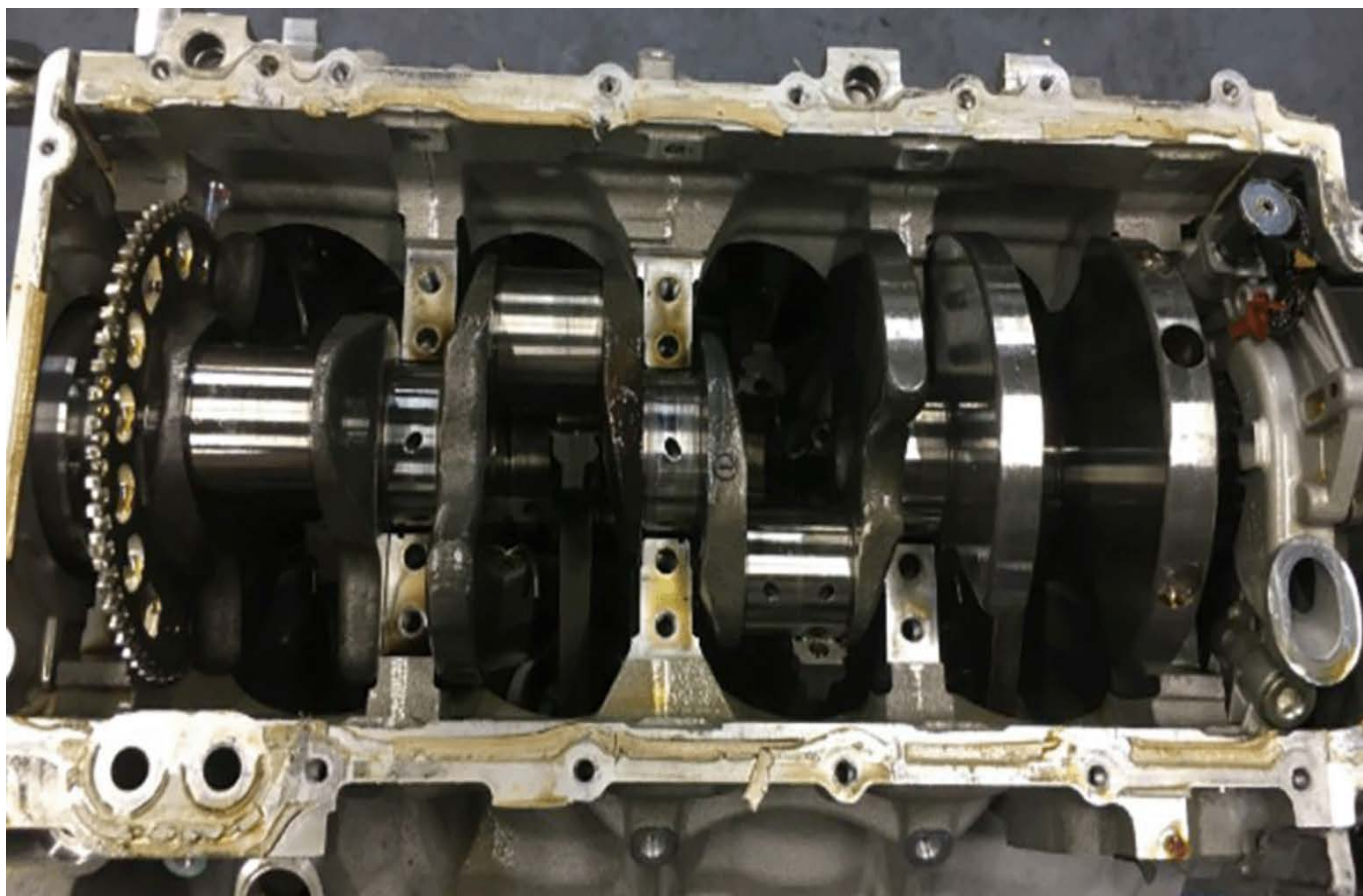
4990880

Example of minor scratching/scoring visible on crankshaft. In this example, the scored components can be replaced without need for engine assembly replacement.

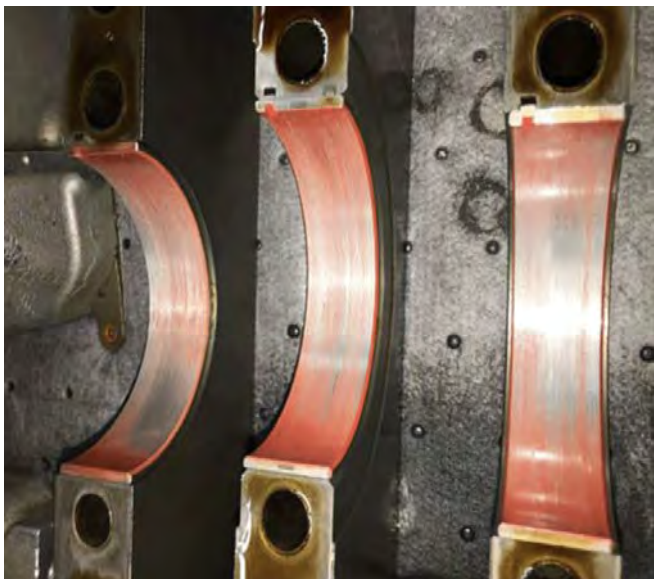
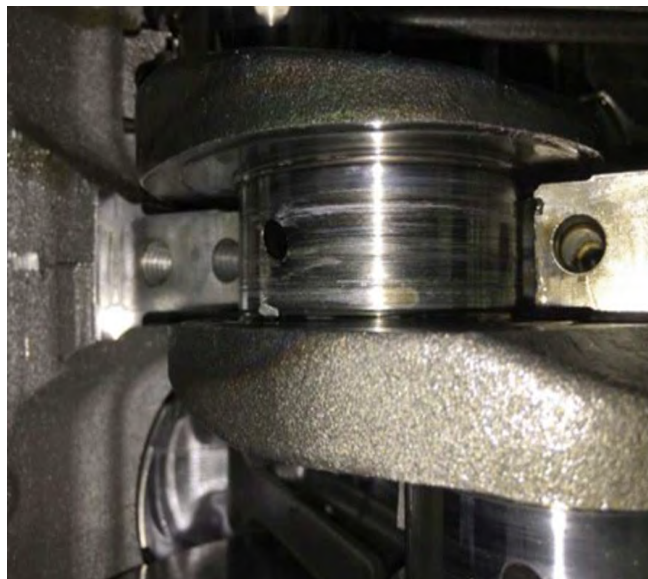
Example of minor scratching/scoring visible on crankshaft. In this example, the scored components can be replaced without need for engine assembly replacement.

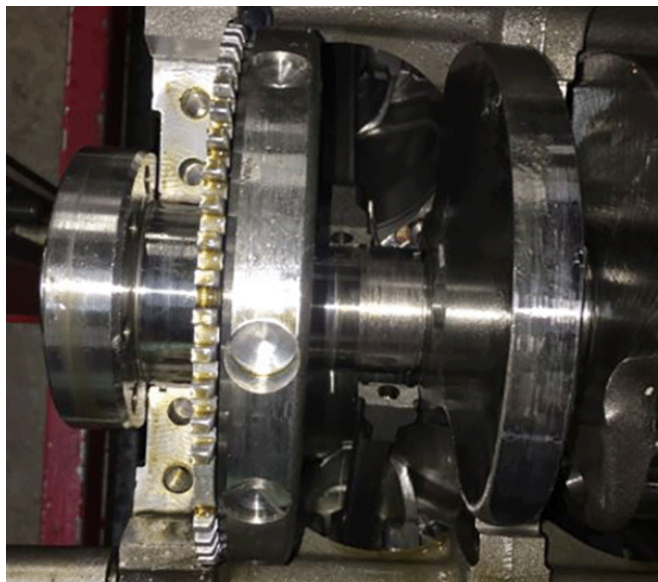
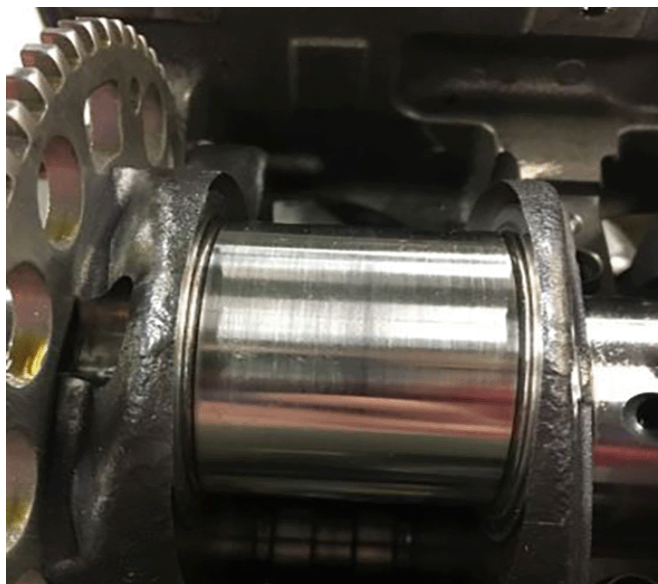
Example of minor scratching/scoring visible on crankshaft. In this example, the scored components can be replaced without need for engine assembly replacement.

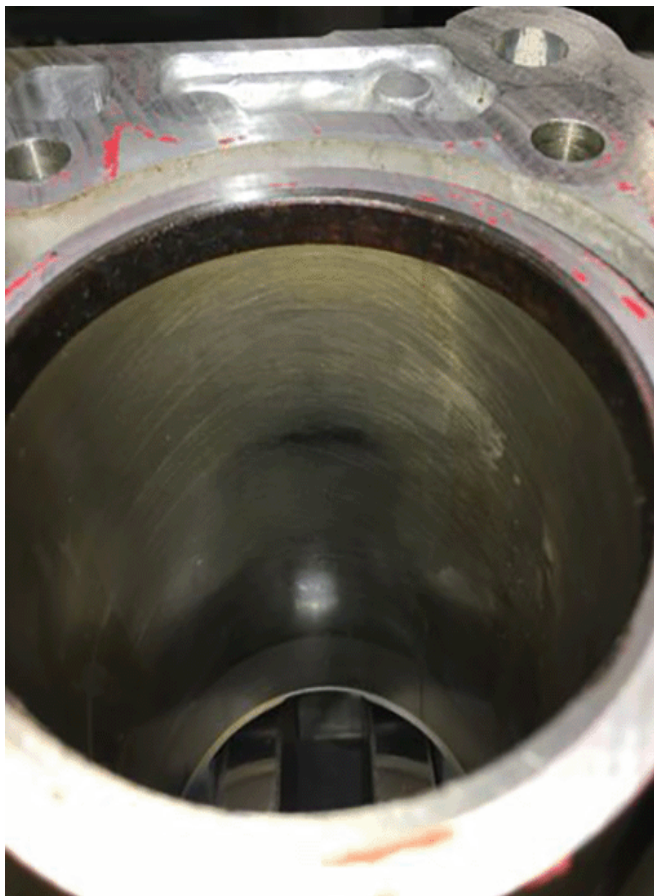
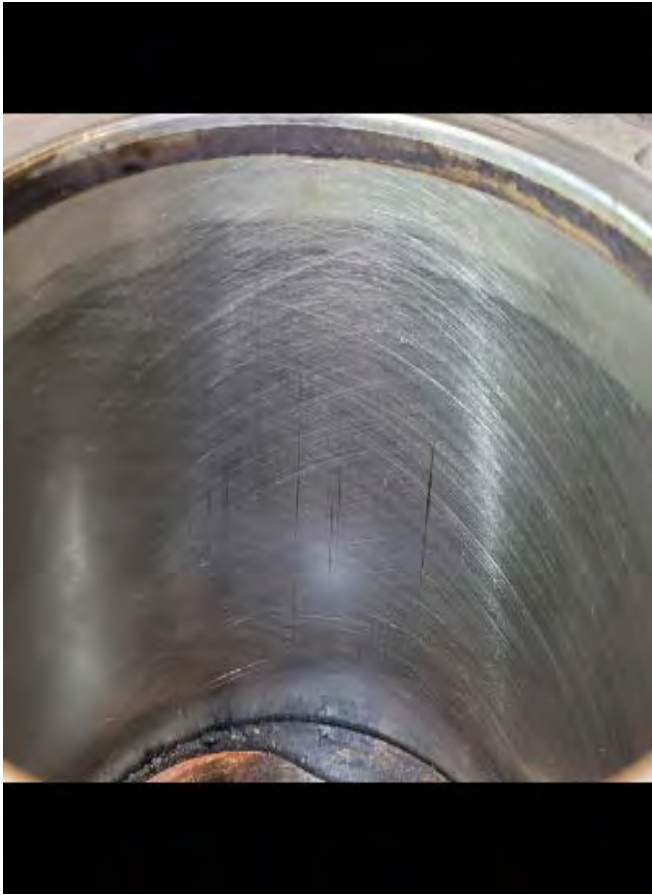
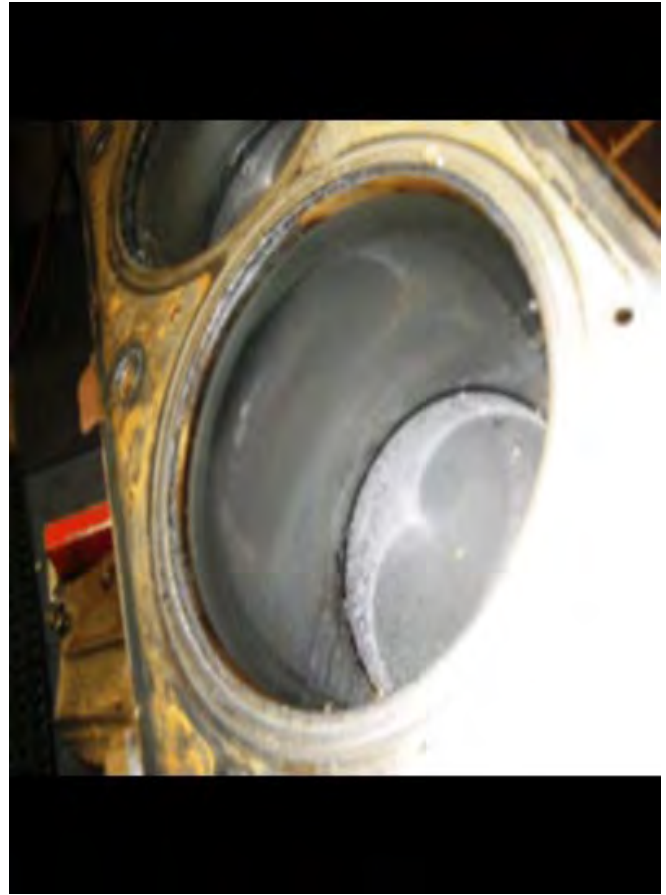
Example of minor scratching/scoring visible on cylinder wall. In this example, if you cannot catch a pick or fingernail on the scratch, the cylinder bore/engine block does not require replacement. If the piston is slightly scored, the scored piston can be replaced without need for engine assembly replacement.

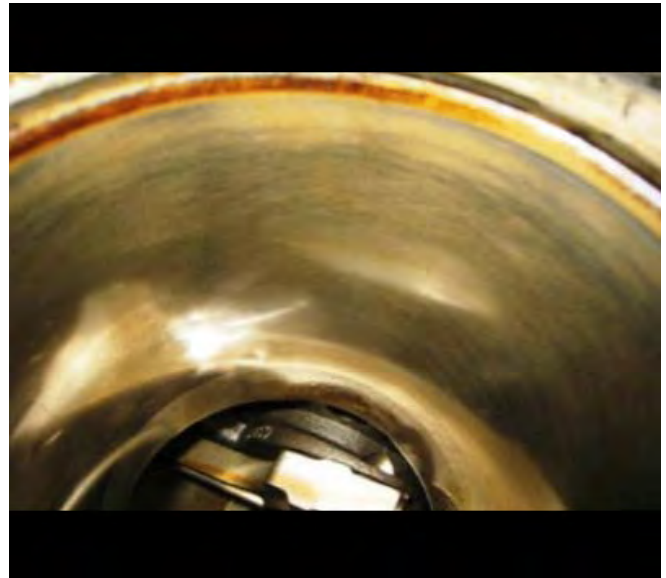
5788571

Suspecting an engine block of possible cylinder bore damage, scoring or out of round as the possible cause of engine oil consumption, misfire, cylinder leakage or blow by.

Note: The peak to valley suspecting an engine block of possible cylinder bore damage, scoring or out of round as the possible cause of engine oil consumption, misfire, cylinder leakage or blow by. spec for crosshatch is .65-2.8 microns. Any deviation and the crosshatch will be gone even if a cylinder is suspected of being oversize, we can only confirm that by checking with an air gauge at the engine plant.

1. Cylinder damage or scoring – The cylinder walls will contain grooves deep enough to catch with a fingernail.
2. Out of round cylinder bore – Contains areas where the crosshatch is missing or worn from different sections of the cylinder bore. If there is crosshatch all the way around the bore from top to bottom, the cylinder bore is not out of round.

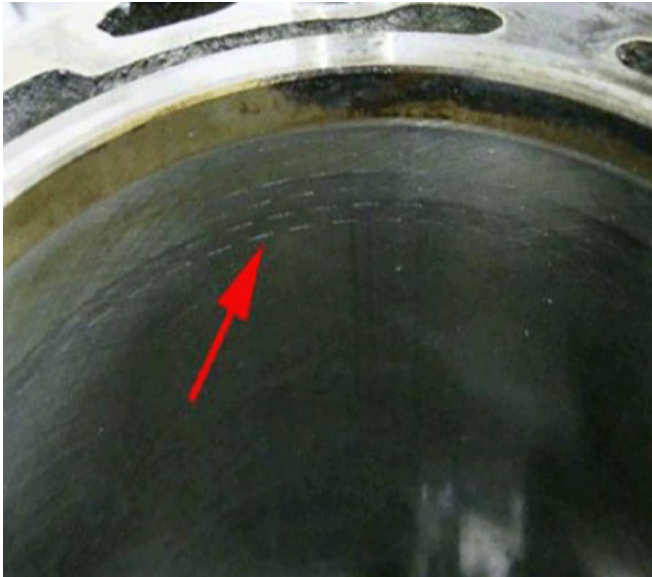
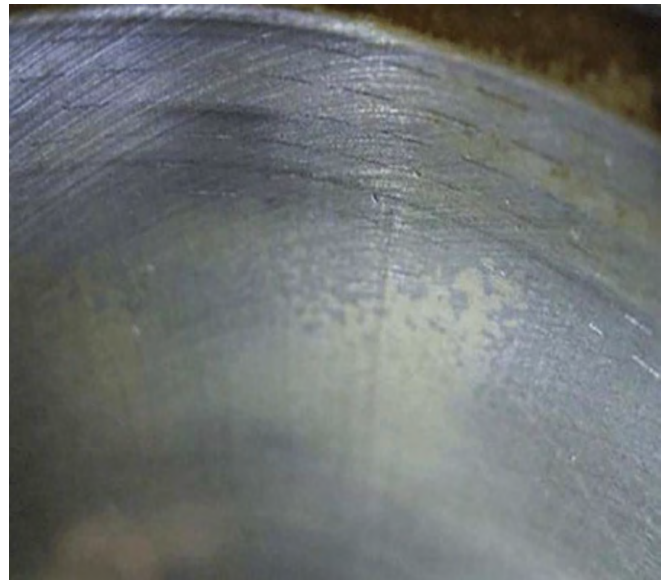
Some technicians may be replacing entire engine assemblies due to marks found at the top of the cylinder bore. These marks are considered normal and are left as a result of a manufacturing laser honing process. **DO NOT** replace the cylinder block or the engine for these normal laser honing marks (refer to PI0725B).

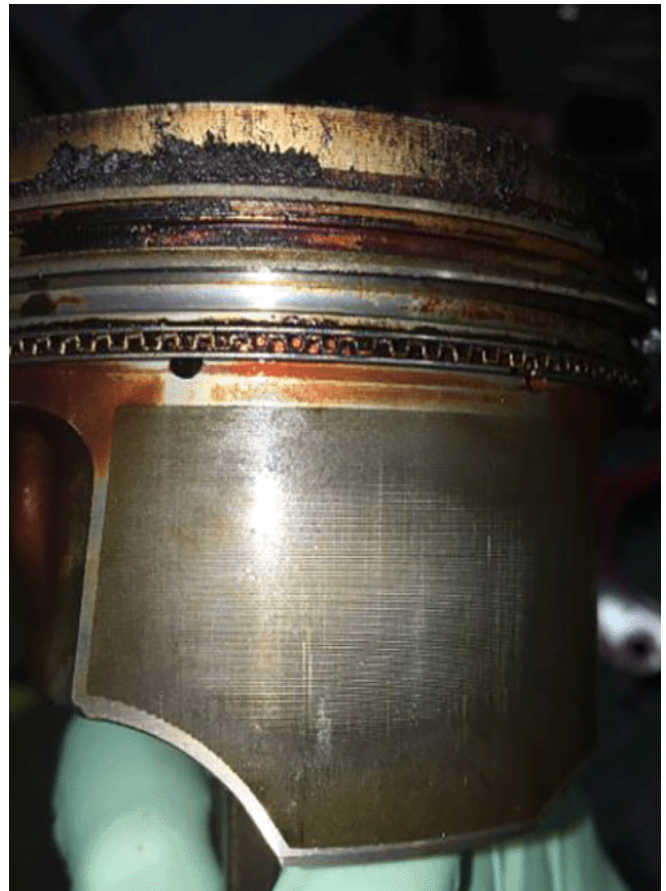
4992916

Example of minor scratching/scoring visible on piston. In this example, inspect for broken and/or stuck rings and piston ring lands and cylinder wall for damage. If no cylinder wall damage or other significant damage, components can be replaced without requiring an engine assembly replacement.

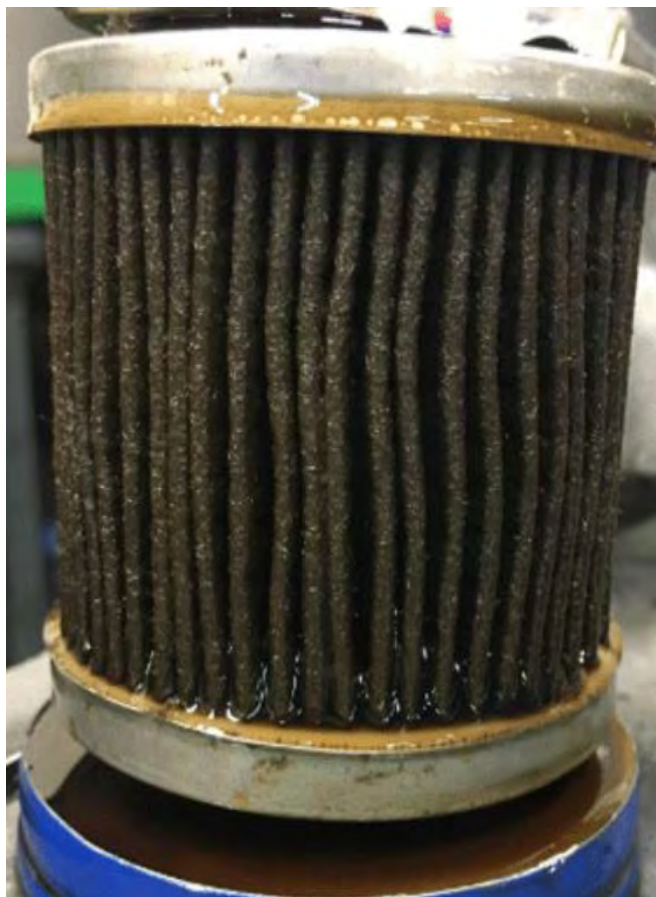
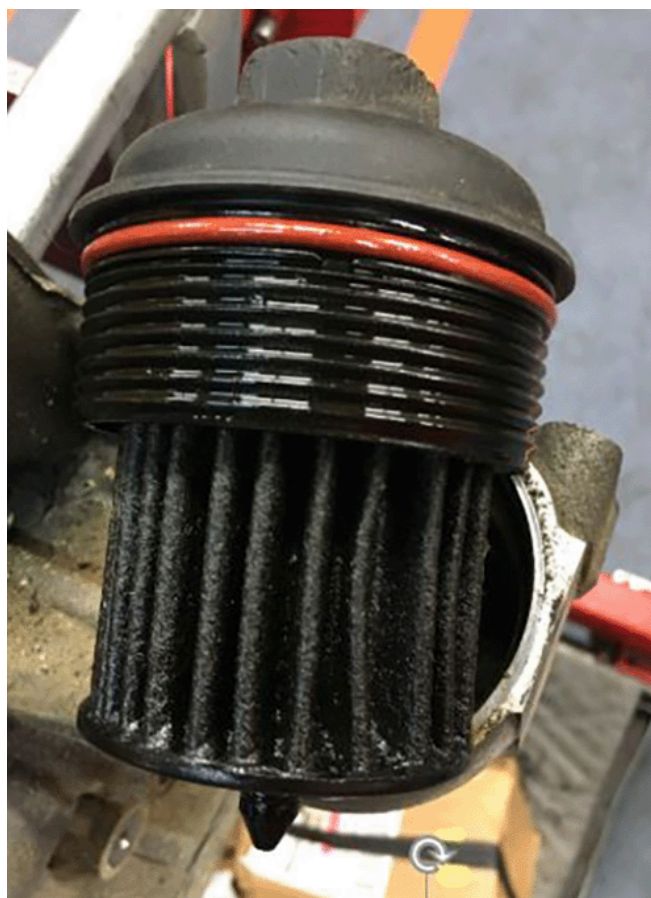
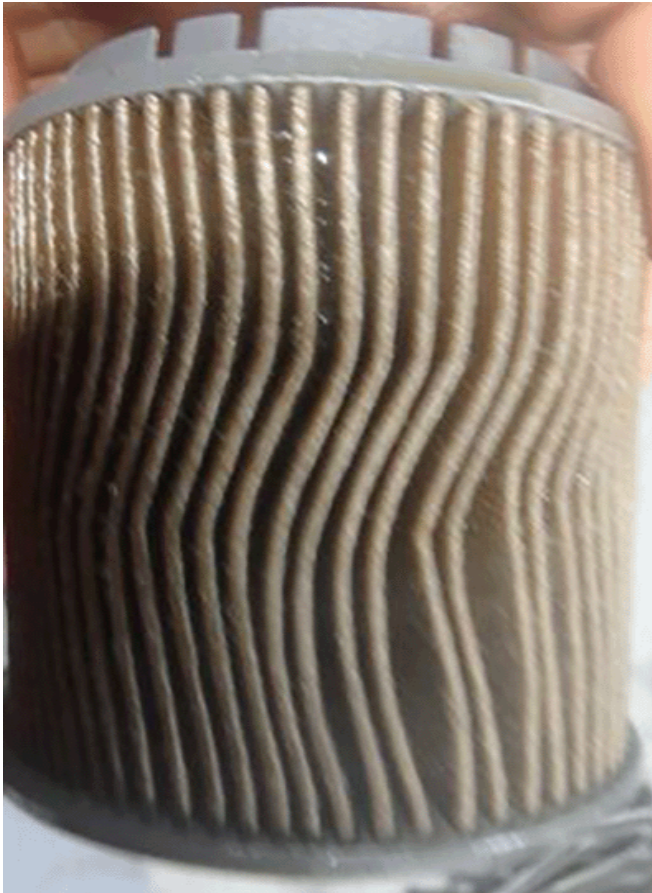
Shown are oil filter pleats with visible metal particles. In this example, minimal amounts of metal particles are visible on oil filter pleats and should not pose a concern.

If excessive amounts of metal particles are observed, or if there is evidence of damaged oil filter pleats, then unfiltered oil with bearing debris may have been pumped into the oil lubrication galleries throughout the engine. This will require further inspection to confirm the degree of contamination and appropriate repair direction. Refer to Service Bulletin #19-NA-256 for HFV6 Gen 1 and Gen 2.
