Service Bulletin

Bulletin No.: 21-NA-228

Subject: Full Size Trucks Idle Time-out Disable

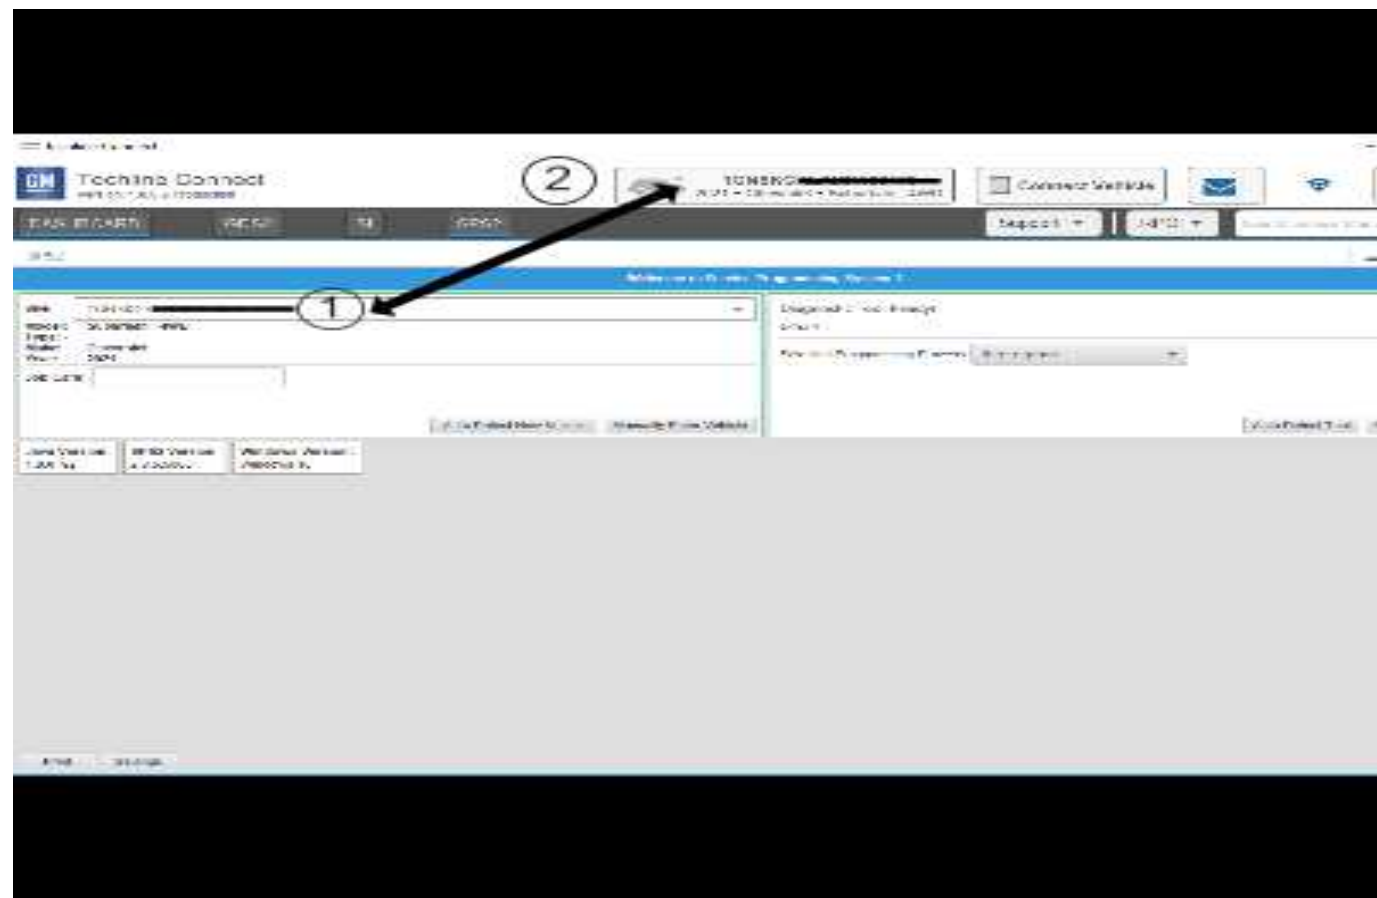
5743643

Caution: Be sure the VIN selected in the drop down menu (1) is the same as the vehicle connected (2) before beginning programming.

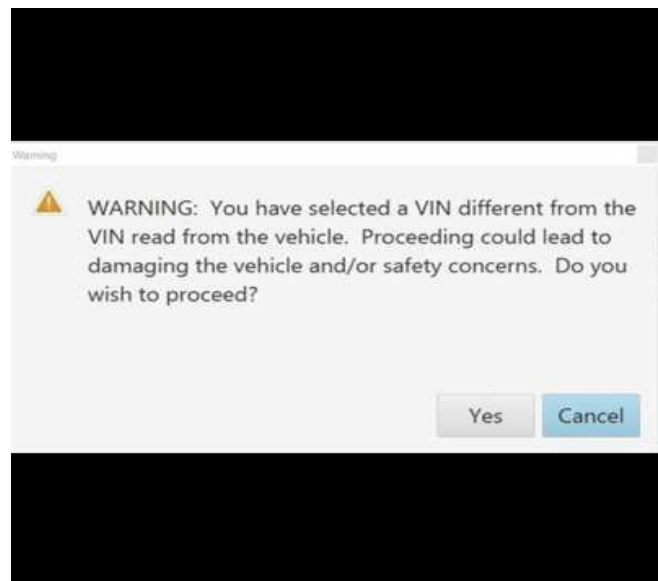
5877000

Important: If the vehicle VIN DOES NOT match, the message below will be shown

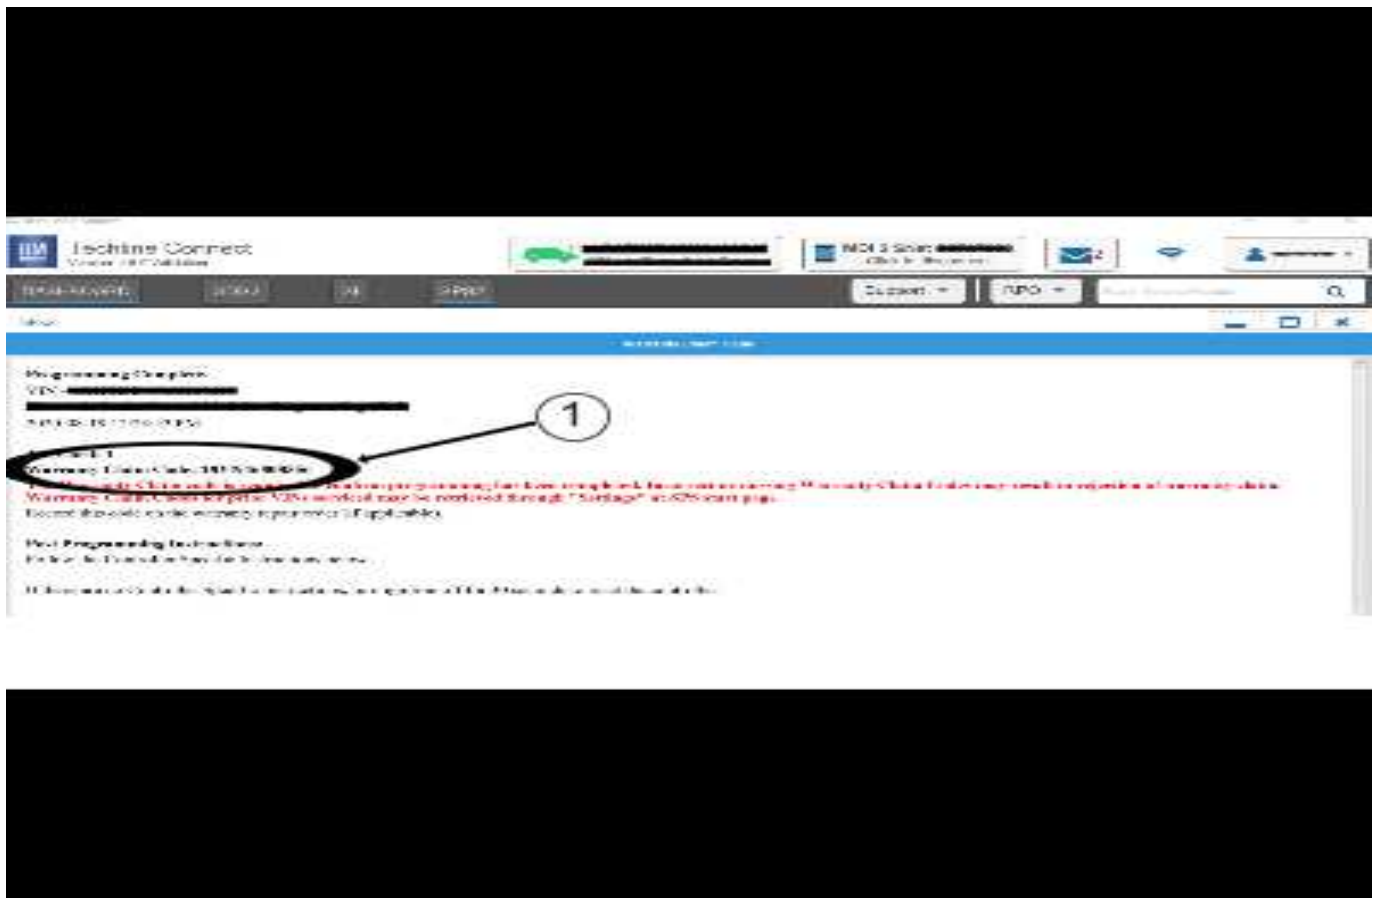
5644478

Important: To avoid warranty transaction rejections, you **MUST** record the warranty claim code provided on the Warranty Claim Code (WCC) screen shown above on the job card. Refer to callout 1 above for the location of the WCC on the screen.

- 2. Record SPS Warranty Claim Code on job card for warranty transaction submission.
