Service Bulletin

Bulletin No.: 22-NA-144

Subject: Service Door Latch, Power Windows, Door Locks and Outside Mirrors Inoperative, Unwanted Theft Alarm Activation, Random Messages Displayed on Driver Information Center (DIC)

Brand:	Model:	Model Year:		VIN Breakpoint:		Engine:	Transmission:
		from	to	from	to		
GMC	HUMMER EV	2022	2022	SOP	NU100230	—	—

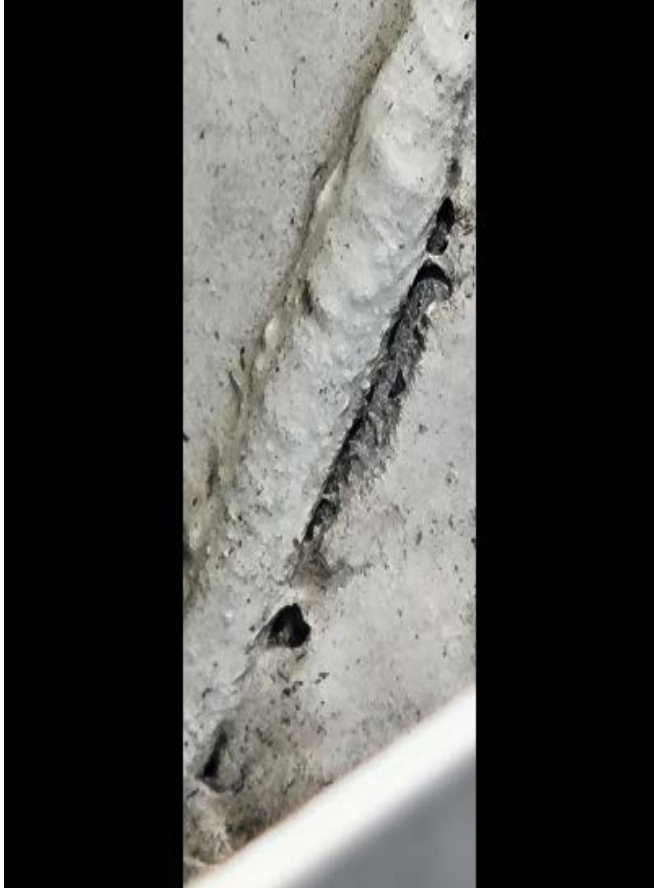
<p>6103692</p> <p>Note: The image above depicts a close-up of a failed seal below the driver side windshield area.</p> <p>This condition may be caused by the driver's front door X500 in-line electrical connector and/or the passenger front door X600 in-line electrical connector, that may have corroded terminals due to a water leak entering inside the upper A-pillar through the panels not sealed properly.</p>
<p>Correction</p>	<p>Open the X500 and X600 to inspect for corroded terminals. Perform a water leak test on suspected sheet metal area, reseal, and re-test for leaks.</p> <p>Repair and/or replace the X500 and/or X600 terminals as required.</p>

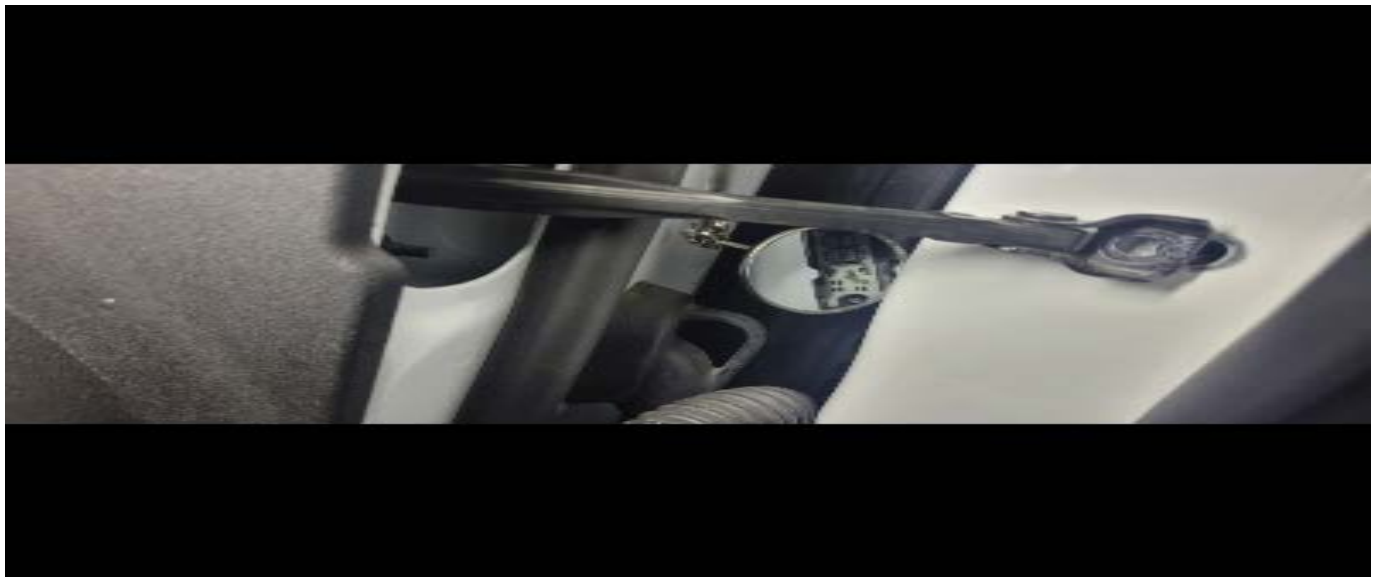
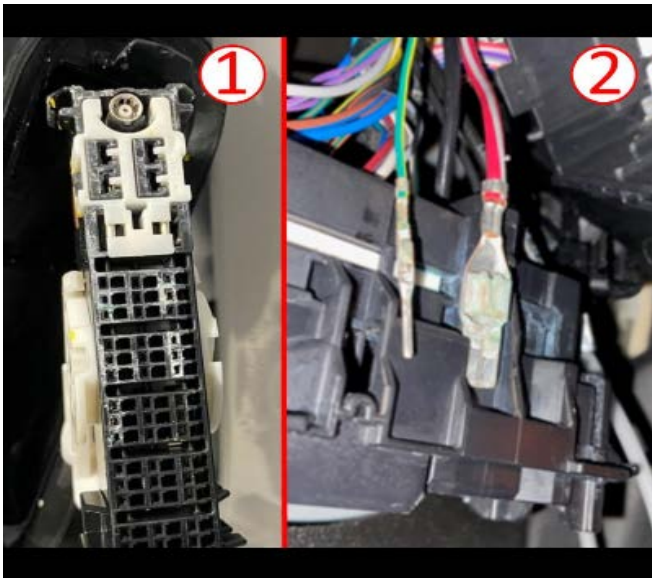
Note: The graphics above are an example of what the corrosion may look like in the X500 connectors.

- If corrosion is found at the door side connector (1) or the instrument side connector (2), continue to step 7.
- If corrosion is not found on the connectors, refer to step 14.

Note: Clean the terminals if at all possible. Only replace the terminals if corrosion has entered the wire.

8. Clean or repair the terminals that **only** require attention. Refer to *Connector Repairs* in the Service Manual.

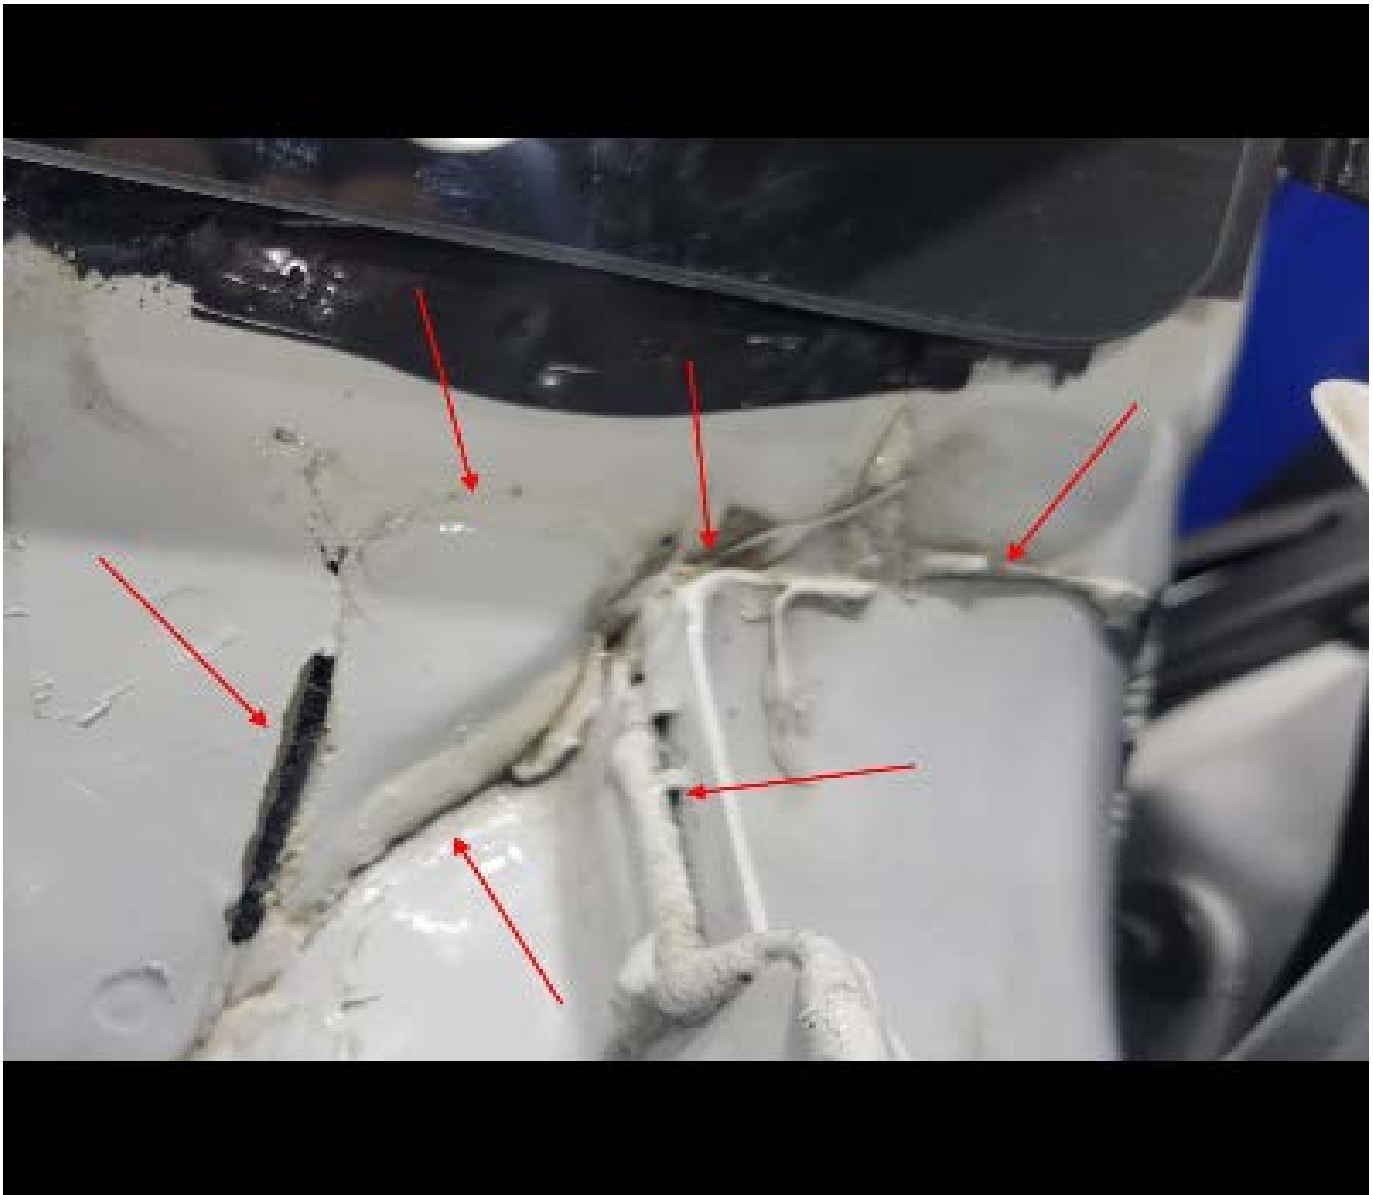
15. Locate the seams where the A-pillar merge to the plenum panel and inner fender as indicated in the graphic above.

16. Wipe the surfaces with Kent Acrysol, P20005, or equivalent, to remove any residual sealer or urethane.

17. Apply a liberal amount of Kent® Quick Seal MSP Seam Sealer, or equivalent, to **All** the seams.
