Subject: Engineering Information - Loss of Propulsion, Loss of Traction and/or Grinding Type Noise Heard After Loss of Traction and/or Vehicle Towed Due to Half Shaft Disconnection

Brand:	Model:	Model Year:		VIN:		Engine:	Transmission:
		from	to	from	to		
Cadillac	XT5	2022	2023	—	—	—	—
	XT6						
Chevrolet	Blazer						
GMC	Acadia

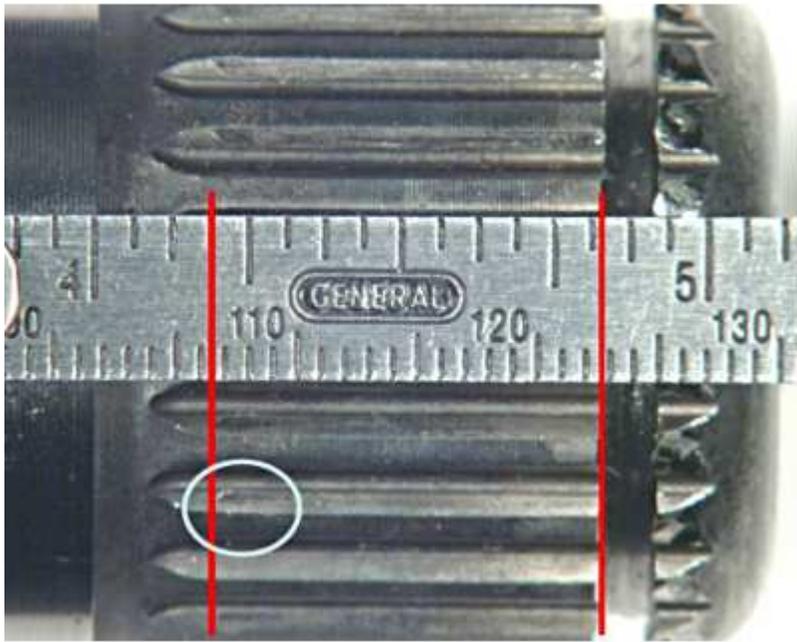
1. Remove the left side front wheel drive shaft, take a clear close up picture of the spline indicating engagement at 16 mm at the end of the groove to the end of the spline, as shown in the picture above. Refer to *Front Wheel Drive Half Shaft Replacement - Left Side* in SI.
