Service Bulletin

Bulletin No.: 22-NA-252

Subject: Information on Malfunction Indicator Light (MIL) Illuminated - DTC U0284, U0285, U1345, and/or U2A9 Set

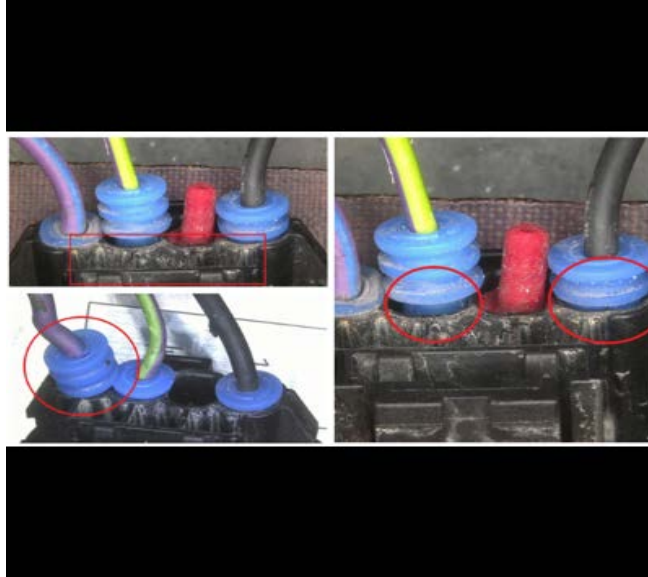
6219342

For DTC U02A9 and U1345:

U02A9 might be set with or without U1345. An unsealed pump connector allowing water leakage into the (M10) charge air cooler pump electrical connector might be the root cause of the communication failure.

Check the CAC Pump connector sealing and look for any corrosion at the pump due to water leakage.

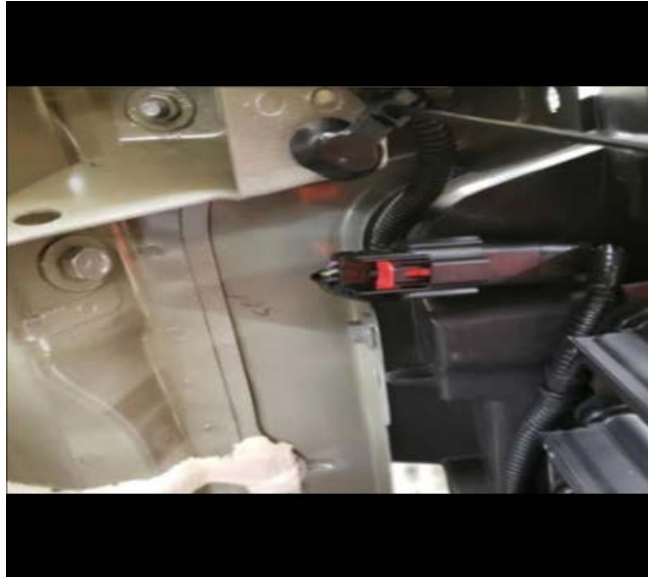
6219339

Cause 2	DTC U1345, U0284 and U0285 may be caused by the engine wiring harness to active grille air shutter actuator in-line connector: <ul style="list-style-type: none"> • Not properly connected • Not properly hold by the rear clip • Grounded on the radiator
Cause 3	DTC U1345 and U0284 may be caused by the active grill air shutter wiring pinched at the radiator support.

For DTC U1345, U0284 and U0285:

Check circuit 4621 connection.

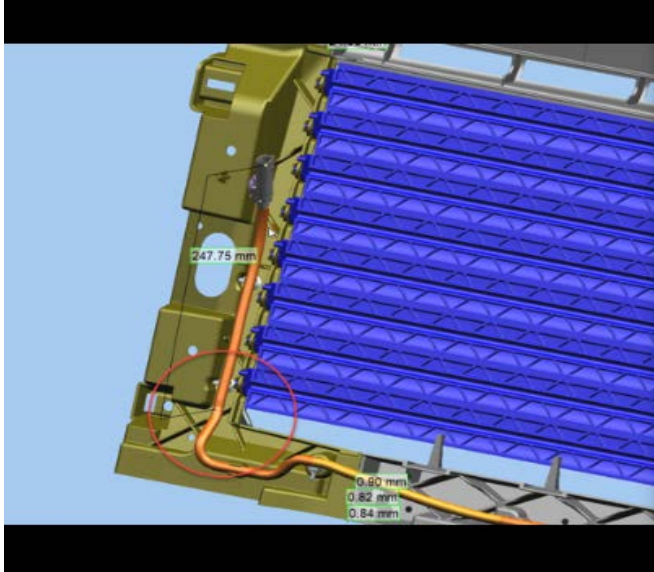
<p>Correction 3</p>	<p>For DTC U1345 and U0284:</p>

<p style="text-align: right;">6219340</p> <p>The graphic above depicts where a pinching condition may be located.</p> <ul style="list-style-type: none"> – Check the active grill air shutter wiring route to identify possible damaged points in the wiring.
---------------------	---
