UPDATE PRIOR TO SALE NOTICE

Global Service Action
Number: N763 UPS8522-2

Subject: Camshaft Carrier Drill Hole	Publication No.: N763 UPS8522-2
	Model: Range Rover (LK)
	Model Year: 2023
	Model: Range Rover Sport (L1)
	Model Year: 2023
	Model: Discovery (LR)
	Model Year: 2023
	Model: Defender (LE)
	Model Year: 2023
	Model: Range Rover Velar (LY)
	Model Year: 2023 - 2024
	Date of Issue: 03 December 2022

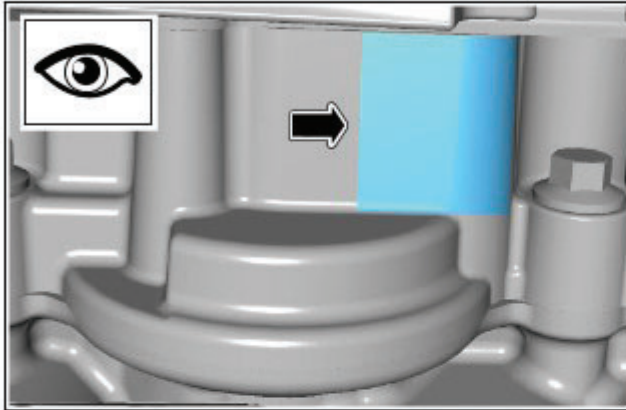
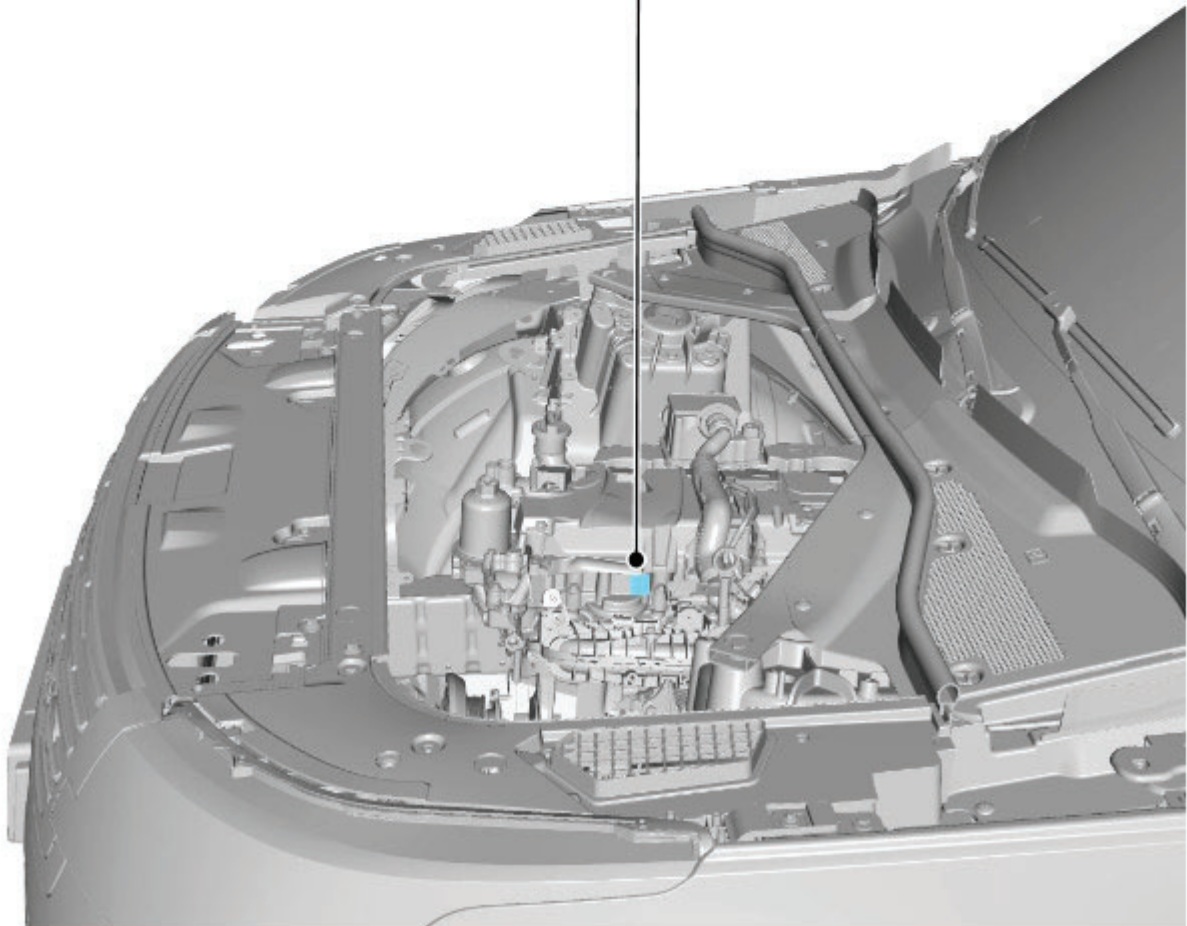
E323282

2. Locate the highlighted area of the camshaft carrier shown in the illustration.

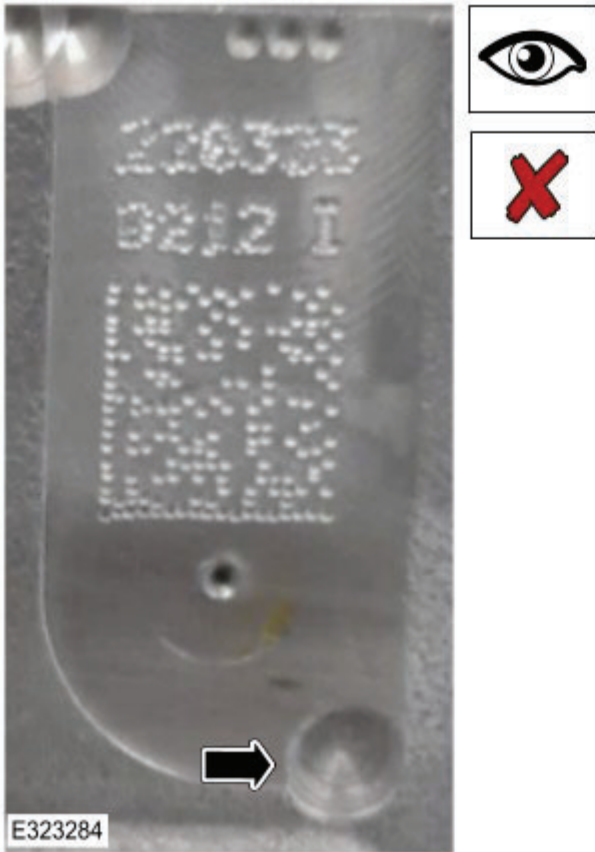
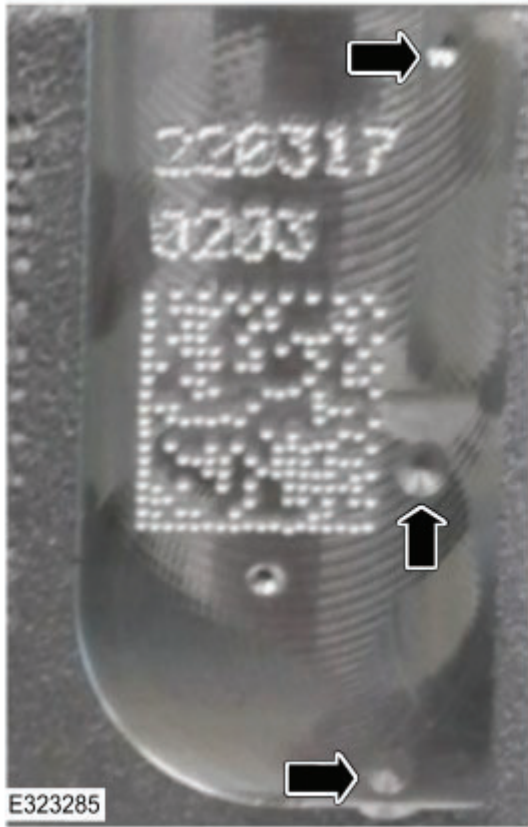
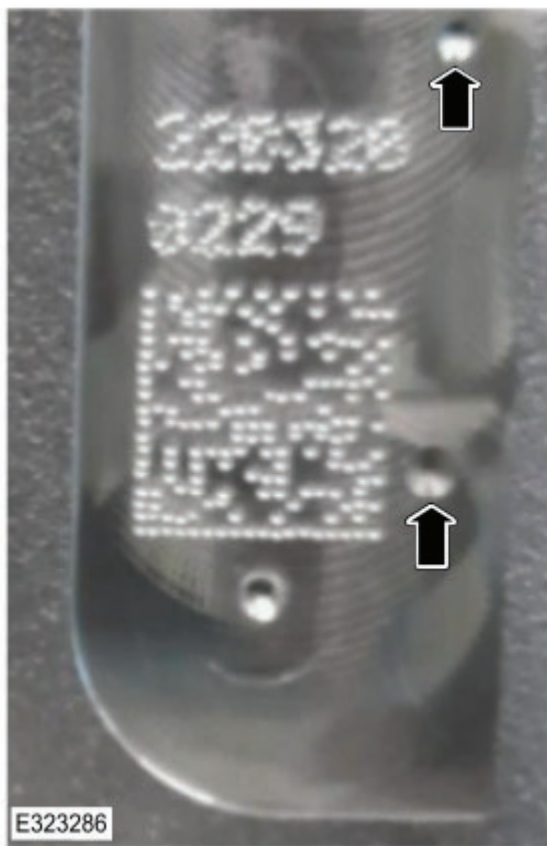
Only inspect for the specific drilled tooling marks which are highlighted by the arrows shown within the illustrations.

3. Inspect the camshaft carrier tooling stamp. The 3 illustrations show 3 potential failure conditions. The arrows shown within the illustrations point to specific drilled tooling marks on the tooling stamp which, if present, indicate a failed inspection.

If **ANY** of the 3 failure conditions are present, **then the vehicle has failed the inspection.**

Contact jlrcamp@jaguarlandrover.com and supply the full 17-digit [VIN](#) of the vehicle, **continue to quarantine the vehicle and wait for further instructions.**

Install the left air filter outlet pipe and release the vehicle, (see TOPIx Workshop Manual section 303-12: Intake Air Distribution And Filtering - Ingenium I6 3.0l Petrol - Removal and Installation - Left Air Filter Outlet Pipe).
