UPDATE PRIOR TO SALE NOTICE

Global Service Action
Number: N763 UPS8522-4

Subject: Camshaft Carrier Drill Hole	Publication No.: N763 UPS8522-4
	Model: Range Rover (LK)
	Model Year: 2023
	Model: Range Rover Sport (L1)
	Model Year: 2023
	Model: Discovery (LR)
	Model Year: 2023
	Model: Defender (LE)
	Model Year: 2023
	Model: Range Rover Velar (LY)
	Model Year: 2023 - 2024
	Date of Issue: 15 December 2022
	Expiry Date: 09 December 2023

SERVICE INSTRUCTION - N763 UPS8522-4

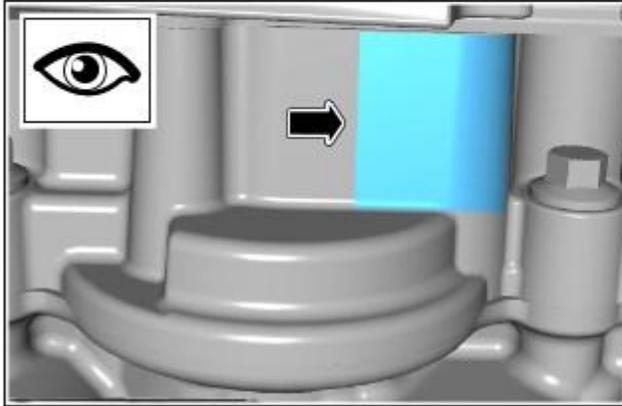
E323282

2. Locate the highlighted area of the camshaft carrier shown in the illustration.

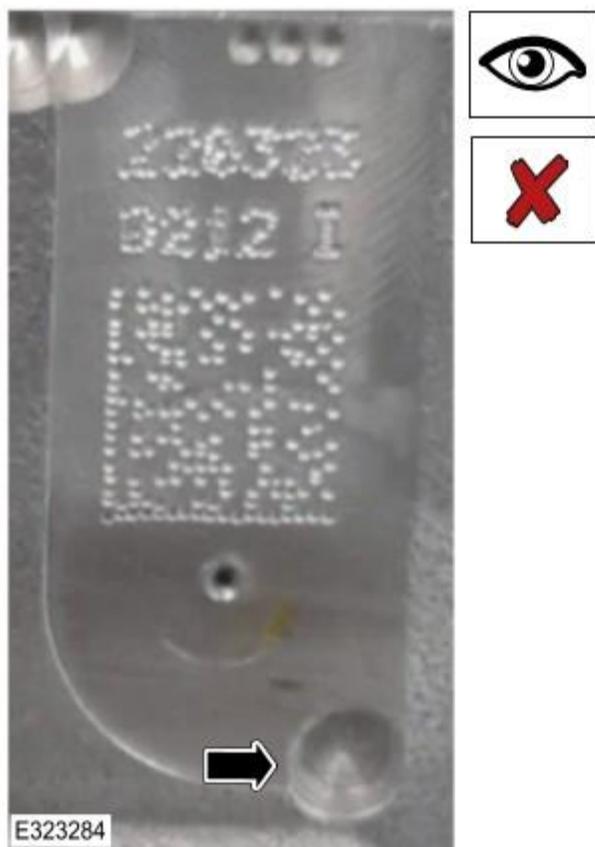
5. The failure condition shown highlights 1 drilled tooling mark in the lower right side of the tooling stamp.

If the 1 drilled tooling mark in the lower right side of the tooling stamp is present, then the vehicle has failed the inspection.

Vehicles which failed the inspection: Contact jlrcamp@jaguarlandrover.com and supply the full 17-digit [VIN](#) of the vehicle, **continue to quarantine the vehicle and wait for further instructions. DO NOT submit a claim for the inspection, instructions for claiming the inspection that failed will be given with the repair process.**

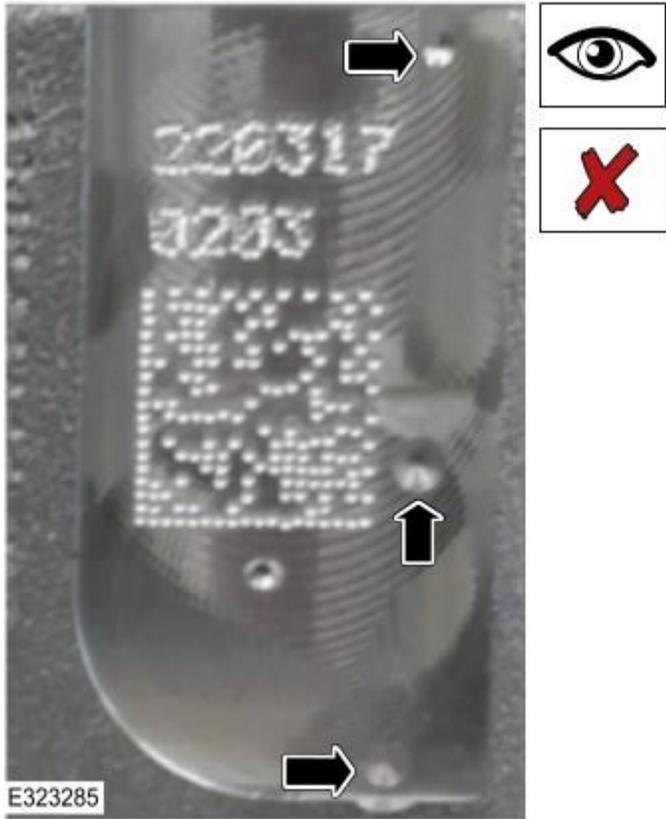
- 6. The failure condition shown highlights 3 drilled tooling marks in the upper, middle and lower right side of the tooling stamp.

If the 3 drilled tooling marks in the upper, middle and lower right side of the tooling stamp are **ALL** present, then the vehicle has failed the inspection.
