**Location:** Powertrain

**Topic:** Grease noted externally of oil and coolant pump bellow

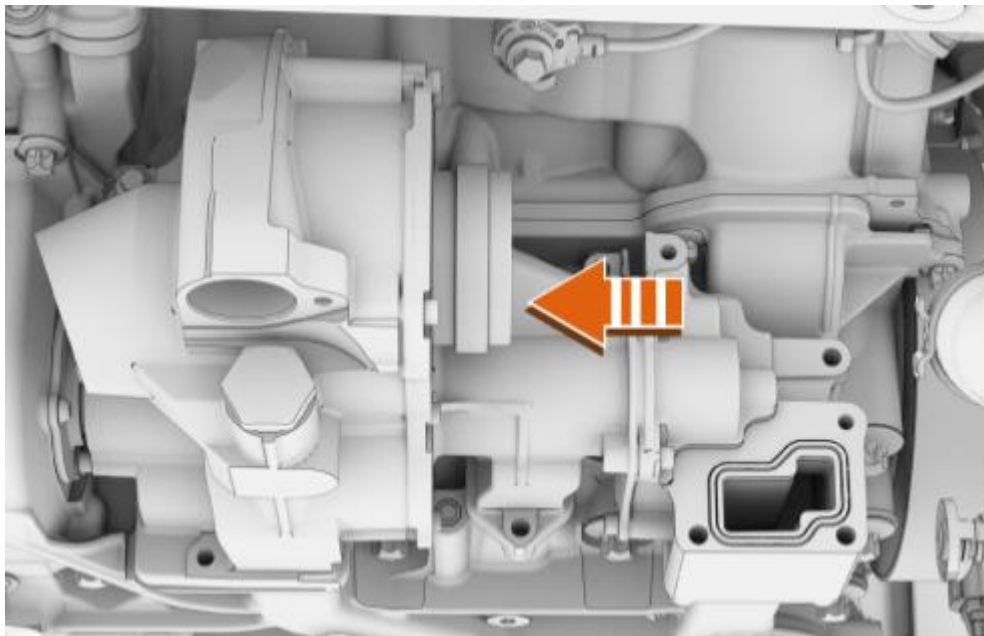
During inspection of the coolant and oil pump, grease may be present on the outside of the connecting bellow between the oil and coolant pump.

**Figure 1.1** – Oil pump fitted without coolant pump showing bellow position

It is necessary to inspect the condition of the bellow to ensure there are no tears or damage and it is seated correctly.

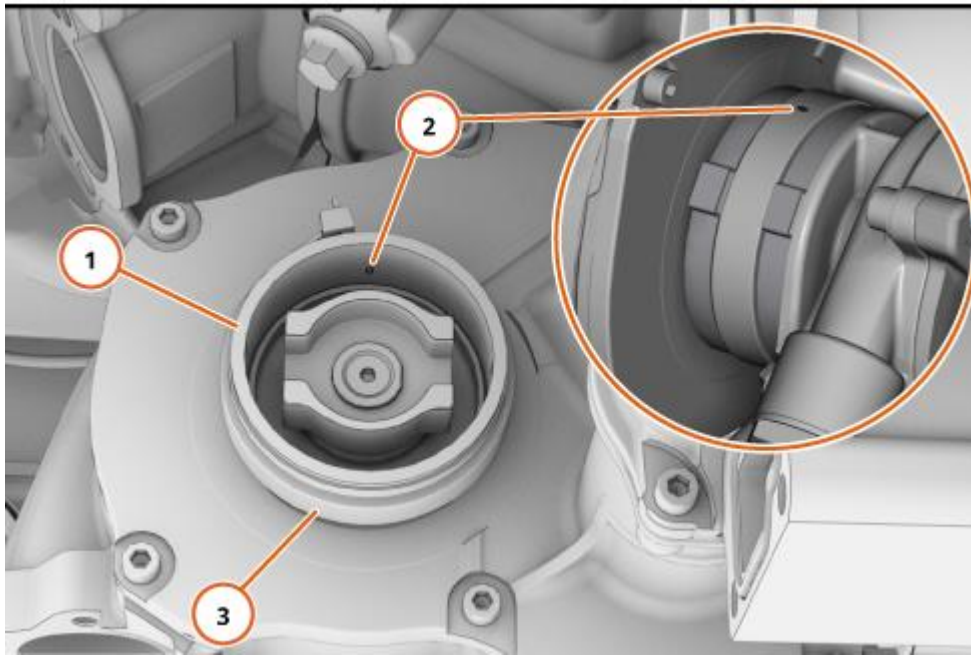
**Figure 1.2** – Bellow vent hole facing upward

This is a dynamic grease filled joint which may allow for some grease to exit via the vent hole under hot running temperatures. This is expected behaviour for this component.

If no concern is found with the bellow, inspect the vent hole and cable tie clasp position ensuring they are positioned facing upward as per **figure 1.2**.

**CARE POINT: Do not use any degreaser or harsh cleaning fluid directly on the bellow**

If there is a contamination concern or grease does continue to leak excessively, please raise a Technical Request for further guidance.
