## STAR ONLINE PUBLICATION

**Case Number:** S2223000014

**Symptom/Vehicle Issue:** Water Leaking From Overhead Console Or Headliner  
Microphone On Sunroof Equipped Vehicle

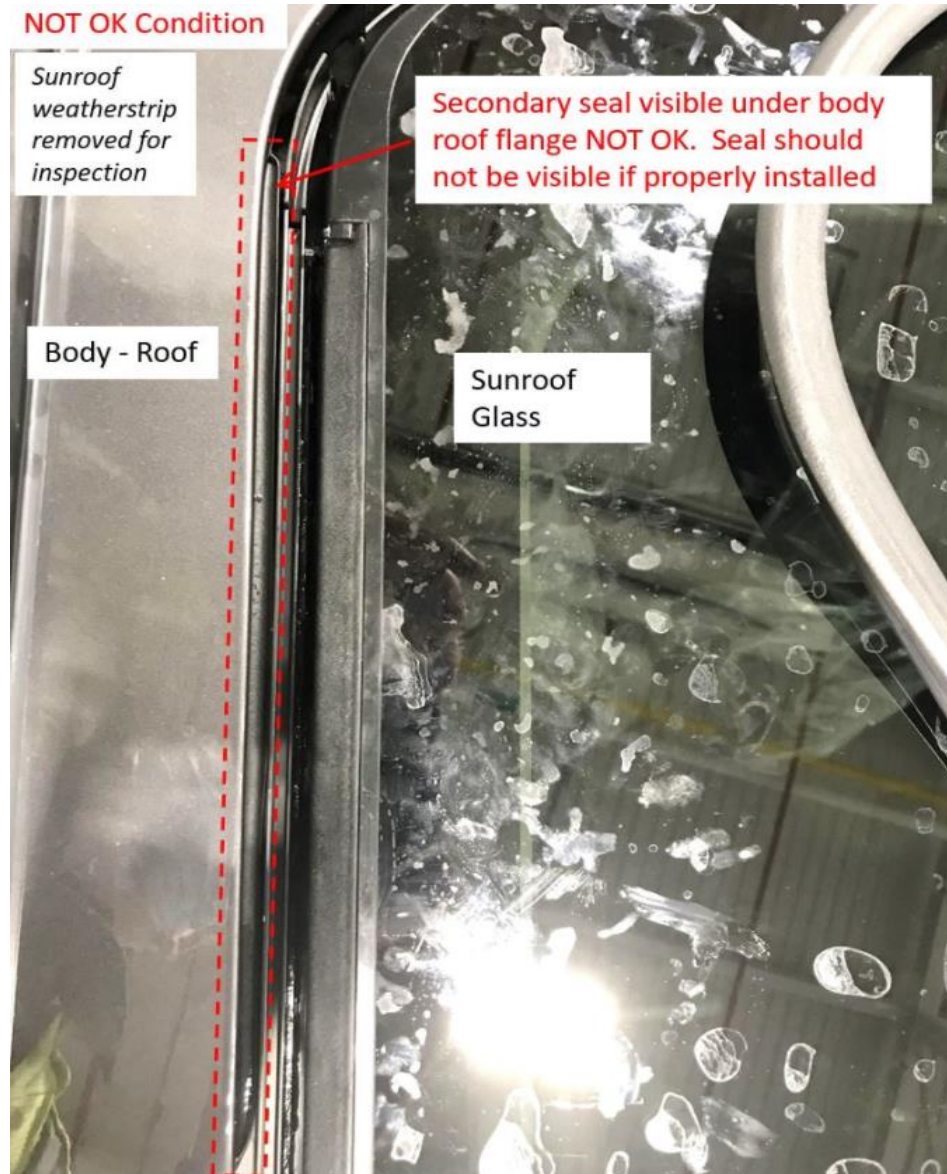
Fig 1

Sunroof weatherstrip removed. Secondary seal visible from top of vehicle. Not correct.

**Discussion:** With sunroof glass in closed position visually inspect from top of roof the interface of front sunroof glass to weatherstrip along the front for pinched wind deflector fabric (Fig 1). Open sunroof glass and remove sunroof exterior weatherstrip (perimeter seal). Visually inspect for sunroof secondary seal trapped under body roof opening flange around entire perimeter of roof opening. If the secondary seal is folded and visible – sunroof frame will require removal to replace the secondary seal. See cut-away images (Fig 2)

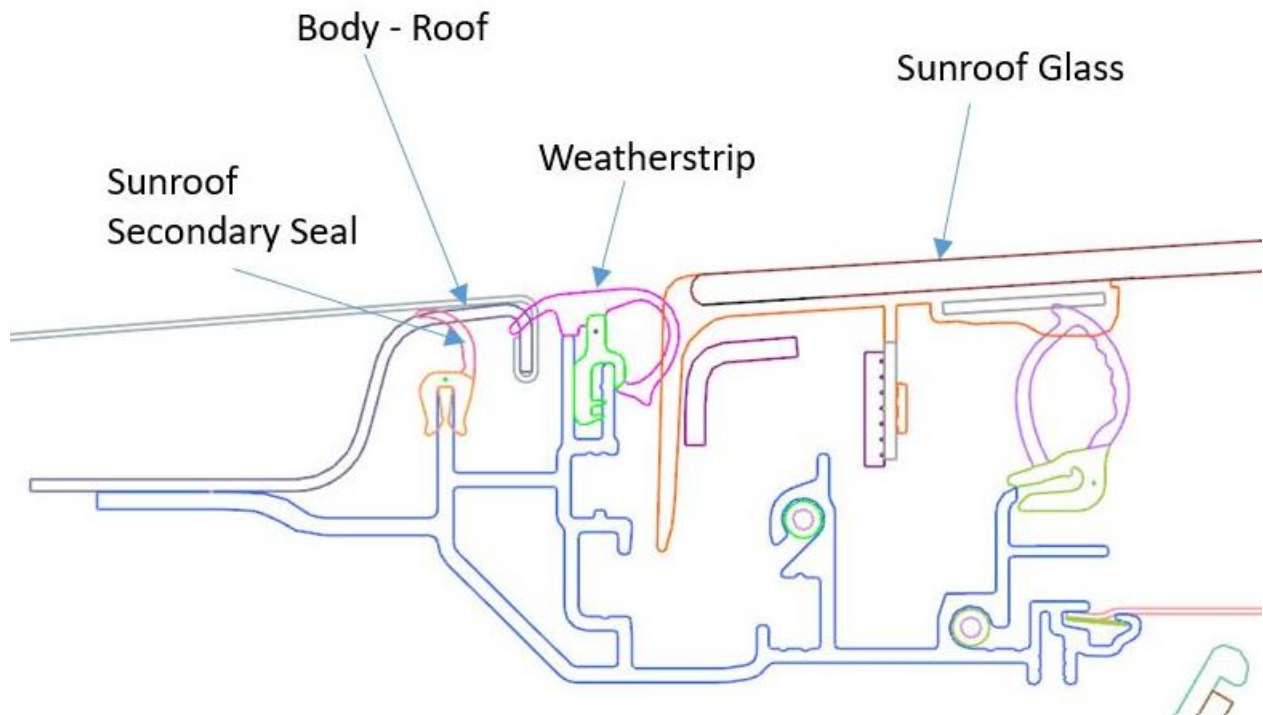
### Correct Condition

Fig 2  
Cut-away cross view of sunroof

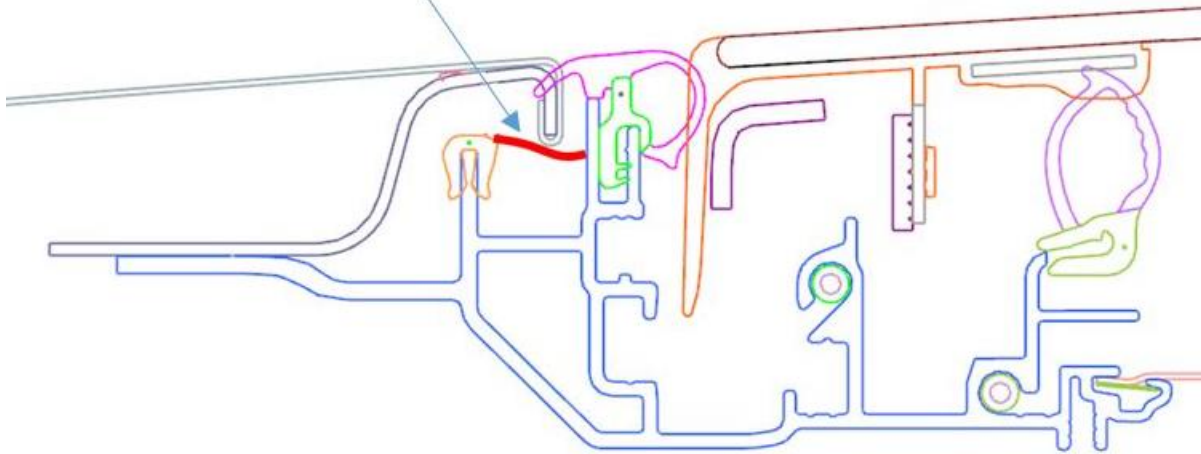
### Not OK Condition

Secondary Seal trapped  
under roof flange

Fig 3  
Folded Secondary Seal

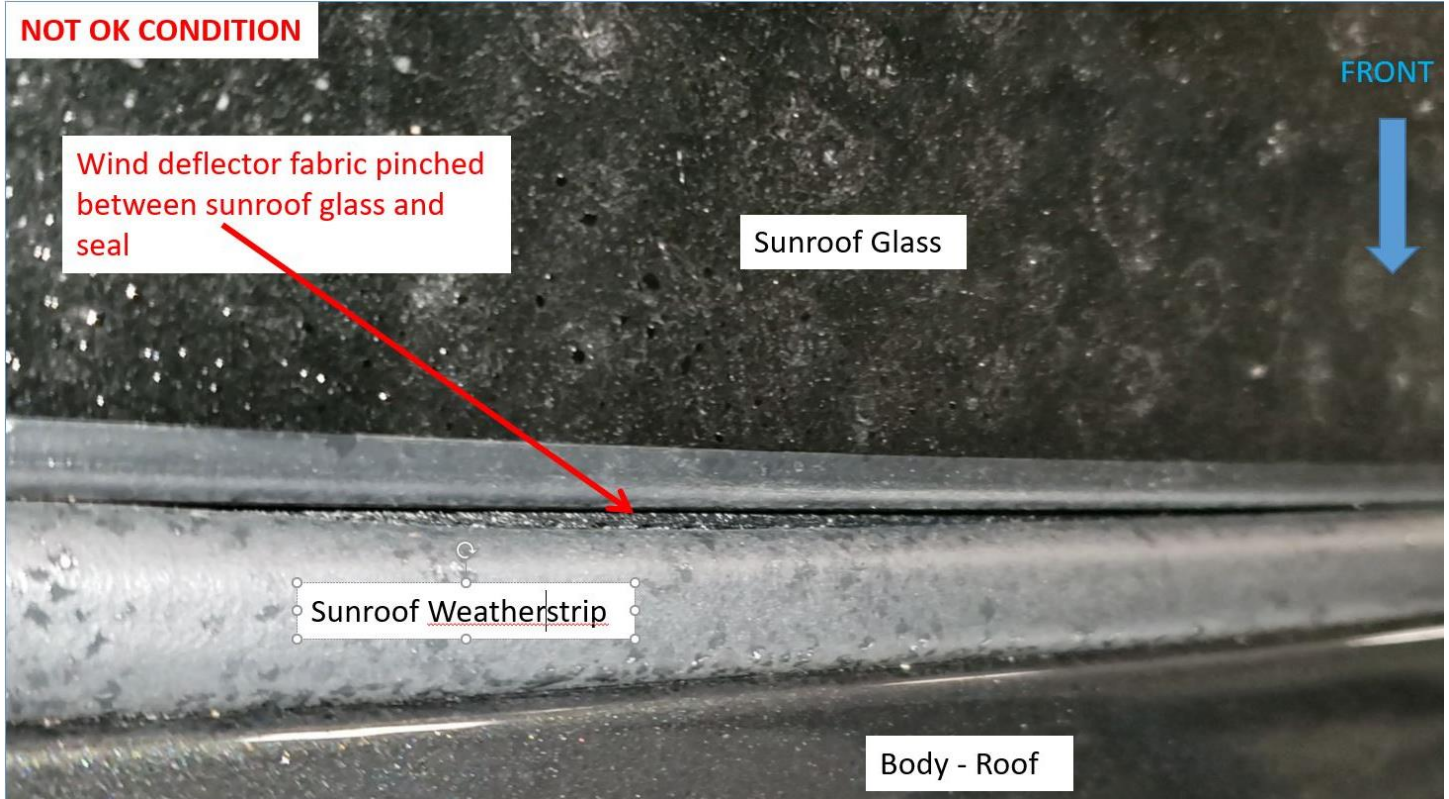
Fig 4  
Wind deflector fabric pinched. Incorrect installation.

If wind deflector fabric is pinched between sunroof glass and weatherstrip replace both the wind deflector and sunroof weatherstrip. (Fig 4)
